Retrofit of
Historic TimberFramed Buildings
in the UK:
monitoring
replacement infill
panels

Physical Monitoring of Replacement Infill Panels: Comparing hygrothermal simulations and dual climate chamber testing

Hygrothermal Monitoring of Timber-Frame Replacement Infill Panels

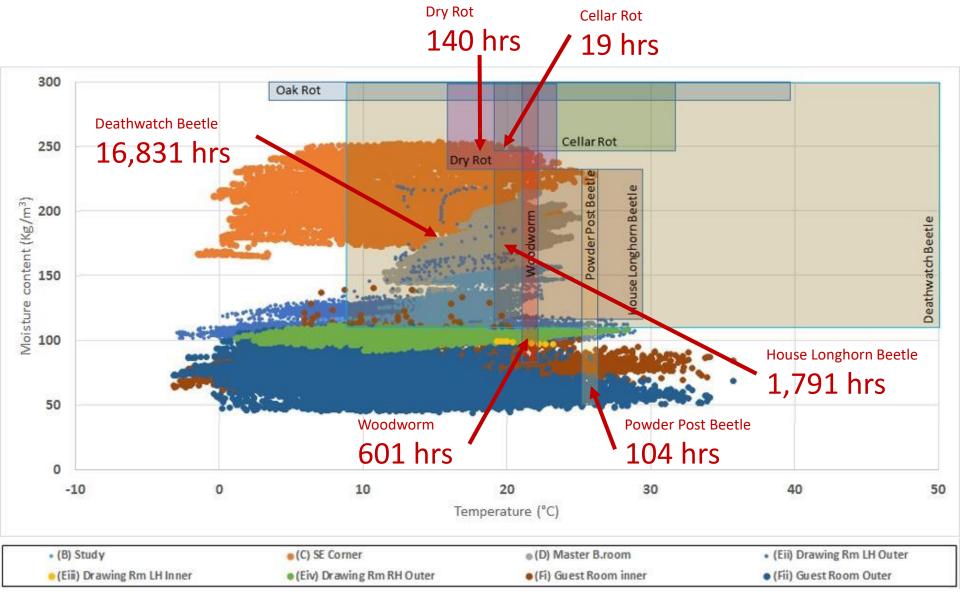
Hygrothermal measurements overlaid with principal Biological Threats.

In Situ Interstitial Hygrothermal Monitoring (Aug 16- Aug 18)

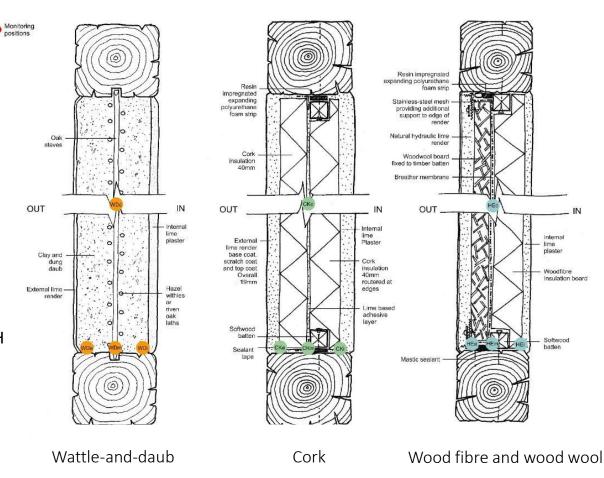
Moisture content – Monitoring v Simulation

Panel Infill Type		Glaser calculation	WUFI® Pro5.3	WUFI® 2D 3.3	Physical monitoring	Agreement
Wattle-and- Daub	Exterior	→	4	4	↑	×
	Centre	→	71	71	→	✓
	Interior	↑	^	^	71	✓
Cork	Exterior	→	71	Ψ	↑	×
	Centre	→	→	→	→	✓
	Interior	→	Ä	↑	→	×
Wood wool and woodfibre	Exterior	→	7	Ψ	1	×
	Centre	↑	↑	Λ.	Λ	✓
	Interior	→	Ψ	Λ.	Ψ	×

Comparison of results from simulation and monitoring: Steady \rightarrow , Decrease ψ , Increase \uparrow

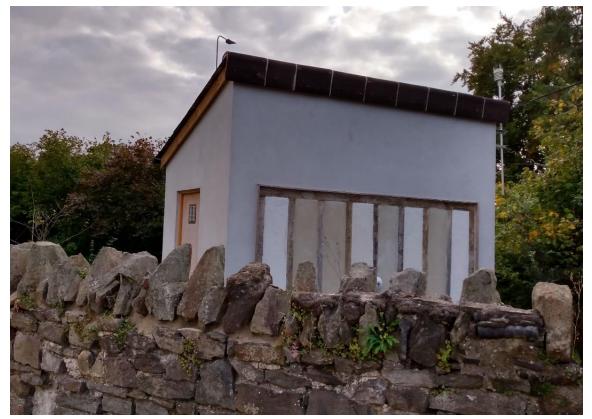
Test cell at Cardiff University, Cathays Campus.

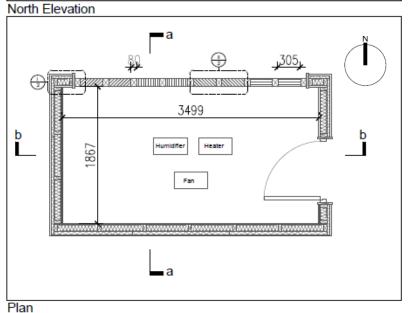
Test infill panels mounted in north façade

- A Wattle & Daub
- B Expanded Cork Board
- C Wood Fibre/ Wood Wool composite
- D Hempcrete

Each pair of panels finished one with lime-hemp plaster, the other with NHL 3.5

North façade chosen with aim to minimise climatic variables

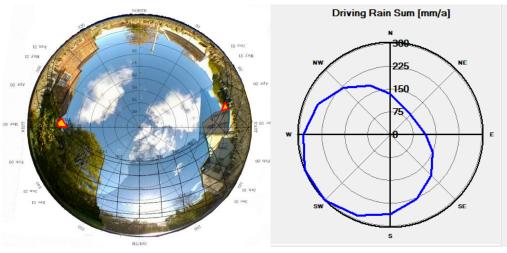
On-site weather station to measure micro climate

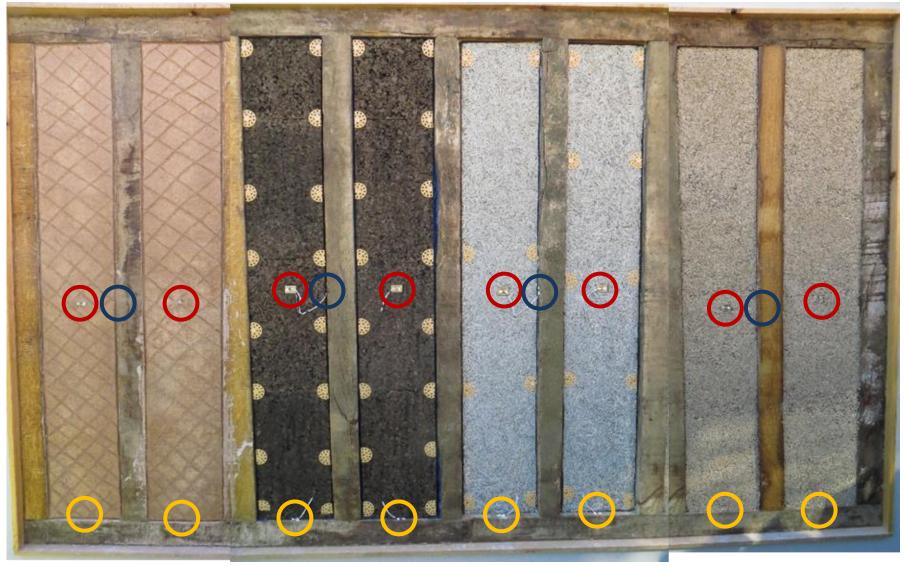
Test panels prior to application of external render with monitoring locations highlighted.

Red- Mid Panel, Blue- Vertical Panel to Frame Junction, and Yellow- Horizontal Panel to Frame Junction

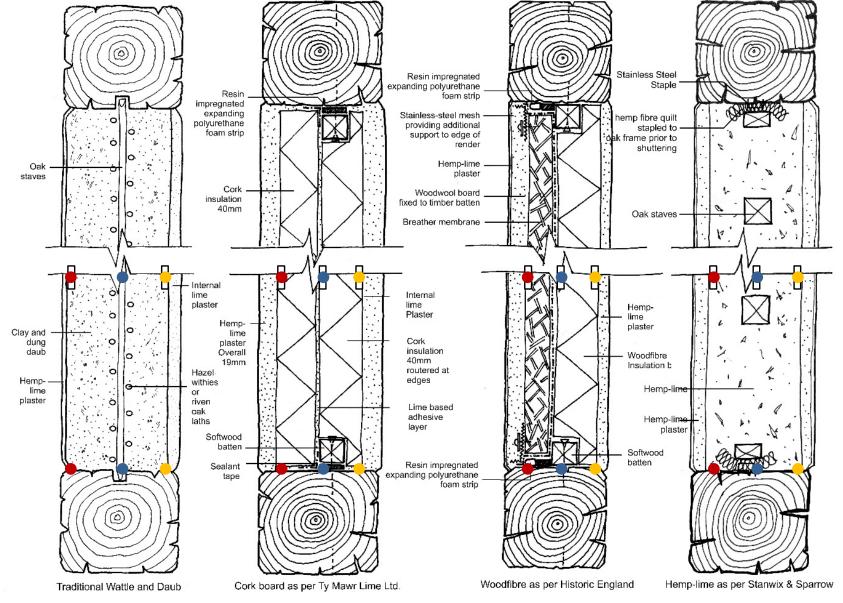
Sections showing panel infill details and monitoring locations. Red- external (e), Blue- central (c), and yellow- Internal (i)

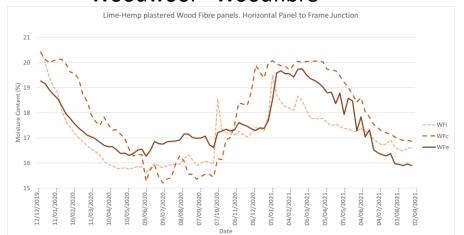
Woodwool - Woodfibre

Moisture content Lime-hemp rendered panels. Horizontal Panel to Frame Junction

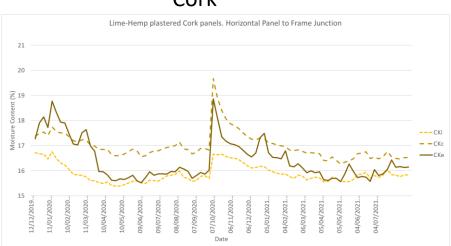
Cork

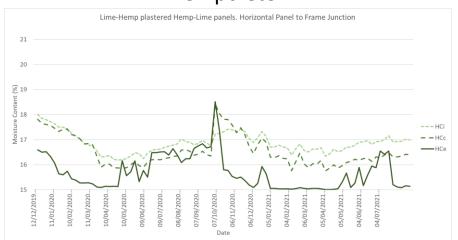
Hempcrete

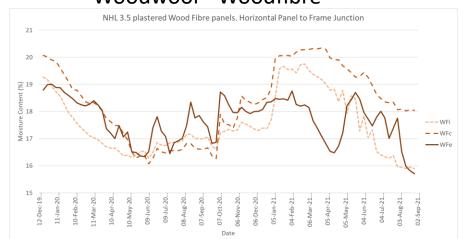
Woodwool - Woodfibre

Moisture content NHL 3.5 rendered panels. Horizontal Panel to Frame Junction

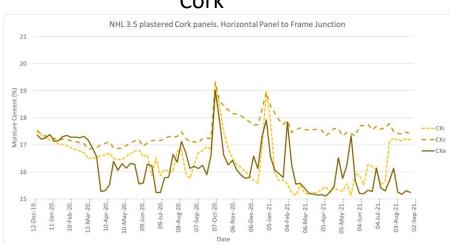
Cork

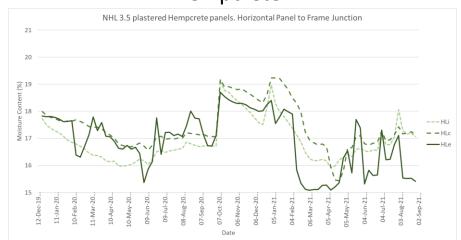
Hempcrete

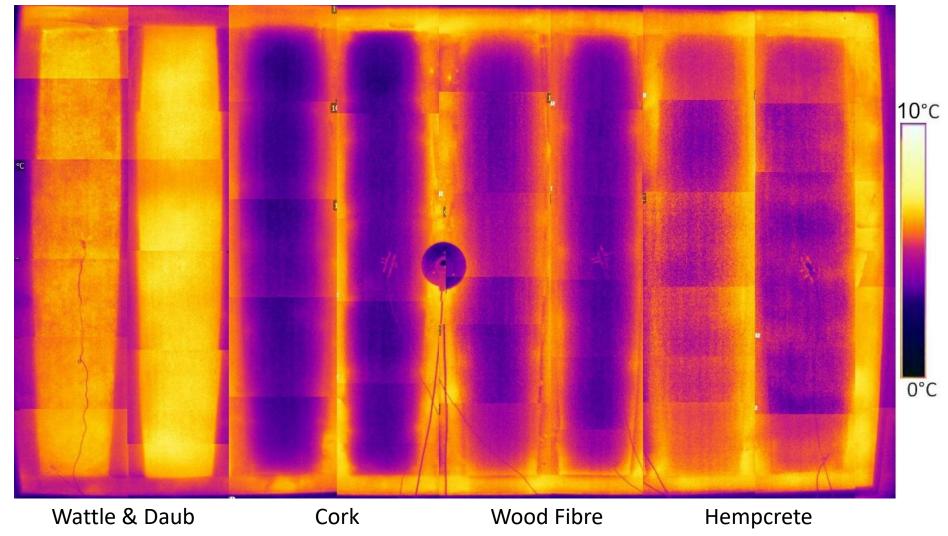
Results of in situ u-value monitoring showing thermal transmittance of test panels for the periods January-March 2020 and November 2020 -January 2021. Best thermal performance highlighted in green, worst in red.

Infill Material	Internal and External finish	Position	No.	Measured Jan/March 2020 (W/m²K)	Measured Nov 2020/ Jan 2021 (W/m²K)	Change	Calculated (W/m²K)	Av. Moisture content Jan/March 2020 (%)	Av. Moisture content Nov 2020/ Jan 2021 (%)	Change
	NHL 3.5	Midpoint	1	2.92	2.95	0.03	2.65	18.2	17.6	-0.6
Wattle &		Corner	2	2.18	2.08	-0.10		17.7	16.7	-0.9
Daub	Lime- hemp	Midpoint	3	2.21	2.39	0.18	1.92	18.6	16.9	-1.8
		Corner	4	2.40	2.38	-0.02		18.0	16.3	-1.7
Cork	NHL 3.5	Midpoint	5	0.54	0.50	-0.04	0.45	16.8	16.6	-0.2
		Corner	6	0.68	0.79	0.11		17.2	17.1	-0.1
	Lime- hemp	Midpoint	7	0.46	0.47	0.01	0.43	17.2	16.6	-0.6
		Corner	8	0.53	0.53	0.00		17.2	16.5	-0.7
Wood Fibre	NHL 3.5	Midpoint	9	0.71	0.63	-0.08	0.58	17.3	17.3	0.0
		Corner	10	0.71	0.79	0.08		18.4	18.3	-0.2
	Lime- hemp	Midpoint	11	0.66	0.66	0.00	0.53	17.3	17.0	-0.4
		Corner	12	0.77	0.83	0.06		18.4	19.3	1.0
Hempcrete	NHL 3.5	Midpoint	13	1.56	0.94	-0.62	0.67	17.5	17.6	0.1

Corner	14	1.54	1.30	-0.24		17.3	18.3	1.0
	Lime- hemp	Midpoint	15	1.22	1.00	-0.22	0.58	17.7	16.9	-0.8
		Corner	16	1.34	1.20	-0.14		16.8	16.1	-0.7
