Acoustic emission for assessment of impact and lightning damage to woven carbon fibre laminates

Key words: Structural Health Monitoring, Composite, Aerospace, Acoustic Emission (AE), Lightning Strike, Compression After Impact.

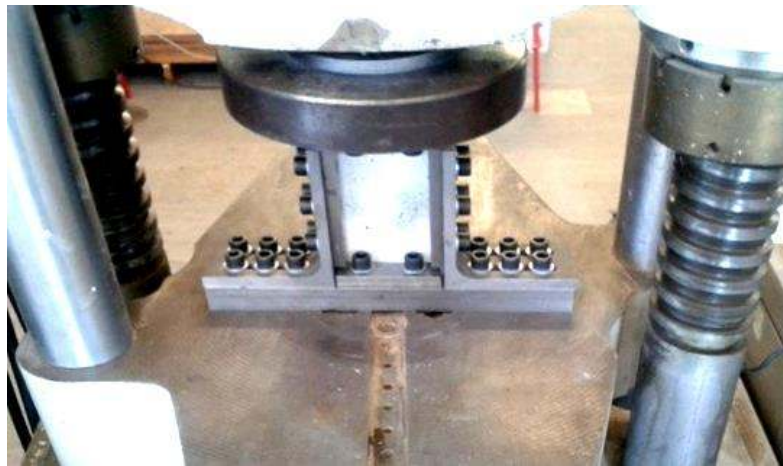
A Compression After Impact (CAI) test according to [8] was then performed on each sample. A bespoke frame was fitted to an electro-mechanic compression testing machine (Figure 3). Knife edges held the specimen in place in order to promote the failure location in the damaged area, and avoid edge failure. Load was increased up to 10kN, released to 2kN and then increased again until failure. The test was performed in displacement control at a rate of 1mm/min. During all the compression tests, AE data was recorded as well with the same setup used during impacts.

Figure 3: CAI specimen fitted in the compression rig

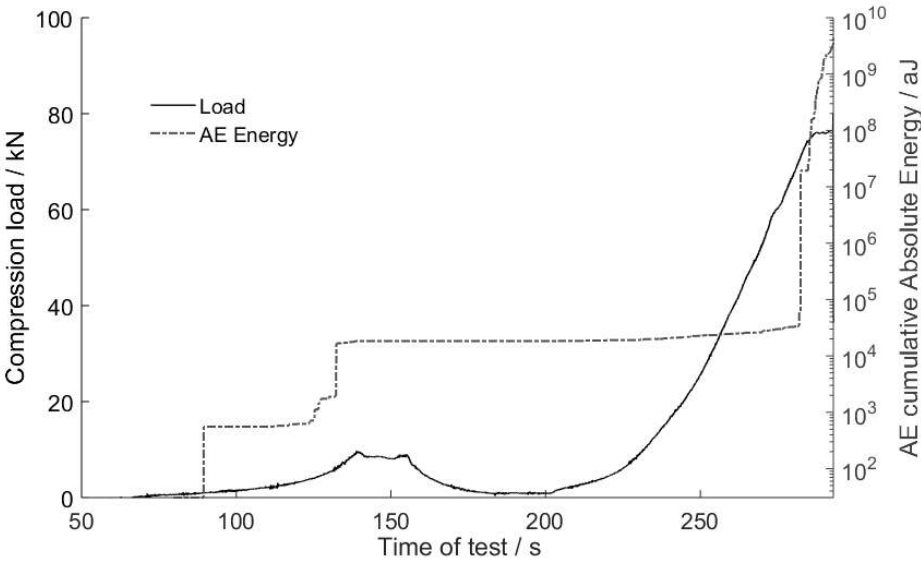
During the CAI tests, AE activity was evident during the first loading cycle (Figure 9); after unloading, no significant emission was detected until the load exceeded the hold load (i.e. the specimen exhibits a strong Kaiser effect). The AE energy increased abruptly shortly after the maximum load was reached; the specimens then tended to fail in the middle section (Figure 10).

Figure 9: load / AE Energy release during a compression test

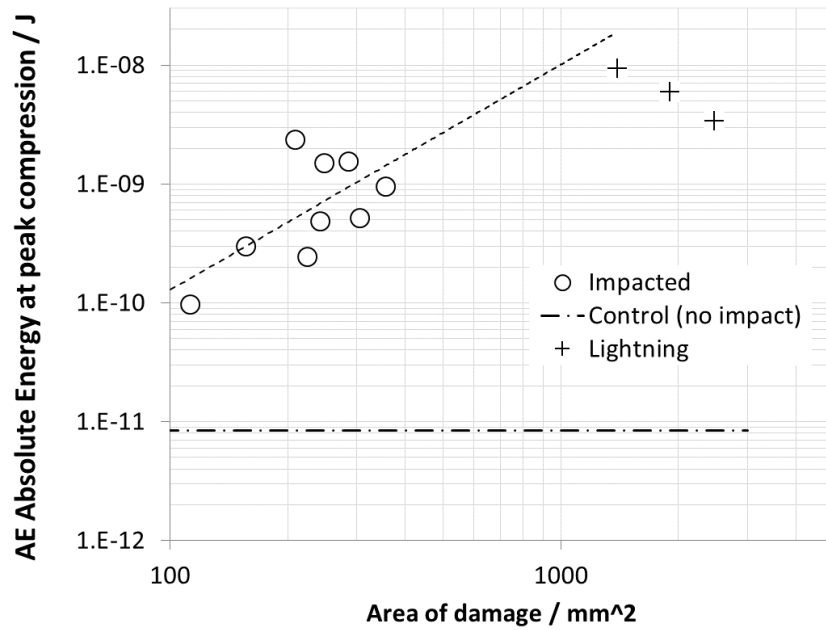
The AE energy values during various phases of the test were compared. Figure 11 shows the cumulative energy release for all specimens at the moment when the specimen reached the peak compression load. A power law trend (linear in double-log scale) is visible although the lightning-struck samples tend to show a form of saturation.

Figure 11: Area of damage versus AE absolute energy released at peak compression

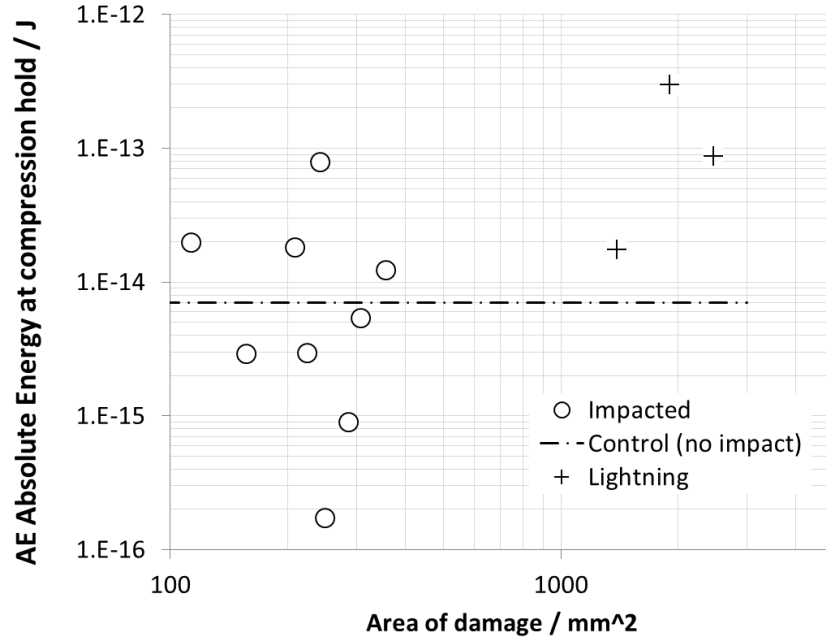
Comparing the AE cumulative energy released during the first phase of the test, until the loading hold, shows no significant correlation (Figure 12).

Figure 12: Area of damage versus AE absolute energy during the first load ramp

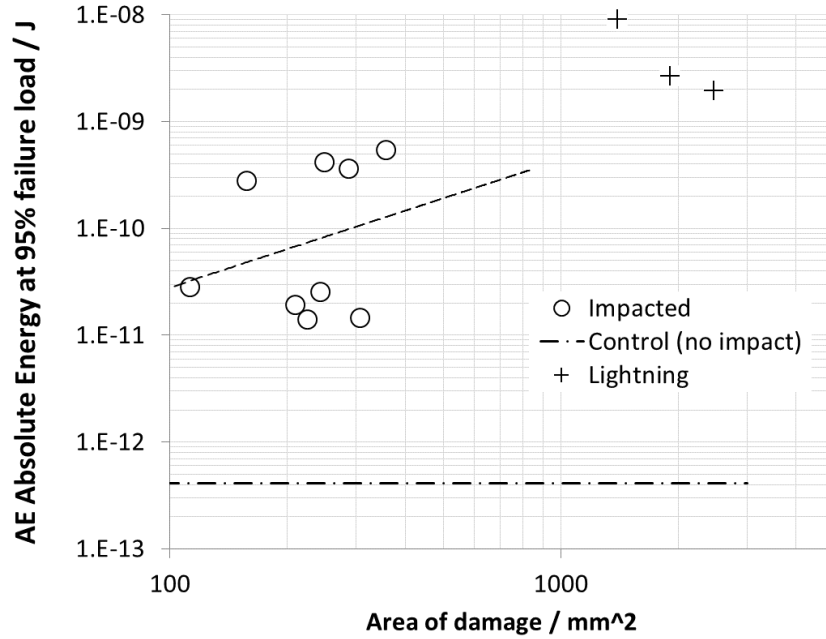
Comparing the total AE energy release at 95% of the peak (failure) load results in a relationship similar to the one seen at peak load (Figure 13).

Figure 13: Area of damage versus AE absolute energy at 95% failure load
