**Cite this article:** Mol L, Gomez-Heras M, Brassey C, Green O, Blenkinsop T. 2017 The benefit of a tough skin: bullet holes, weathering and the preservation of heritage. *R. Soc. open sci.* **4**: 160335. <http://dx.doi.org/10.1098/rsos.160335>

# The benefit of a tough skin: bullet holes, weathering and the preservation of heritage

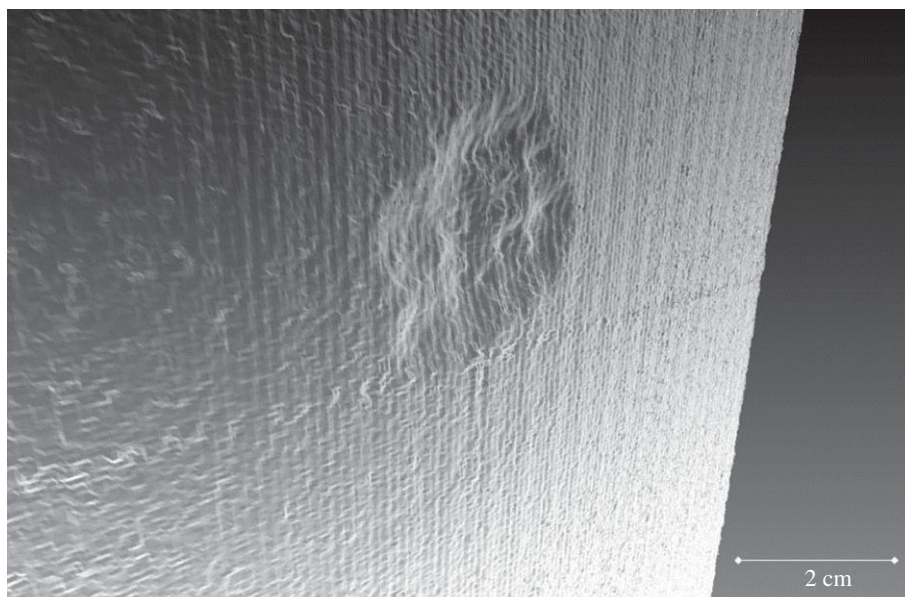
**Figure 5.** Mephisto Eos 3D scan of a bullet impact on the stone surface (not treated with Wacker OH 100).

Material loss from the surface after the bullet impact was almost negligible, as it averaged 2.57 g (0.05% of total weight) per sample (table 2), though loss of surface was clearly visible, as illustrated by figure 5. Interestingly, there was no noticeable difference reported between loss of mass from Wacker OH 100 treated surfaces and non-treated surfaces.

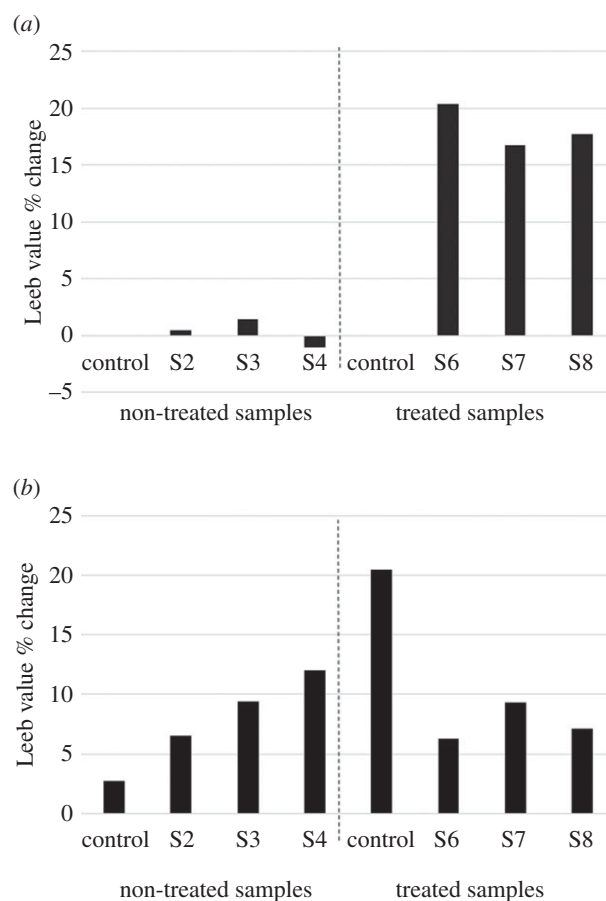
**Figure 6.** (a) Loss of strength of rock surface as measured after bullet impact and (b) loss of strength of rock surface as measured after environmental stress cycles in cabinet.

The repeated measurements of the sample surfaces are shown in figure 6. The initial Wacker OH 100 treatment shows a significant increase in the measured surface hardness at samples 5–8. This fits the

However, this increase in hardness appears to be rapidly reversed at the time of impact, while the overall surface hardness in samples 2–4 does not appear to reduce as dramatically, staying either roughly even (strength loss of 0.40% in sample 2 and 1.44% in sample 3) or in the case of sample 4 strangely increasing a fraction (1.04%). To interpret this data the elasticity of the rock face needs to be taken into account; while Wacker OH 100 can protect the surface from overall weathering processes such as abrasion and infiltration of moisture, owing to its hydrophobic nature [26], it can also be a deterioration factor as the loss of elasticity within the stone surface can severely decrease the overall stability of the surface upon impact. This phenomenon has been previously noted by Momber [34] who concluded that harder surfaces (as simulated by the Wacker OH 100 treatment) are prone to developing fracture networks upon impact whereas in softer materials (as simulated here by the untreated surfaces) crack formation was dampened by plastic flow of the impact resonance. It, therefore, appears that while the Wacker OH 100 treatment initially strengthened the surface, the noticeably lowered rock surface hardness values indicate that the impacts have created a network of microfractures across the rigid surface.

A further investigation of the overall results on strength loss (figure 6) indicates some unexpected results, while the impact of the initial bullet had a far greater impact on loss of strength on the surface-hardened samples, this trend reversed under the environmental strains placed upon the stone samples in the environmental cabinet, where environmental strain as recorded by surface strength loss had a greater impact on the non-treated samples. The presence of water at the foot of the block (samples 3, 4, 7 and 8) was detrimental irrespective of the presence of case hardening.

As can be seen in figures 6 and 7, all samples were negatively affected by the environmental cabinet treatment. However, the extent to which the samples were affected by the treatment appeared to be strongly related to the nature of fracture network developed at the time of impact, as based on the research set out by Momber [34]: The rigid, Wacker OH 100 treated, fractured surface appears to be more vulnerable to temperature changes overall, whereas the untreated and more plastic surface appears to cope far better with the thermal stresses placed upon the samples in the environmental cabinet but suffered noticeable degradation of the impact area, leaving it vulnerable to potential cavernous weathering. The pre-impact condition of the surface is therefore instrumental in determining the impact of a projectile, such as a bullet, and projecting future deterioration patterns.

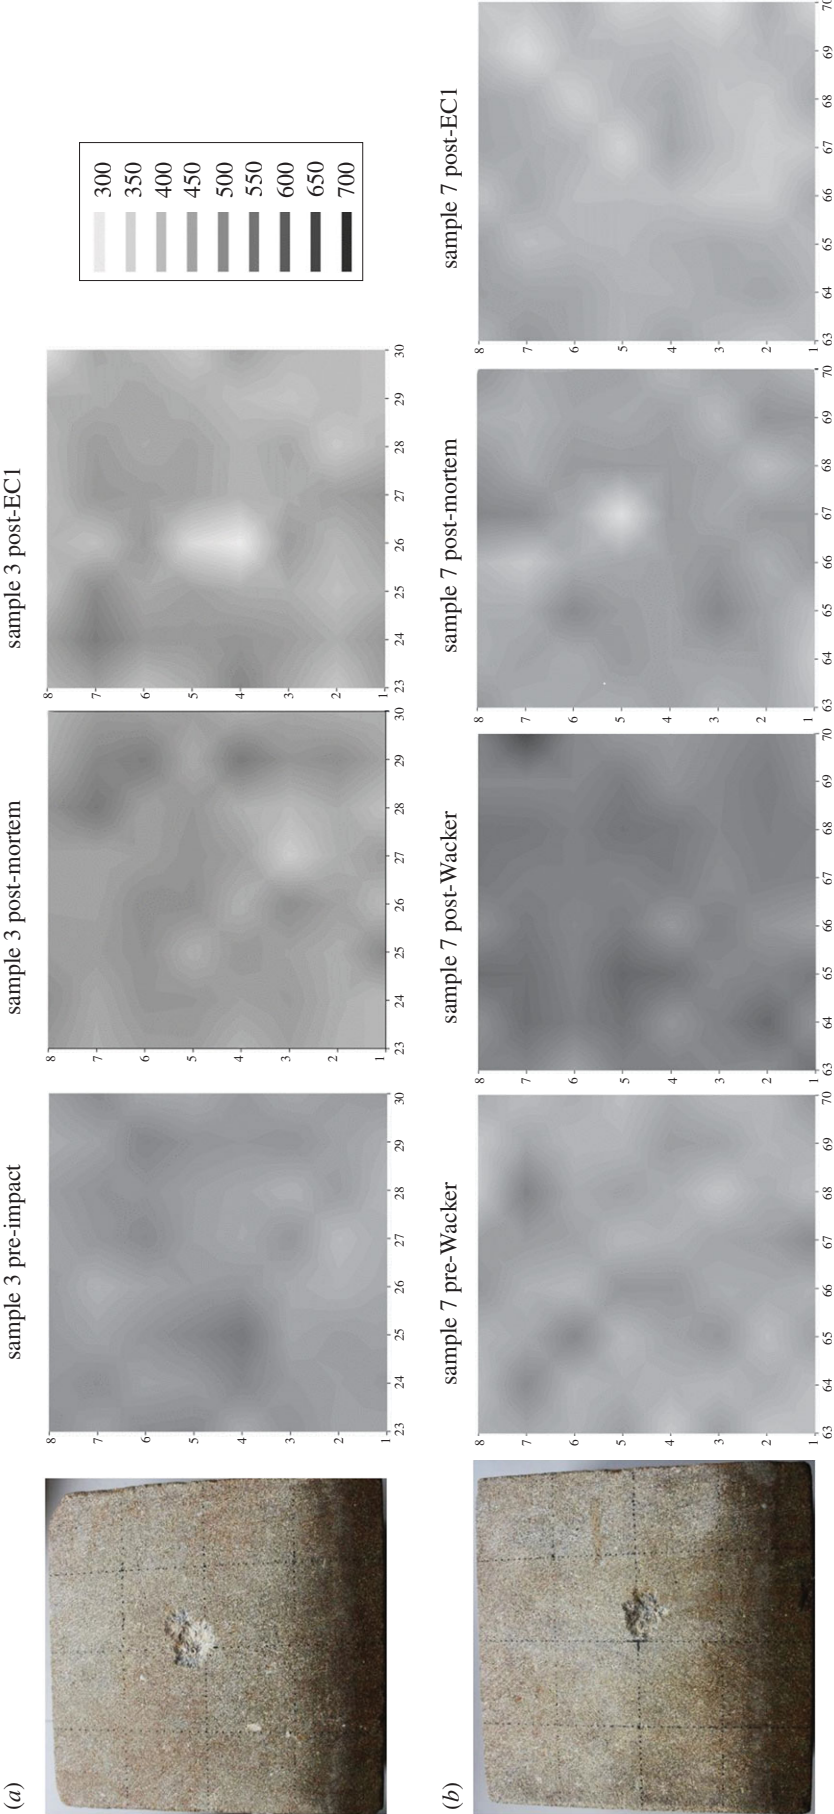
**Figure 7.** Piccolo data from samples 3 (a, sample not treated with Wacker OH 100) and 7 (b, sample treated with Wacker OH 100 and shot) in Leeb value. Values were interpolated using SigmaPlot area plot.

However, mean values cannot adequately describe spatial variations in elastic properties. Therefore, the Piccolo data from samples 3 and 7 measured across the surface of the block have been plotted in figure 7 to show change during the various stages of the experiment. Here, two interesting trends emerge. Firstly, sample 3, which was not treated with Wacker OH 100, does not show weakening directly corresponding to the impact area, although damage is apparent elsewhere. This follows the trend of the absorption of the impact by the more elastic nature of the surface (compared with the Wacker OH 100 treated surface). However, after the environmental cabinet treatment there is a clear weakening of the impact area, as represented by the lighter coloured area and relatively stable measurements around the impact area. This trend is reversed in sample 7 where initially the impact area is clearly identifiable post-impact (the very light grey area that corresponds with the location of the impact), accompanied by a general deterioration of the surface strength across the surface of the block. This impact area is much less visible after the environmental cabinet treatment. Instead there appears to be a general but less severe deterioration of the surface.

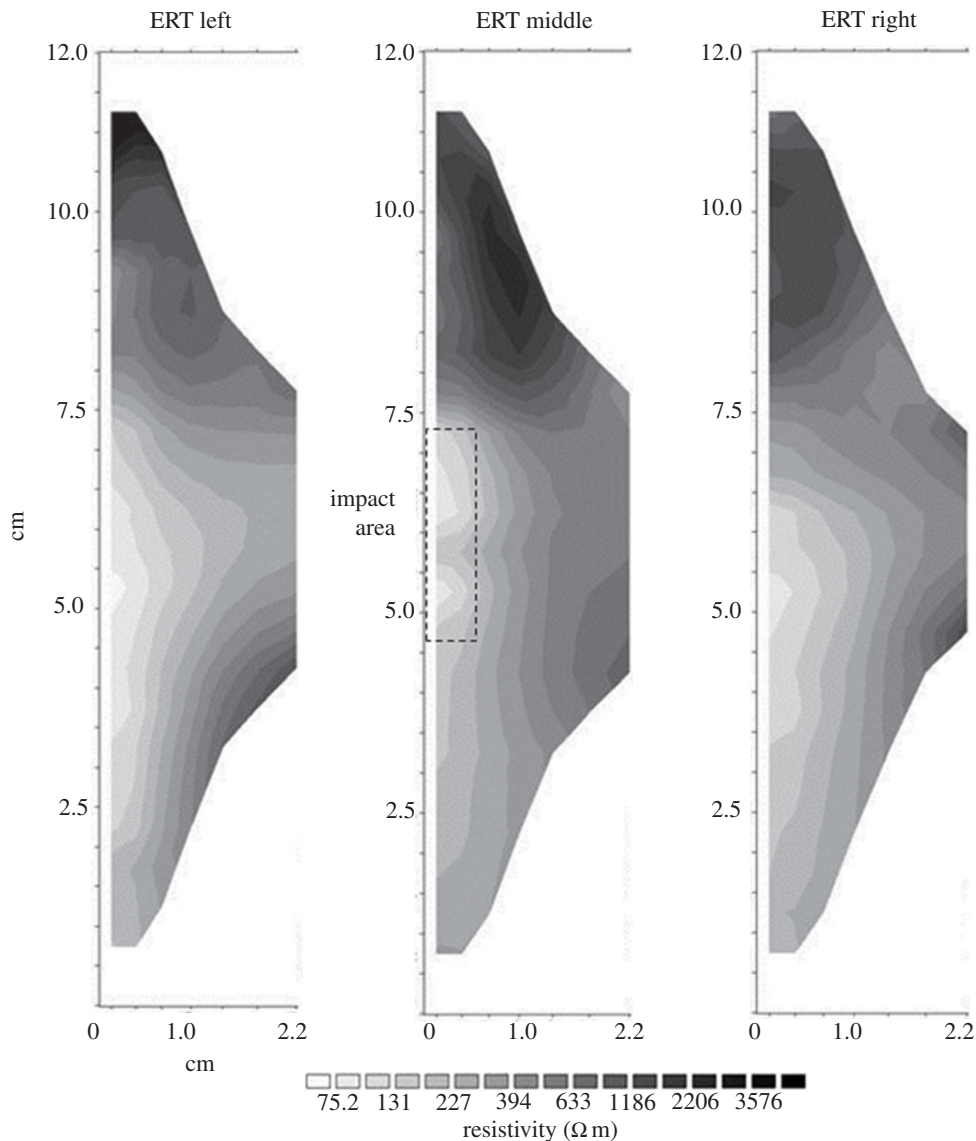
**Figure 8.** ERT transects of sample 3 (not treated with Wacker OH 100) after the environmental cabinet treatment.

Resistivity measurements were taken along three transects across the stone sample (for sampling strategy, see figure 4). The middle transect covers the impact area and it was expected that the most noticeable changes would be seen in this area. Figure 8 shows the distribution of moisture in sample 3 after the environmental cabinet treatment. This sample was not treated with Wacker OH 100. The areas of low resistivity (light greys and whites) are assumed to indicate higher moisture content, whereas the

dark grey and black areas indicate high resistivity, are assumed to be lower moisture contents. Capillary rise facilitates the upward movement of moisture until it reaches the impact area where it moves towards the surface and evaporates. An accumulation of moisture within the subsurface impact area can also be distinguished, forming a wedge shape of low resistivity into the stone body and saturating the inter-grain spaces in the fracture network. At the middle transect, the direct impact area shows a higher moisture content than in the surrounding area, suggesting that the evaporation is indeed concentrated in this area, as previously suggested.

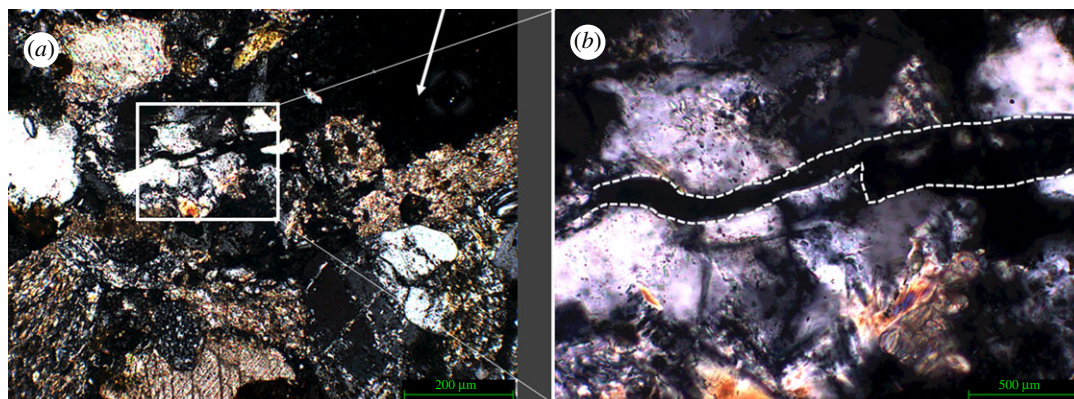
**Figure 11.** (a) Part of the impact area of sample 2 (not Wacker OH 100 treated); arrow indicates direction of impact. (b) Close-up of the fragmented and separated quartz found in the impact zone of sample 2, and white dashed lines clarify the position of the separation.

Quartz in the direct impact zone showed noticeable fracturing along the impact area. Figure 11*a* illustrates the fractures observed in the impact zone of sample 2 which was not treated with a consolidant. The absence of this surface support has resulted in the separation of the quartz fragment along the fracture line. Figure 11*b* shows a close-up of the area.

The bullet impacted in the area directly to the right of the fractured quartz, therefore, the conclusion could be drawn that the fracture and subsequent separation of the crystal is the result of the shockwaves generated at impact travelling sideways through the near-surface of the stone sample. The absence of a consolidant, and therefore a higher relative elasticity of the surface, facilitates sideways movement of the crystals. This type of separation was not observed in the samples treated with consolidant. This observation supports the notion that the nature of a micro-fracture network created upon impact is as dependent on the state of the material pre-impact as it is on the type of impact. As figure 12*a* illustrates, sample 3 exhibits this type of fracture network in the area directly adjacent to the impact. Figure 12*b,c* illustrates the geometric nature of the fracture network.

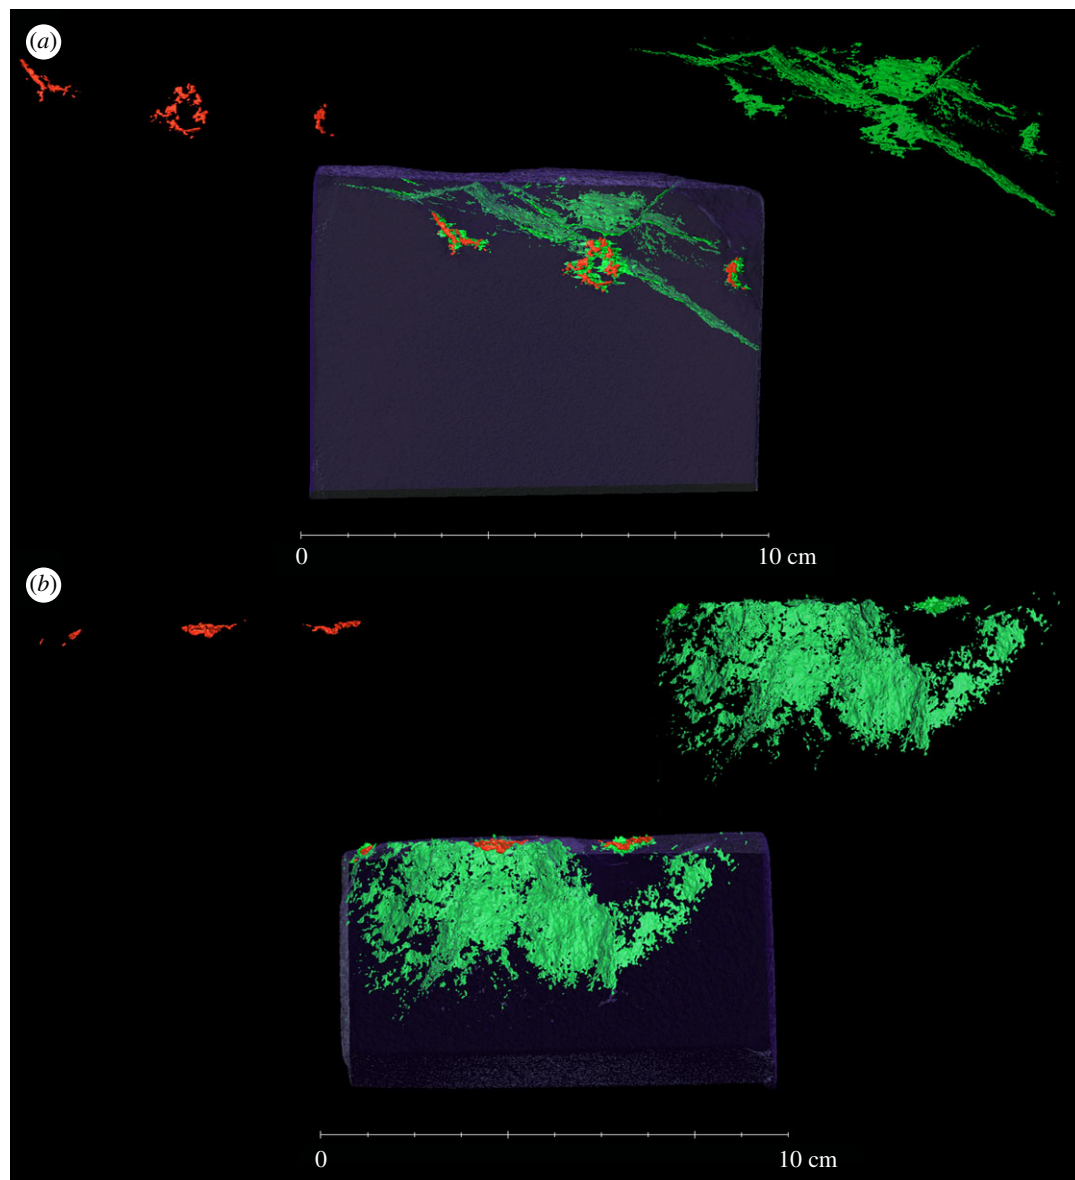
**Figure 16.** X-ray of impact areas, green demarcates areas of low density (fractured), whereas red indicates areas of higher density, likely to be lead deposits from the bullet encasing. (a) Frontal view (line of sight parallel to travel of bullet) and (b) top-down view. This sample was not treated with Wacker OH 100.

As all previous tests indicated both deformation of minerals around the impact zone as well as consolidation of the clay, a sample was scanned using X-ray tomography to map out compaction and fracture zones. These results are shown in figure 16, where the impacts coincide with compacted areas, whereas the fractured area extends onto the surface, radiating out from underneath the impact zones. The damage appears to have been caused by stress travelling into the block as the bullet hit, towards the

edges of the block while following a bedding plane within the stone sample. This exploitation of a pre-existing weakness is a commonly observed mechanism in stone under environmental stress [36]. These results also confirm the creation of compaction areas at the site of impact, which in turn affects impact site response to environmental stress and potential for long-term deterioration.
