Transformations in Exposure to Debris Flows in Post-Earthquake Sichuan, China

This supplementary material provides additional visual and methodological support for the damage assessment discussed in the main manuscript (lines 375 to 401). It includes six satellite images, two for each of the three study catchments, capturing the landscape before and after major debris flow events. Each image pair highlights the spatial extent of inundation and damage to the built environment. Inundated zones are shaded in brown, and image annotations include notable infrastructure – infrastructure, hydrological receptors, sediment deposition etc. These supplementary figures and methods are intended to enhance the transparency and reproducibility of the analysis presented in Figure 5 of the manuscript.

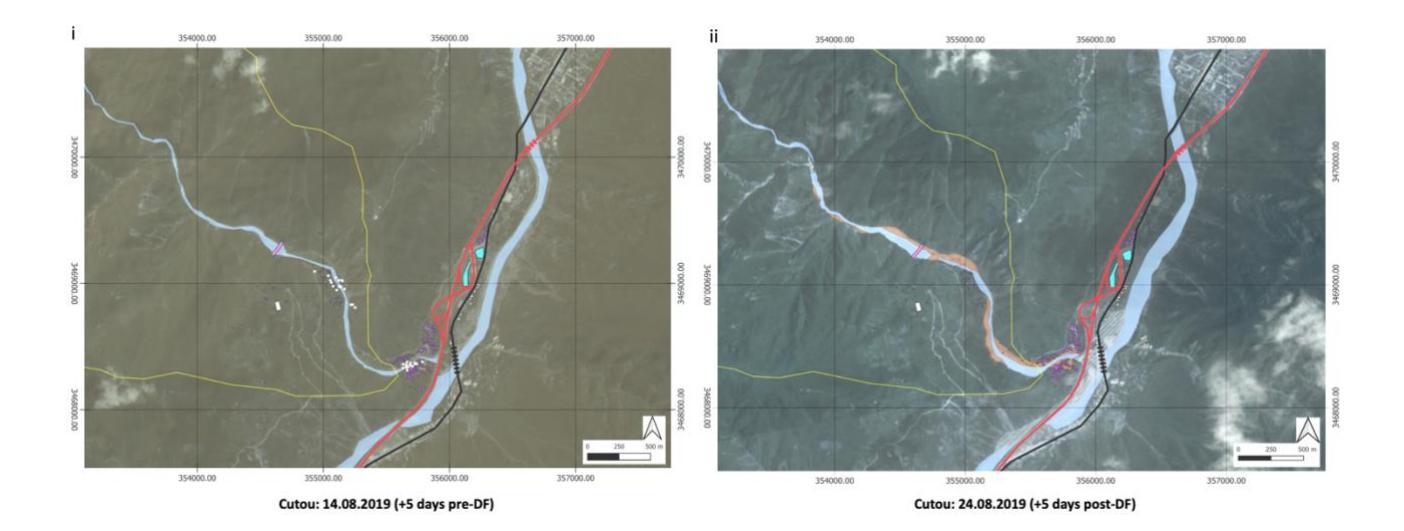
Figure S1. Pre- and post-debris flow event satellite imagery of Cutou Gully (© Google Earth 2019).

Satellite images showing the catchment area of Cutou Gully (i) before and (ii) after the debris flow event of 2019. Areas of debris flow inundation are highlighted in brown. Notable features include damage to built structures, scarring and erosion within the channel, and sediment deposition. Image interpretation supported the classification of affected areas as damaged, reconstructed, or newly developed, as outlined in the methodology and aided Figures 5 and 6 of manuscript. Satellite data sourced from Google Earth (2023).

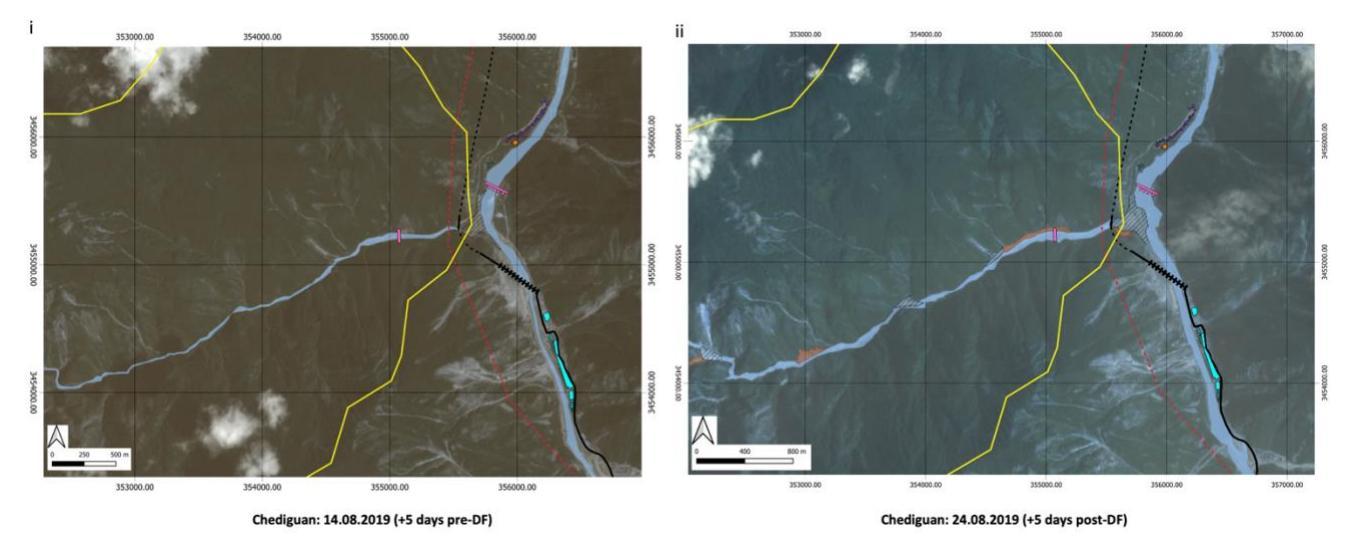
Figure S2. Pre- and post-debris flow event satellite imagery of Chediguan Gully (© Google Earth 2019).

Satellite images showing the catchment area of Chediguan Gully (i) before and (ii) after the debris flow event of 2019. Areas of debris flow inundation are highlighted in brown. Notable features include damage to built structures, scarring and erosion within the channel, and sediment deposition. Image interpretation supported the classification of affected areas as damaged, reconstructed, or newly developed, as outlined in the methodology and aided Figures 5 and 6 of manuscript. Satellite data sourced from Google Earth (2023).

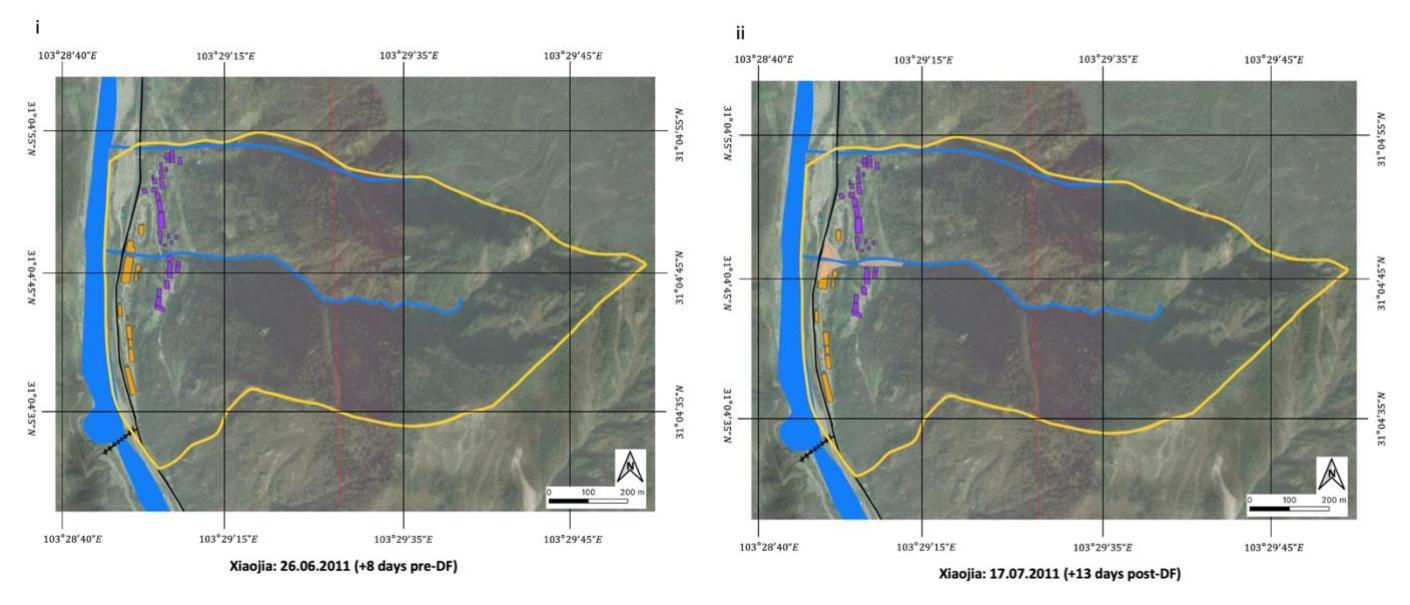
Figure S3. Pre- and post-debris flow event satellite imagery of Xiaojia Gully, (© Google Earth 2011).

Satellite images showing the catchment area of Xiaojia Gully (i) before and (ii) after the debris flow event of 2011. Areas of debris flow inundation are highlighted in brown. Notable features include damage to built structures, scarring and erosion within the channel, and sediment deposition. Image interpretation supported the classification of affected areas as damaged, reconstructed, or newly developed, as outlined in the methodology and aided Figures 5 and 6 of manuscript. Satellite data sourced from Google Earth (2023).
