Development and Testing of Vascular Networks for Self-healing Cementitious Materials

Robert Davies, Ph.D., CEng¹, Tony Jefferson, Ph.D., CEng², and Diane Gardner, Ph.D., CEng³

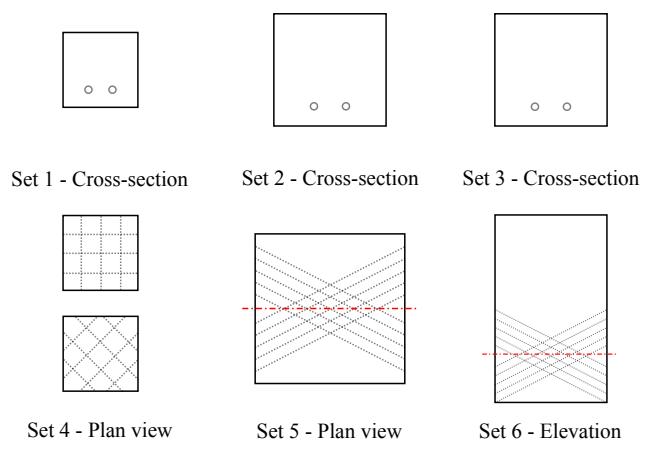
Fig. 5. Flow network from Sets 1-6 (not drawn to scale)

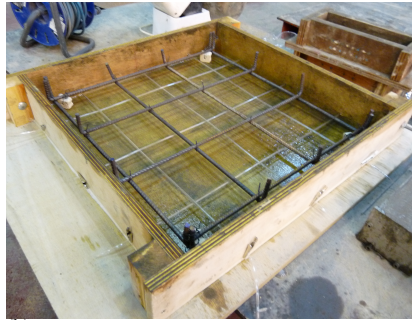
Fig. 8. Concrete slab mould flow network set-up (a) specimen 1 (b) specimen 2 (c) general support and loading arrangement

280 A loading frame, fabricated from 50 mm square hollow steel sections, provided simple supports
281 on all 4 sides of the slab. The central patch load was applied at a controlled displacement rate of
282 0.005 mm/s through a 100 mm square 25 mm thick steel plate and 8 mm thick fibreboard. The
283 displacement was monitored at the centre on the underside of the slab and at the mid-span of one
284 support. The loading setup can be seen in Fig. 8c. The slab was supplied with healing agent and
285 then loaded to 100 kN, unloaded and cured under moist hessian sacks for 28 days before re-loading
286 for a second time.

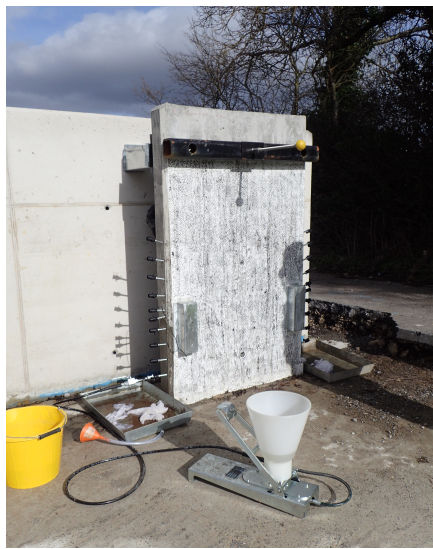
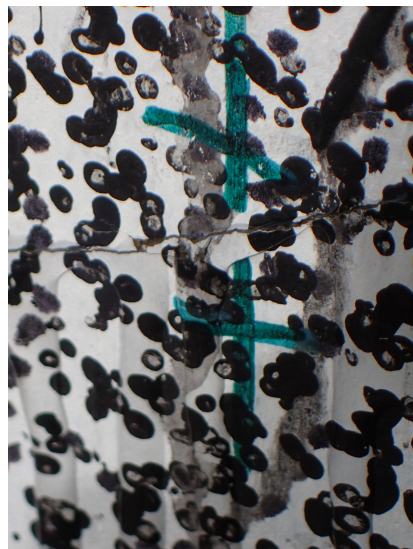
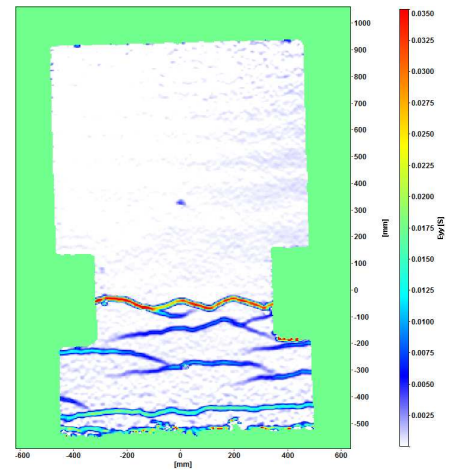
Fig. 19. Site trial (a) Panel E containing vascular networks with healing agent pump arrangement (b) Closeup of crack with healing agent leaching (c) DIC strain plot panel E Control with vascular networks at a load of 20 kN

474 A digital image correlation (DIC) technique was used to monitor the strains on the front face
475 of the panel. The results, shown in Fig. 19c, give the strain plot for Panel E. The crack pattern
476 observed on Panel E at a load of 20 kN supports previous observations that the network channels
477 act as crack inducers, with the diagonal crack pattern reflecting the form of the vascular network
478 (Fig. 19a and 19b).

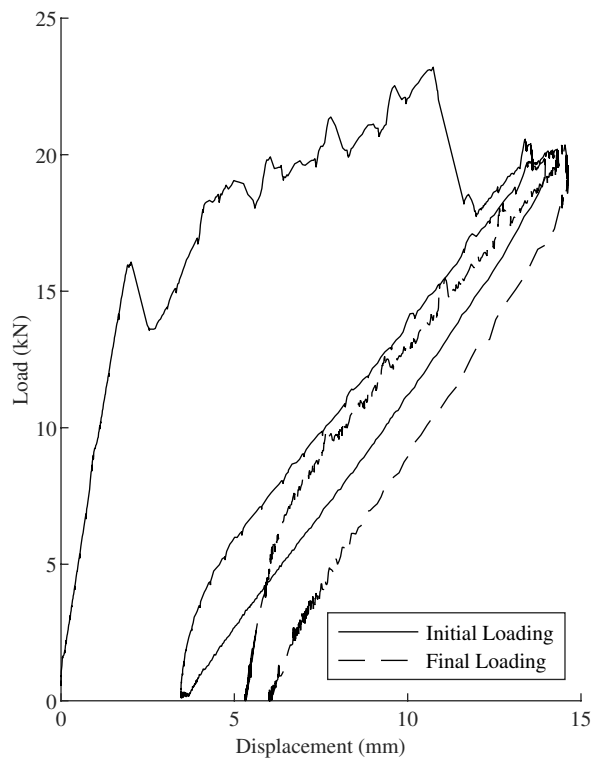
Fig. 20. Load versus CMOD for initial and final loading of site trial panel E

479 The panel was reloaded to the original load at 231 days after casting and the load versus
480 displacement results compared pre-and post-healing (see Fig. 20). The presence of substantial steel
481 reinforcement in the panel, masks the influence of healing on the load-displacement response, which
482 made it difficult to quantify the mechanical strength recovery which could be directly attributed
483 to the vascular network. Despite the clear site-trial evidence of healing agent flow into the cracks
484 (surface leakage), there was only minimal evidence of healing using visual assessment techniques.
485 It is suggested that a range of non-destructive techniques such as in-situ permeability testing,
486 ultrasonic techniques and microscopy be employed in future tests to help identify the recovery of
487 mechanical and durability-based properties.
