RESEARCH ARTICLE

Subsurface fracturing of sedimentary stones caused by bullet impacts

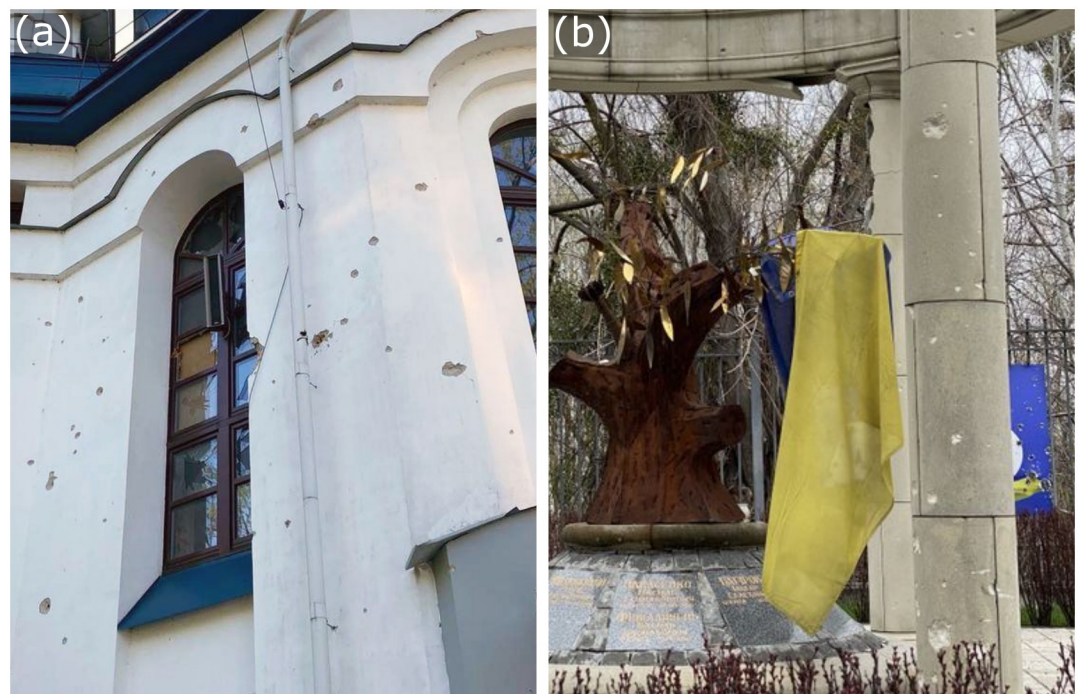
Fig 1. (a) Shrapnel damage to the facade of the St Nicholas Church caused by Russian shelling in the town of Irpin, a suburb to the NW of Kyiv in Northern Ukraine [2]. (b) Impact damage to columns of the Alley of ATO Heroes memorial, also in Irpin. It is reported to have been caused by small arms fire from Russian forces in February 2022 [1, 2].

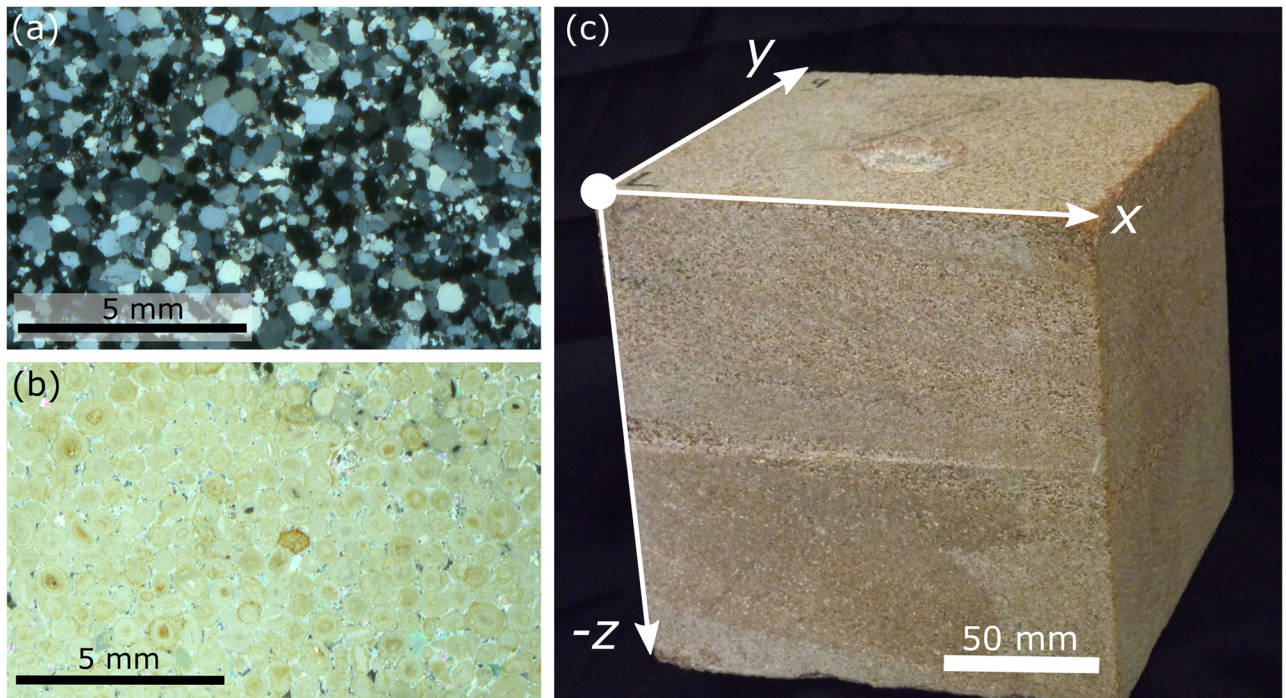
Fig 2. Thin section micrographs taken under cross polarised light of undamaged Stoneraise Red Sandstone under cross polarised light (a), a fine-medium grained (0.125–0.5 mm) quartz rich sandstone, and undamaged Cotswold Hill Cream Limestone (b), an oolitic limestone with an average grain size of 0.5 mm. Both lithologies show no pre-existing fracturing in the undamaged section. (c) Damaged target block of Stoneraise Red Sandstone indicating the reference scheme adapted from [19].

A 3D reference scheme, adapted from Tikoff et al., [19], was employed to describe the spatial position of thin sections, observations, and measurements within the block. The target face of the sample is defined as the XY plane and the Z axis is orthogonal to this and negative into the block (Fig 2c). The crater centre is defined as the point at the centre of the crater floor, typically the deepest point, and is used as the reference location from which to measure distances to fractures and damage within the sample.

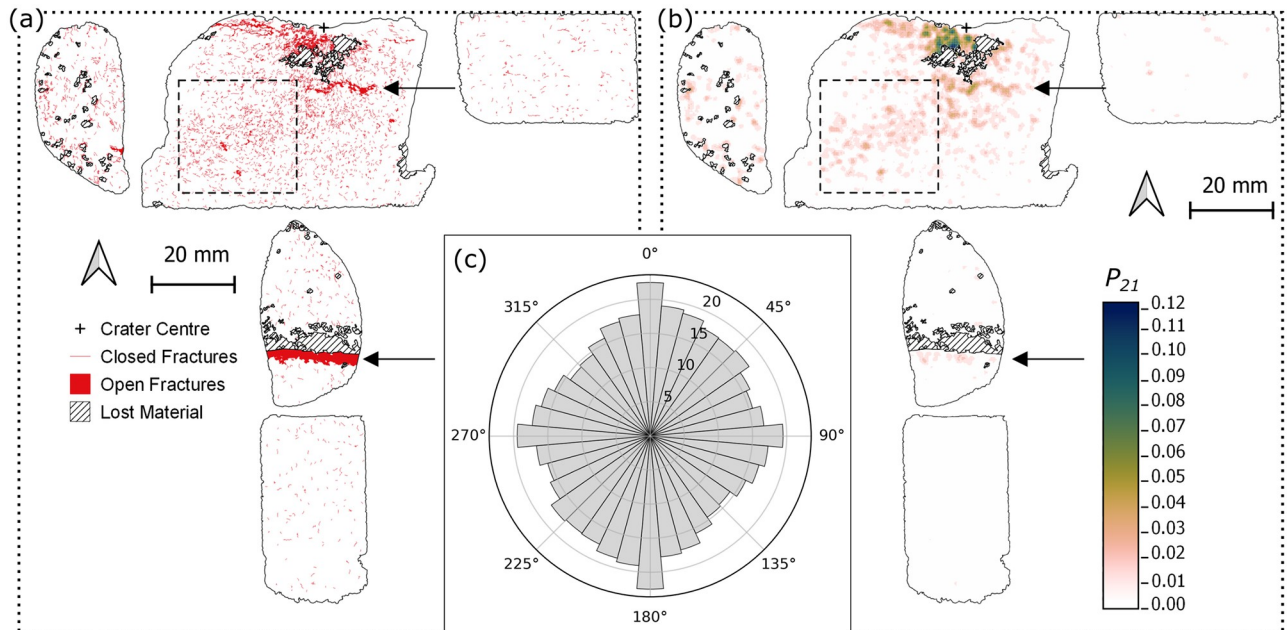
Fig 3. Fracture map (a) through the centre plane (XZ) of a Stoneraise Red Sandstone sample (SRS_09). Open fractures (solid red regions) are visible oriented sub-parallel to the target surface close to the impact crater, at a depth of 20 mm and ~80 mm below the crater (black arrows). There is a high number of closed (red line) fractures within a 7 mm radius of the crater centre. There is a high P_{21} fracture intensity values across the thin sections. The highest values (dark blue) are within 7 mm of the crater centre. There is a region of relatively higher fracture intensity (dashed square) with an approximate orientation of $35^{\circ}/215^{\circ}$. For both maps impact direction is top to bottom and the original block outline is shown as a dotted line. (c) Equal area rose diagram showing the orientation of all fractures, weighted for fracture length, mapped within the sandstone sample. Radial scale is the square root of frequency.

The sandstone sample (SRS_09) has a shallow, bowl shaped crater with an area equivalent diameter of 40 mm and a maximum depth of 5.1 mm [24]. 20 mm directly below the crater floor is an open (<1.5 mm) fracture that is 16 mm in length, but does not reach the edge of the section (Fig 3a). 80 mm directly below the crater centre there is an open fracture with a minimum aperture of 1.4 mm. Maximum aperture cannot be determined because the upper fracture wall shows evidence of material loss from sectioning (Fig 3a and 3b). Both of these open fractures are sub-parallel to the orientation of beds defined by grain size changes, $\sim 5^\circ$ from the target face (XY plane i.e. $90^\circ/270^\circ$ relative to the Z axis in the thin sections). Two dominant orientations of fractures become apparent from the rose diagram: the first are, as described above, sub-parallel to the bedding orientation of $90^\circ/270^\circ$, while the second group is approximately orthogonal to this, with orientations $0^\circ/180^\circ$ (Fig 3c).

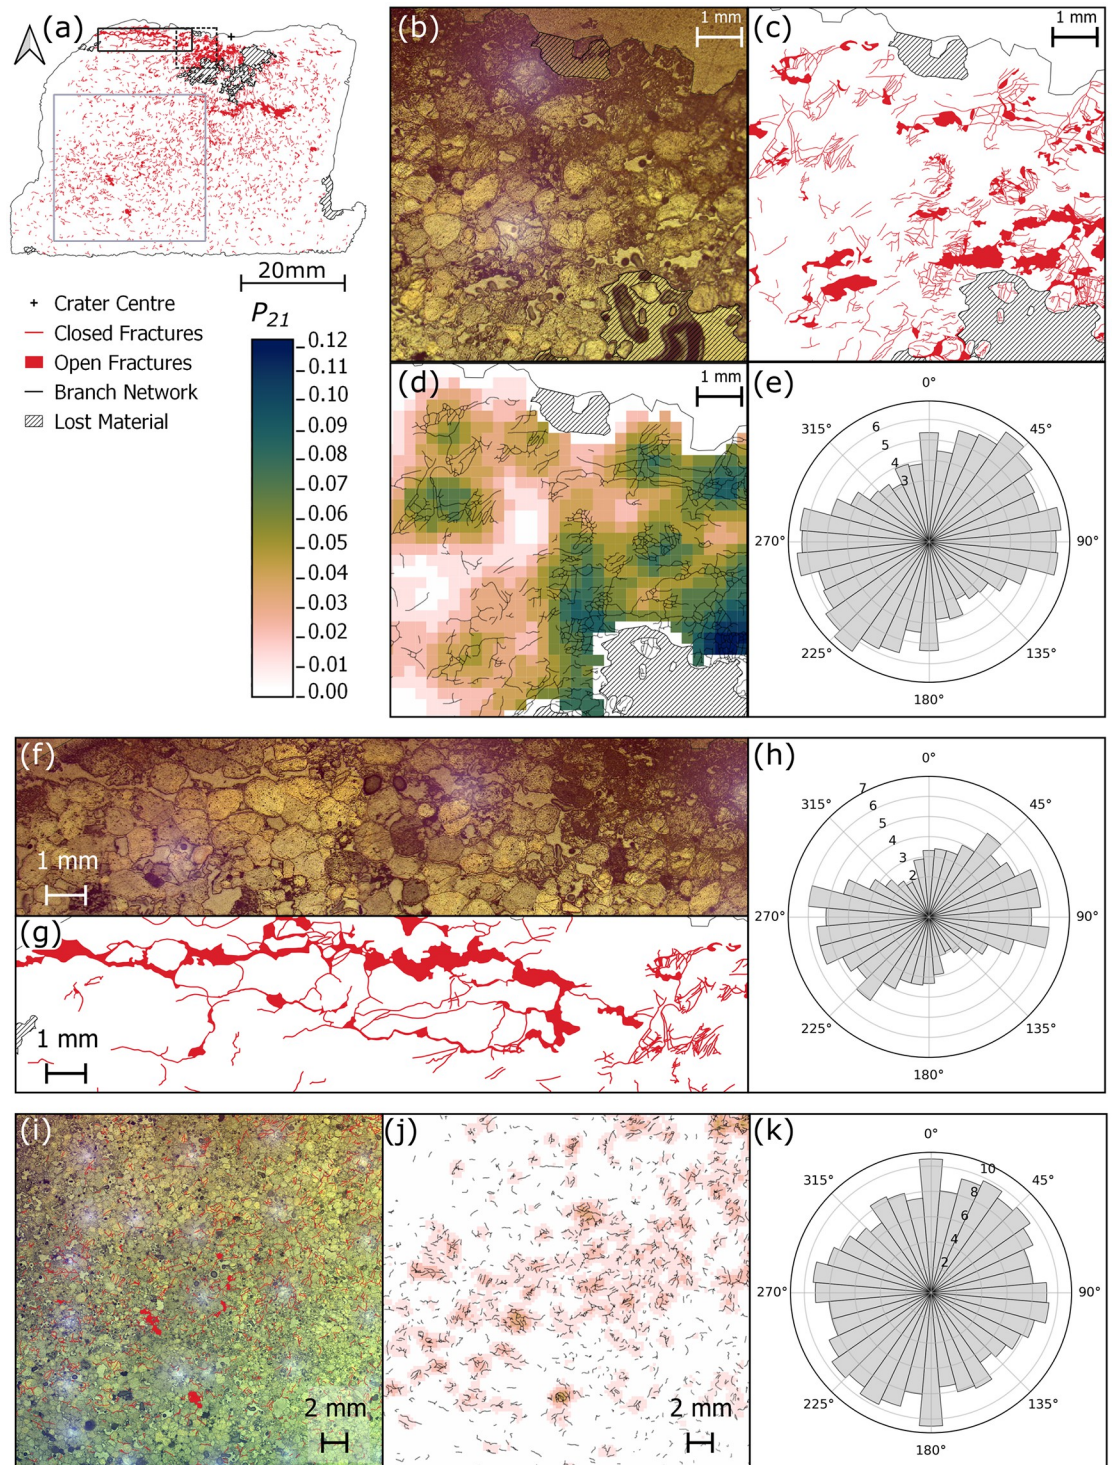
Fig 4. (a) Fracture map of the thin section through the impact crater in Stoneraise Red Sandstone (SRS_09), showing closed and open fractures (red). Dashed box shows the location of panels (b-e). Solid black box outlines the location of panels (f-h). Grey box shows the location of panels (i-k). (b) Reflected light photomicrograph showing substantial grain crushing (top of frame) at the crater floor and a high number of trans- and intergranular fractures in the region beneath. Interconnected fracture pathways are seen in the fracture map in panel (c). The highest fracture intensity value (0.124) is observed in the lower right of the P_{21} intensity map (d), 5.9 mm from the crater centre (out of frame towards the top right). Topology parameters were calculated using the branch network (black lines) interpreted by the NetworkGT plugin based on a threshold image of the digitised fractures (red lines). The orientations of the digitised fracture network show a slight predominance in orientation around $45^{\circ}/225^{\circ}$ and $90^{\circ}/270^{\circ}$. (f-g)

Reflected light micrograph and corresponding fracture map of open, extensional fractures directly below the crater edges. Fractures are oriented sub-parallel to the target face as seen in the rose diagram for the region (h). (i) Reflected light photo micrograph and fracture network showing a region of fracturing from below the crater to the SW corner of the central section. (j) P_{21} fracture intensities and NetworkGT branch map for the same region. There appears to be a slight trend of fracture orientations from $45^\circ / 225^\circ$ (k), though the dominant orientation for the region is perpendicular to the target face. All rose diagrams (e, h, k) are plotted as equal area diagrams, orientation frequency is weighted for fracture length, and the radial scale is the square root of the weighted frequency.

Directly below the crater centre is a zone of primarily closed intra- and trans-granular fractures, forming a region of intense fracturing that extends to a depth of ~7 mm below the crater floor (Fig 4a–4e). The highest P_{21} fracture intensity value calculated (0.124) is in this region, 5.9 mm away from the crater centre (Figs 3b and 5b). Many grains exhibit multiple closed fractures that originate at contact points with adjacent grains, forming connected networks across multiple grains. Open extensional fractures are visible just beneath the crater floor traversing from the crater centre towards the rim (Fig 4f and 4g). These fractures have both inter- and trans-granular pathways, with no measurable lateral displacement between fracture walls. They are primarily sub-parallel to the target face of the samples (Fig 4h). In the top central section there appears to be a band of damage stretching from the SW corner of the section to an area of material loss directly below the crater centre (Fig 4a and 4i–4k). The band has an approximate orientation of $35^{\circ}/215^{\circ}$.

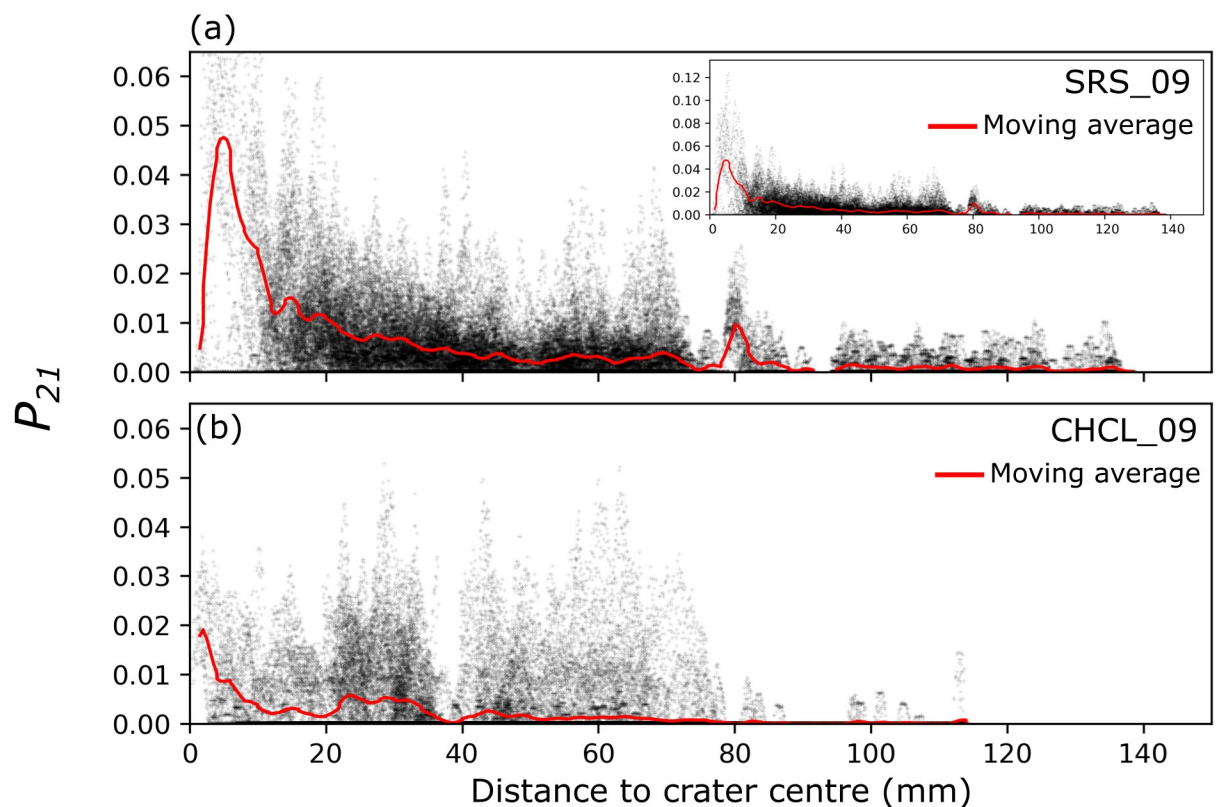
Fig 5. P_{21} fracture intensity with increasing distance from the crater centre for the sandstone (a) and limestone (b) target blocks. Red line is a 2 mm moving average of P_{21} intensity with distance from crater centre. Inset shows the full extent of P_{21} values in the sandstone target.

There are few fractures in the thin sections further than 80 mm below the crater floor, and those present are short, intra-granular fractures, typically confined to a single grain. This is visible in the small peak in P_{21} intensity at 80 mm below the crater centre (the large open fracture), followed by very low intensity values with increasing distance from the crater centre (Fig 5a).

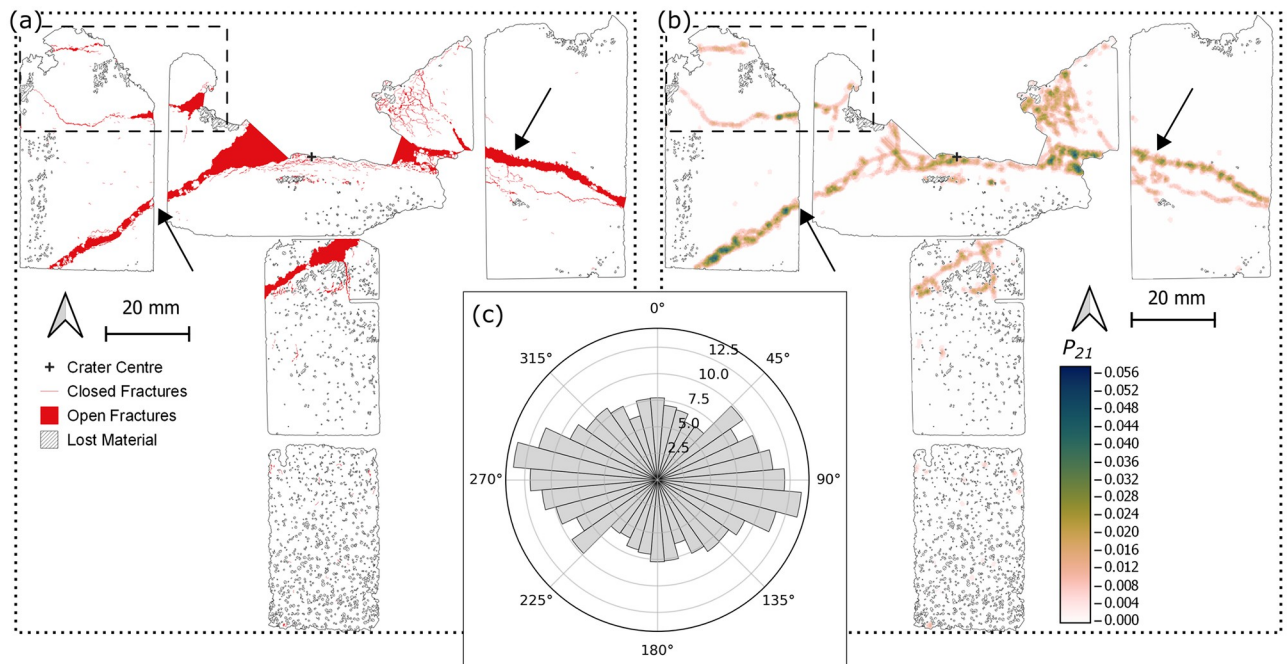
Fig 6. Fracture map (a) through the centre plane (XZ) of the Cotswold Hill Cream Limestone (CHCL) sample (CHCL_09). An open fracture (black arrows) is present across multiple thin sections, intersecting the edges of the target block and the crater. Open fractures are visible sub-parallel to the target face and forming incipient spall fragments (dashed rectangle). There are crater floor parallel, closed fractures (red line) directly below the crater centre. (b) Map of P_{21} fracture intensity values across the thin sections. The highest values (dark blue) are localised along the wide open fracture (black arrows) and around the crater centre. For both maps impact direction is top to bottom and the original block outline is shown with a dotted line. (c) Equal area rose diagram showing the orientation of all fractures, weighted for fracture length, mapped within the limestone sample. The fractures are predominantly sub-parallel to the target face. Radial scale is the square root of frequency.

Fractures throughout the sample are generally sub-parallel to the target face (Fig 6c), although there is another group of fractures with an orientation of $50^\circ/230^\circ$. Material below the spall zone surface is highly fractured, with grain sizes beyond the scale of observation in optical sections (Fig 7a–7c). The top surface of the incipient wedge is the floor of the spall zone surrounding the central excavation and has an orientation of approximately $45^\circ/225^\circ$. Some fractures within the wedge, particularly those close to the spall surface, are oriented parallel to the spall surface, while other fractures throughout the wedge are perpendicular to this surface (Fig 7c). Higher P_{21} values reflect the higher fracture intensity in these regions (Fig 7d). This orthogonal pair of fractures is bisected by a third group, with orientations of approximately $100^\circ/280^\circ$ (Fig 7e.)

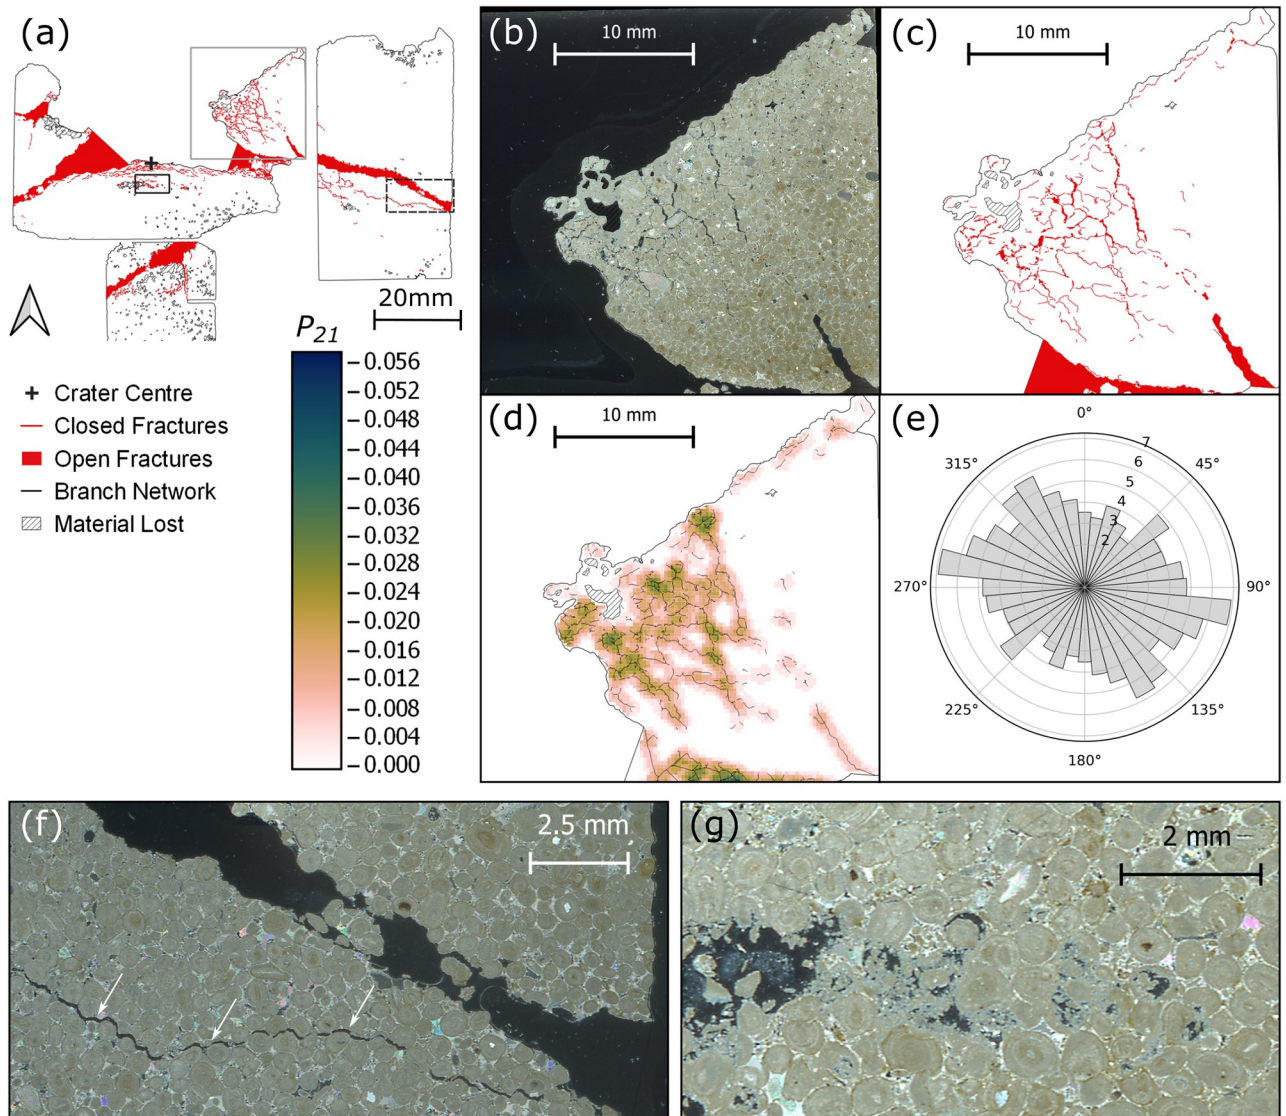
Fig 7. (a) Fracture map of the top central and right thin sections of sample CHCL_09 showing closed (red line) and open (solid red) fractures. Grey box indicates the location of panels (b-e), dashed black box indicates location of panel f and solid black box panel g. (b) Photomicrograph taken under cross polarised light (XPL) of an incipient wedge formed at the edge of the crater. (c) Fracture map showing multiple orientations of open and closed fractures in the wedge, corresponding to increased P_{21} intensity, as shown in panel d. (e) Equal area rose diagram of length weighted fracture orientations in panels b-d. Radial scale is the square root of frequency. (f) Photomicrograph under cross polarised light of a large open fracture present across several sections that intersects the edge of the target block. The fracture contains clasts of wall rock and has narrower fractures sub-parallel to it but several mm away (white arrows). (g) Photomicrograph under XPL highlighting a region of crushed ooids and carbonate material 6 mm below the crater floor.

Clasts of wall rock occur within the large open fracture that crosses multiple thin sections. There are several narrower (< 0.15 mm) open fractures sub-parallel to, but distinct from, the large fracture (Fig 7f). Up to 2 mm beneath the floor of the central excavation there is a set of open fractures < 0.2 mm wide and parallel to the crater floor. 6 mm below the crater floor is a zone of crushed ooids and very fine grained material, below the scale of observation (Fig 7g). There is another large open fracture (0.6–5.5 mm wide) starting at least 20 mm below the crater floor and oriented towards the lower left of the block (in section view), intersecting the edge of the section area at a depth of 30 mm below the crater floor (thin section below the crater centre in Fig 7a).

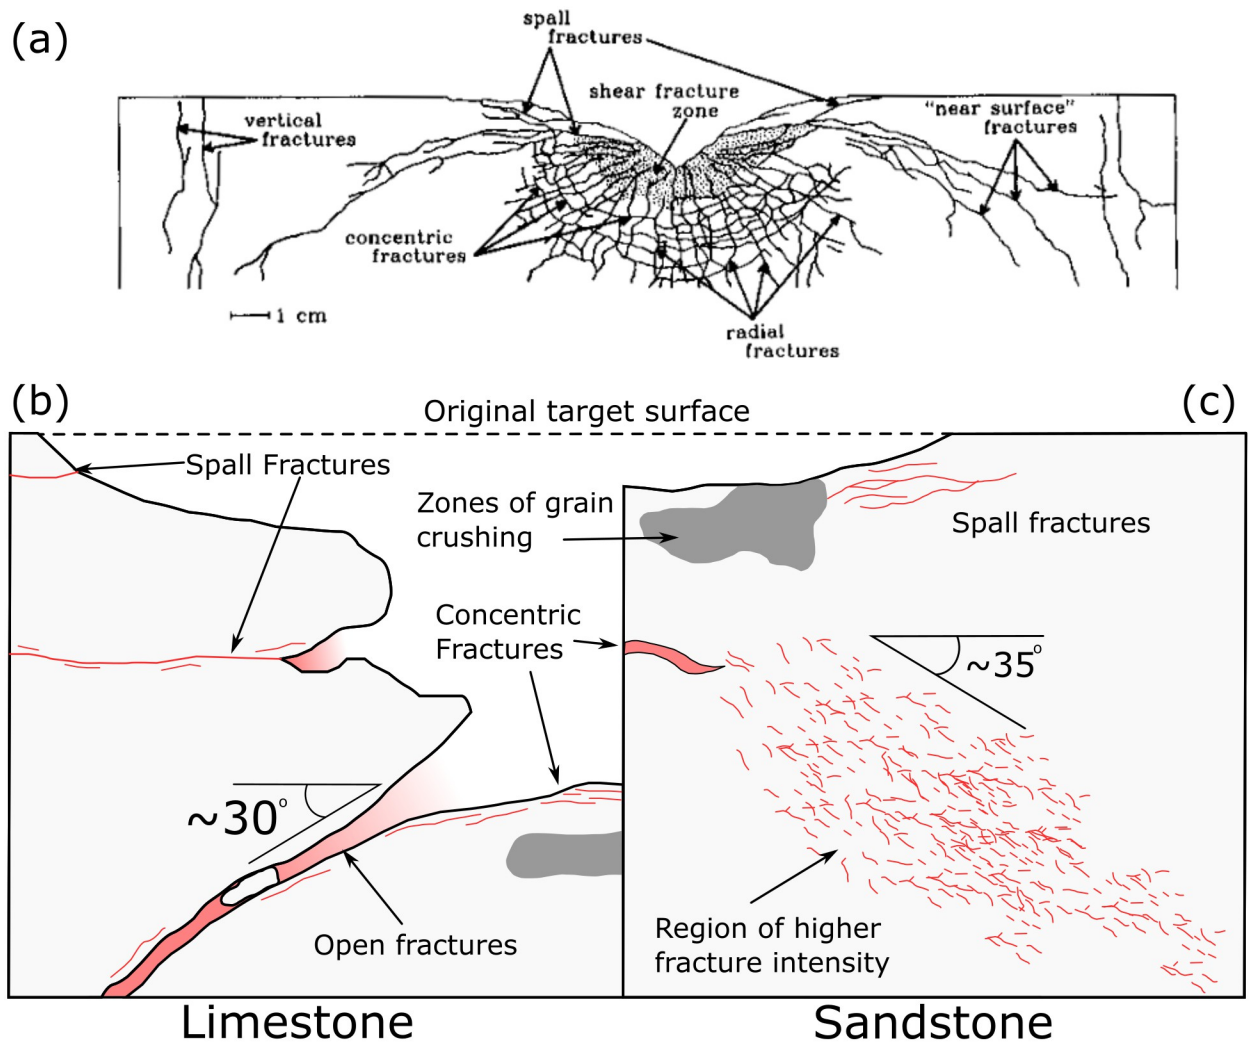
Fig 8. (a) Summary sketch of damage to San Marcos Gabbro during a hypervelocity impact [34]. Schematics (not to scale) of damage observed in limestone (b) and sandstone (c) targets shot with 7.62 x 39 mm ammunition.

The open fracture observed in the limestone sample dipping away from the crater resembles the ‘near surface’ fractures observed below hypervelocity impacts into gabbro (Fig 8) [34]. Polanskey and Ahrens [34] suggest that the fractures form along the boundary between a near surface region, as defined by Melosh [35], and deeper regions of the target. In the near surface region, target material experiences reduced peak compressive stress due to the reflection at a free surface of compressive stress waves as tensile waves of equal magnitude. As rock is generally weaker in tension than compression, these tensile waves can overcome rock strength and result in extensional fracturing, i.e. spallation. Polanskey and Ahrens [34] show good correlation of both location and orientation between the boundary of the near surface zone and ‘near surface’ fractures below hypervelocity impacts. Calculation of the near surface boundary for the experiments conducted here, as defined in Melosh [35] (Eq 2), resulted in a depth below target surface (Z_p) of 4.2–9.3 mm for the limestone experiment (Fig 9a) and 4.1–14.2 mm for the sandstone experiment (Fig 9b).

Both target lithologies of this study exhibit extensional fractures parallel to the crater floor, resembling observations of concentric fractures below hypervelocity impacts [26, 34, 50, 52] (Fig 8a and 8c). Similarly concentric fractures are also present beneath point loading experiments in glass and ceramics. However the fractures beneath the point loading experiments are thought to be caused during the unloading phase, as the load on the compressive zone below the indenter is released [50, 53].

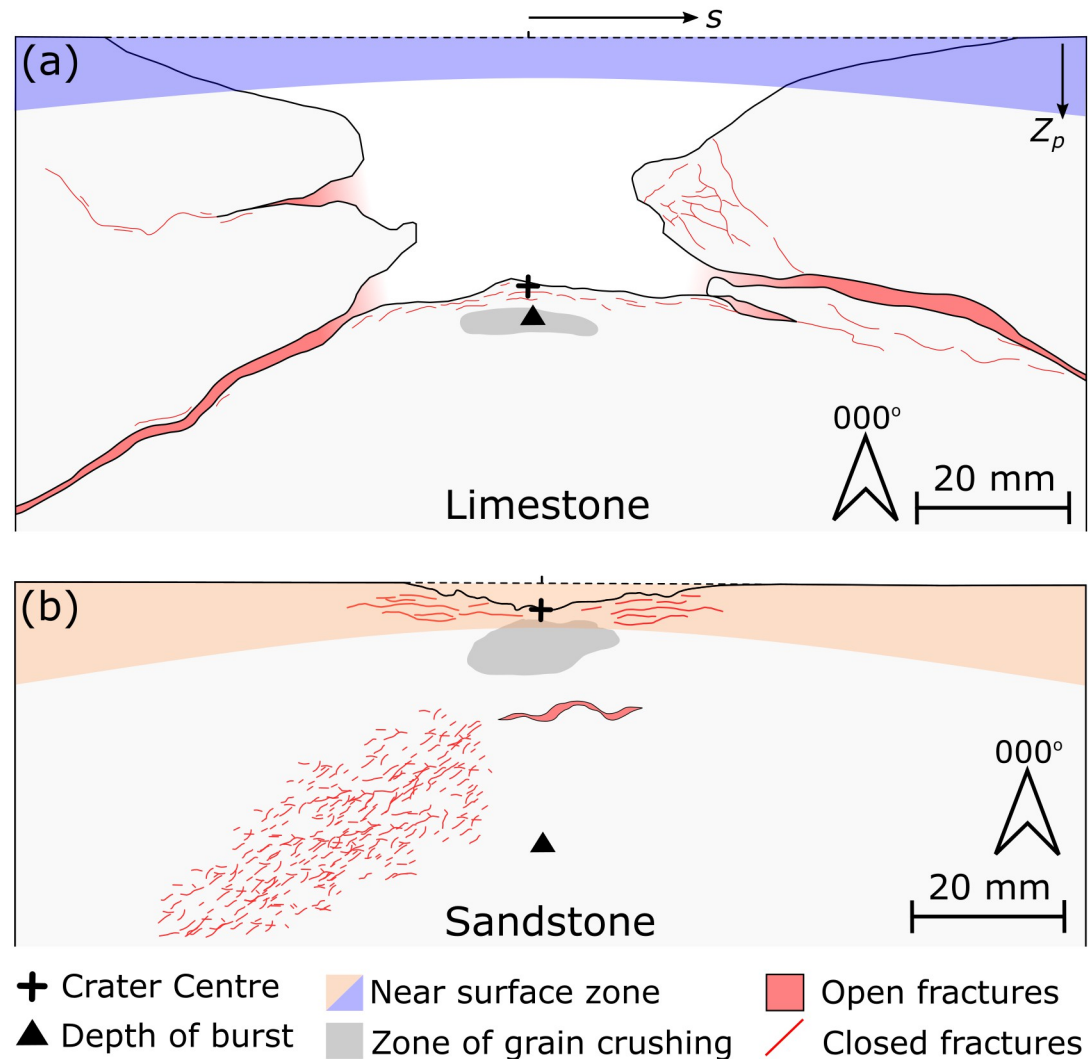
Fig 9. (a) Summary diagram of damage to Cotswold Hill Cream Limestone. The predicted depth of burst (d) (triangle) and crater centre are a similar distance below the original target face (dashed line). Z_p is the depth of the near surface zone parabola at lateral distance (s) from the impact point. The theoretical near surface zone is shaded blue. (b) Summary diagram of damage to Stonerise Red Sandstone. The predicted depth of burst (d) (triangle) is substantially deeper in the target than the crater centre. Z_p is the depth of the near surface zone parabola at lateral distance (s) from the impact point. The theoretical near surface zone is shaded orange. Vertical and horizontal scales are the same.

correlation with the observed subsurface fracturing (Fig 9). Fractures are present in the near surface zone of the sandstone target, but they are parallel to the crater floor or target surface, comparable to those labelled 'spall fractures' by Polansky and Ahrens [34] (Fig 8a). One experiment of Polansky and Ahrens [34], using a commercial lead bullet fired at 890 ms^{-1} , created near surface fractures with a steeper inclination than predicted by their theoretical near surface parabolas. The results of this experiment resemble the orientation of the increased fracture intensity zone in the sandstone target of this study. Winkler et al. [36] observed localised shear zones below hypervelocity impacts into quartzites that dip away radially from the crater centre, some of which have orientations similar to those observed in the sandstone target of this study. The shape of the near surface zone is strongly controlled by the stress pulse caused by the impact [34, 35]. The model discussed above assumes the rise time remains constant as shock/stress propagates [35], which is unlikely for the ogive nose shape of the projectile in this study.

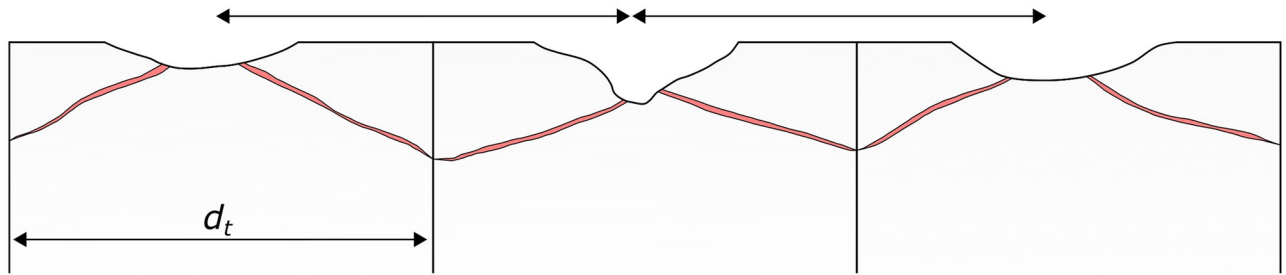
Fig 10. For impacts with a spacing less than the diameter of the impacted block a , subsurface conical fracture and damage zones can form an interconnected network that affects a greater region than suggested by the surface damage alone.

not occur in isolation; structures typically have multiple impacts across their surface. If these impacts have subsurface damage zones similar to those in this study, there is the possibility they may link up in the subsurface. Fig 10 illustrates how multiple impacts with a spacing less than the impacted block diameter may form interconnected fracture networks below the surface that have a much greater footprint than the observable surface damage. The increased permeability and decreased stone strength resulting from the interconnected damage zones may exacerbate material loss and greatly increase degree and rate of future deterioration. The interaction of subsurface damage from multiple impacts is an interesting and important avenue for future research.
