Turgo, Nelson , Ellis, Neil , Tang, Lijun, Sampson, Helen and Acejo, Iris 2013. The use of mandatory equipment on-board. Presented at: Seafarers International Research Centre Symposium 2013, Seafarers International Research Centre Symposium Proceedings (2013). Cardiff, UK: Seafarers International Research Centre, pp. 54-72.

The Use of Mandatory Equipment On-board – A New Study

Nelson Turgo, Neil Ellis, Lijun Tang, Helen Sampson, Iris Acejo

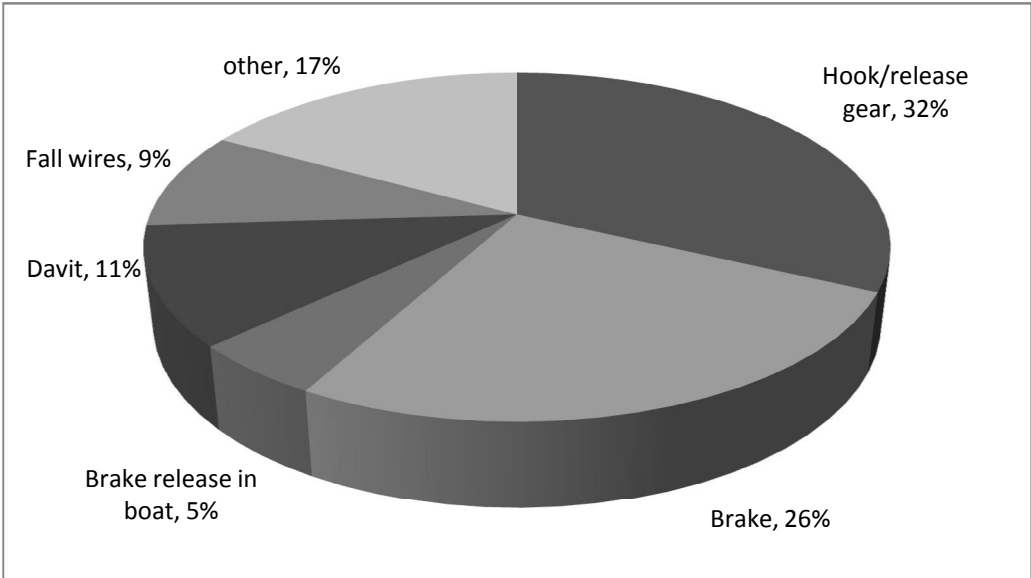
Figure 2: Component failure in lifeboat accidents (from OCIMF survey 1994)

hook has emerged as a particular problem, as it may open when unanticipated by seafarers and drop a lifeboat into the water from a considerable height. The OCIMF 1994 survey revealed that release system failure and brake failure were two major contributory causes of davit-launched totally enclosed lifeboat accidents (see Figure 2). The subsequent *MCA Research Project 555* (MCA 2006) suggested that while lifeboat accidents also arose from problems associated with other elements of lifeboat launching systems, such as winches, and falls, most serious accidents, especially those leading to fatalities, occurred because of on-load release hook problems.

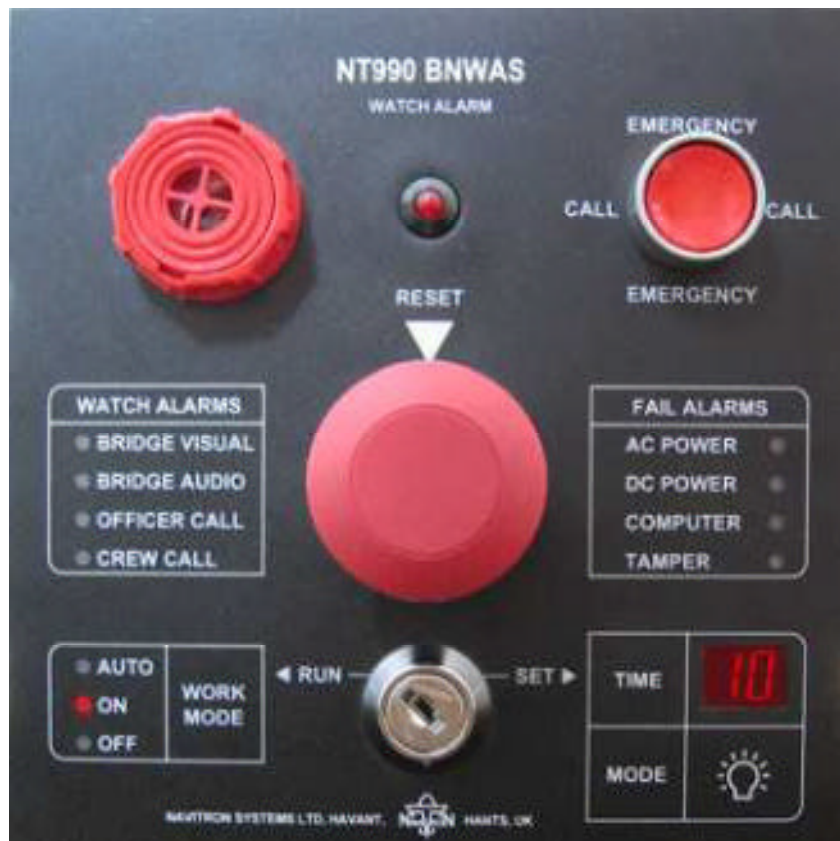
Figure 3: Example of a BNWAS bridge panel

In order to try to stop watch keepers falling asleep the BNWAS requires the bridge watch keeping officer to periodically (every 3 to 12 minutes depending on the setup) push a button, to prevent an alarm being triggered in the cabins of deck officers and/or of the captain. Other more advanced systems use motion sensors to detect whether the watch keeper is awake, or monitor how bridge navigational equipment is being used to see if seafarers are mentally alert. If these systems detect a lack of motion or a lack of alertness over a certain period of time, the alarm will be triggered. A typical example of a BNWAS panel is shown in Figure 3.
