Albano, Maurizio , Waters, Ronald T., Charalampidis, P., Griffiths, Huw and Haddad, Abderrahmane 2016. Infrared analysis of dry-band flashover of silicone rubber insulators. IEEE Transactions on Dielectrics and Electrical Insulation 23 (1) , pp. 304-310. 10.1109/TDEI.2015.005026

# Infrared Analysis of Dry-band Flashover of Silicone Rubber Insulators

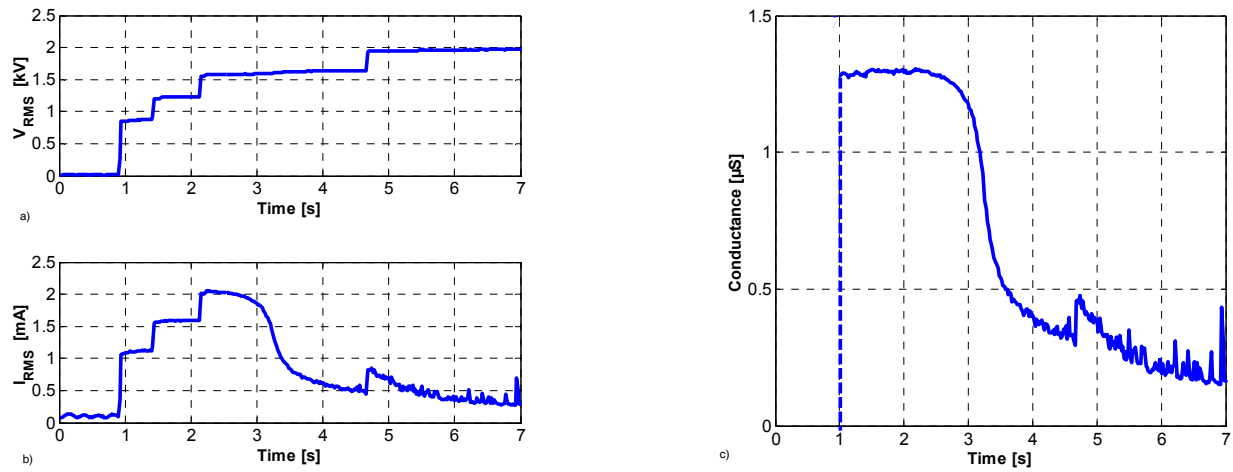
**Figure 1.** Dry band inception on insulator at the start of a ramp voltage test. SDD  $0.64 \text{ mg/cm}^2$   
 Stepped applied voltage (a), Leakage current (b), Leakage conductance (c).

Figure 1a illustrates the initial steps of a full-voltage ramp test, which was applied to a fully wetted insulator. The voltage control system has not at this stage achieved the steady-state rate of  $10 \times 400\text{ V steps/minute}$ . Figure 1b is the resulting leakage current. For the first two voltage steps, the leakage conductance is maintained constant at about  $1.25\text{ }\mu\text{S}$ , and the trunk sections were shown by the IR camera to be uniformly heated, which confirmed that the pollution layer conductance  $k$  was also uniform. This is changed by a further voltage step to  $1.6\text{ kV}$ , which soon leads to a reduced conductance of about  $0.3\text{ }\mu\text{S}$ . At  $2\text{ kV}$  the leakage conductance falls within  $2\text{ s}$  to  $0.25\text{ }\mu\text{S}$  or less. This discontinuity and loss of conductance is strongly indicative of the formation of local drying of part of the moist pollutant surface, with the inevitable formation of a complete dry band. Subsequent characteristics of the leakage current are later shown in Figure 5d.

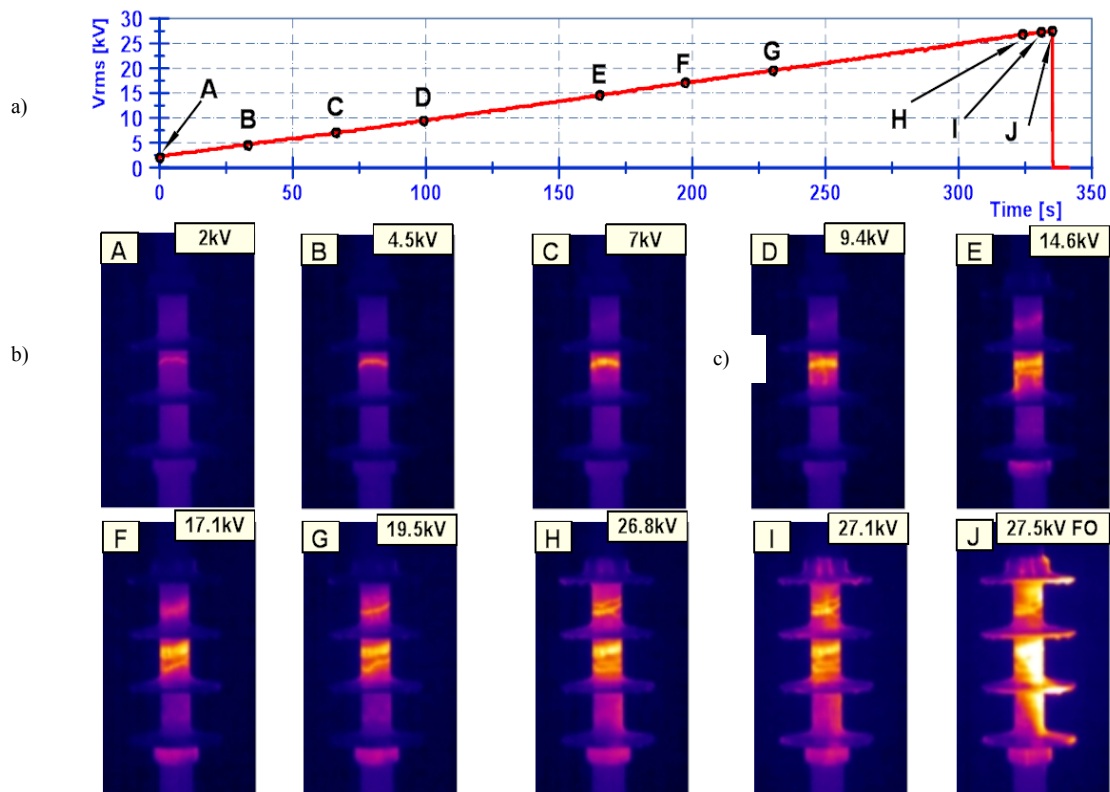
**Figure 2.** Formation and development of dry-bands at stages A – J during a ramp voltage test. SDD  $0.64 \text{ mg/cm}^2$ .

Figure 2 shows the development of dry-bands on the top and middle insulator trunk sections during a ramp voltage test. A heated ring (dry band) is formed on the middle trunk at low voltage ( $2\text{ kV}$ ). This brightens with increasing voltage (see images in Fig. 2 at  $4.5\text{ kV}$ ,  $7\text{ kV}$  and  $9.4\text{ kV}$ ) until, in this case at  $14.6\text{ kV}$ , a second dry band forms just below the first on the same trunk, with the third band forming on the upper trunk. At  $27.1\text{ kV}$ , five bands are present, although in this instance, none forms on the third lowest trunk section before flashover occurs at  $27.5\text{ kV}$ .

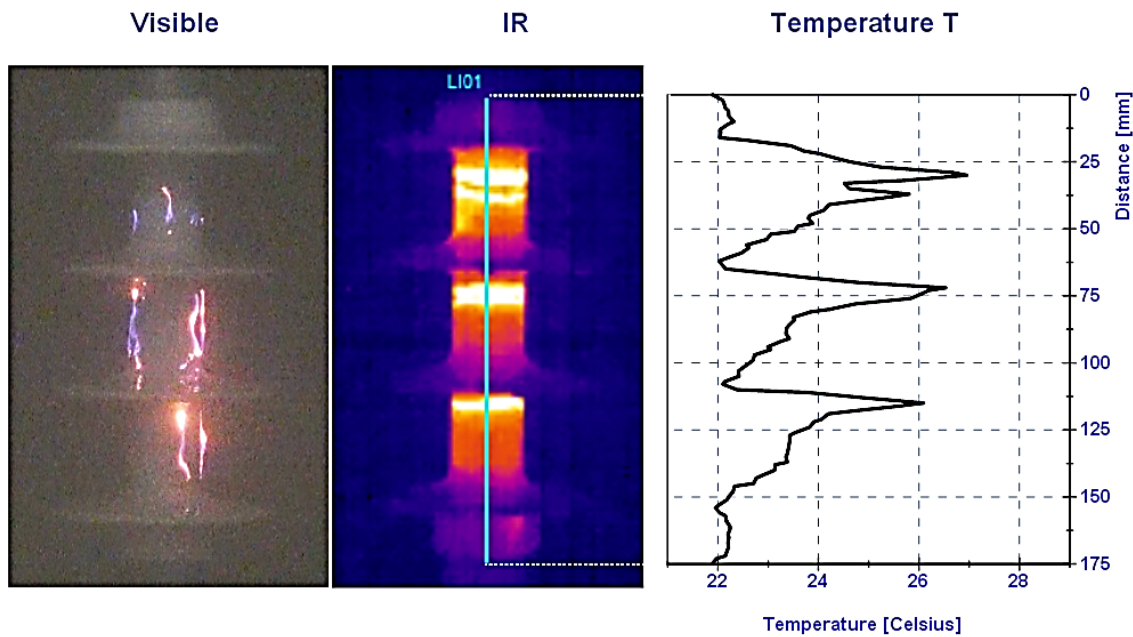
Figure 3. Visible image, infrared record and temperature profile at 22 kV on ramp

Flashover at 25 kV. SDD  $0.64 \text{ mg/cm}^2$ .

The temperature rise associated with dry-band formation is modest. The insulator in Figure 3 is in a fog environment at  $17^\circ\text{C}$ , yet most of the trunk surfaces are at  $22^\circ\text{C}$  and the dry bands reach  $26\text{--}27^\circ\text{C}$ .

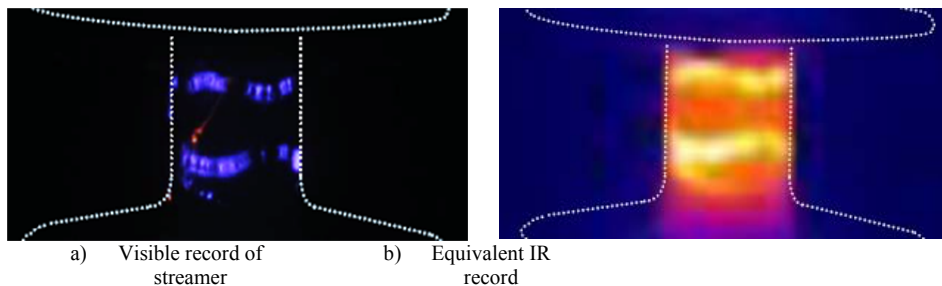
Figure 4. Visible and IR close-ups of streamer discharges and dry-band heating at 17 kV on ramp. SDD  $0.64 \text{ mg/cm}^2$ .

Close-up visual photography (Figure 4) reveals faint discharges that bridge the bands, whose violet colour is consistent with the appearance of atmospheric streamer breakdown. The shapes of the heated surfaces of the dry bands that are visible in Figure 4b are congruent with the shapes of the bands of streamer discharges in Figure 4a. The voltage fall across the band associated with a low-current glow or streamer discharge is significant, and may ensure that the local power dissipation within the band sustains a rate of evaporation that matches the wetting rate. This persistence of dry-band heating indicates that these streamer discharges provide current continuity across each band despite the low conductance caused by moisture loss. A transition to a spark channel would account for the partial-arc development visible in Figure 3.

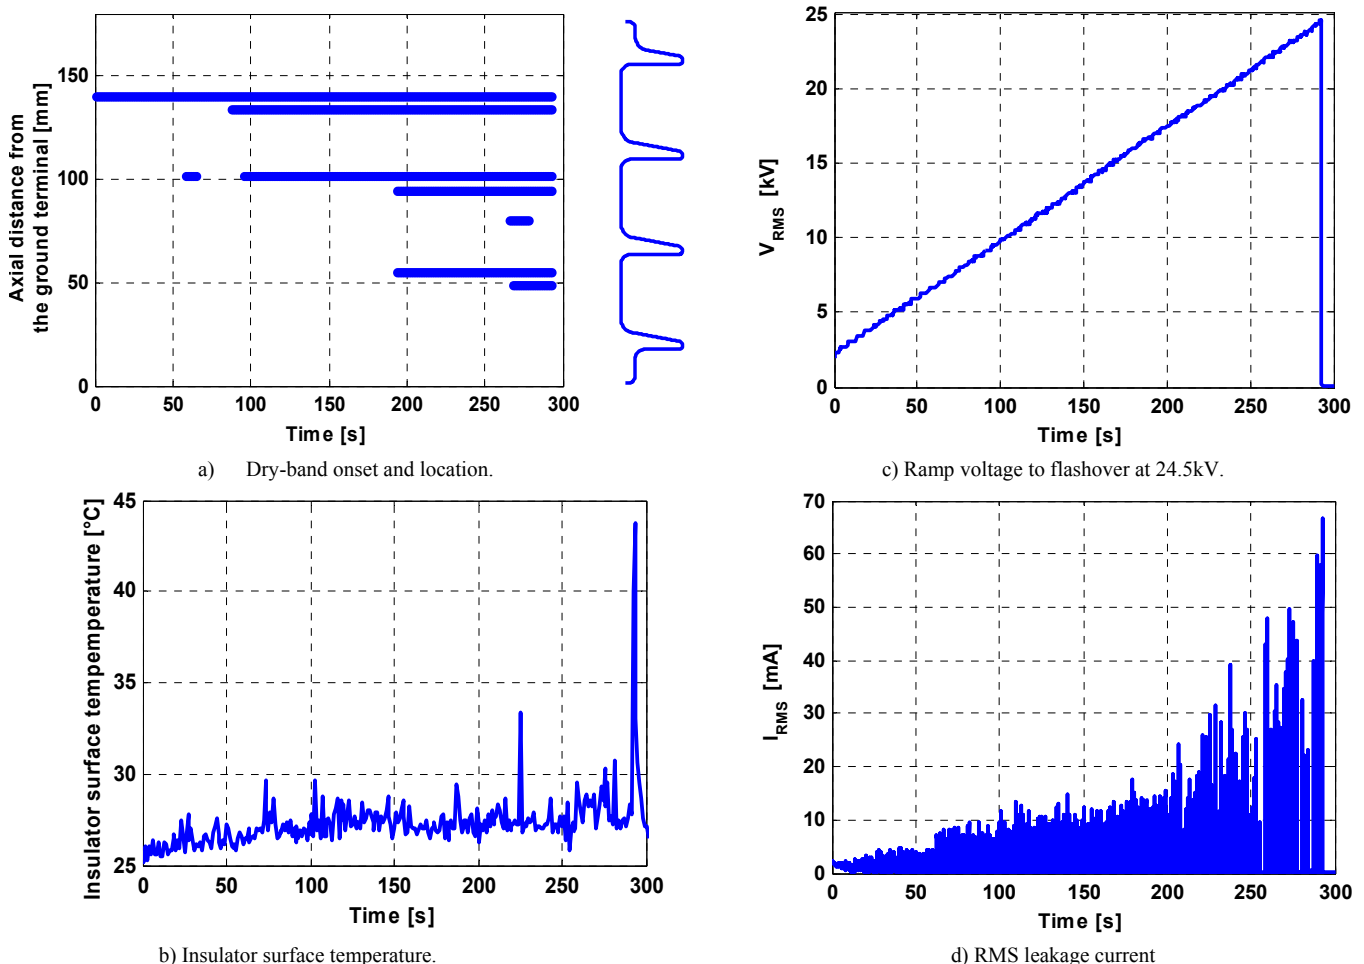
Figure 5. Pre-flashover dry-band development and leakage current growth. SDD 0.64 mg/cm<sup>2</sup>.

Figure 5 represents results from a test similar to that of Figure 2. The horizontal bars indicate the times of onset of each band, its location and the increasing number of dry bands during an applied ramp leading to a FOV of 23 kV. The first bands in this example are located on the upper (high voltage) trunk section of the insulator, with seven bands appearing at the middle and then lower (ground) sections before a flashover in this instance at 290 s.

Throughout this period, the average band temperature rise remains fairly constant (Figure 5) at about  $10^\circ\text{C}$  above the fog temperature. At higher voltages, increases in band temperature of up to  $15^\circ\text{C}$  above ambient temperature could occur. The transient increases to higher temperatures are associated with short-lived partial arc discharges which bridge the dry bands (Section 3.5).

The pre-flashover RMS ramp voltage and current accompanying the dry-band development of Figure 5a are seen in Figures 5c and 5d to attain a typical partial-arc value of 60 mA, compared with less than 1 mA in dry-band streamers. Figure 6 shows the correlation of visual and infrared records with post-processed electrical data of a ramp test at successive instants during the 290 s before flashover (n.b. a scale of time-before-flashover is used here to facilitate comparison with other tests). Such tests confirm that the streamer discharges of a dry band are always a necessary precursor for the formation of partial arcs that may eventually lead to insulator flashover. Partial arcs are brighter than the streamers, and their often yellow colour suggests the presence of sodium ions from the pollution layer. During post-processing the number of partial arcs per second ( $N_p$ ) is computed from the number of current transients greater than 0.5 mA during successive windows of 1 s [5]. It is noticeable that  $N_p$  reduces with increasing voltage. This reduction of partial-arc activity near flashover may be the result of the increasingly numerous and wide dry bands revealed by the IR records, so that even the substantial partial arc of event numbered VI in Figure 6b does not lead to flashover, which later occurs at 29 kV. The energy dissipation shown in Figure

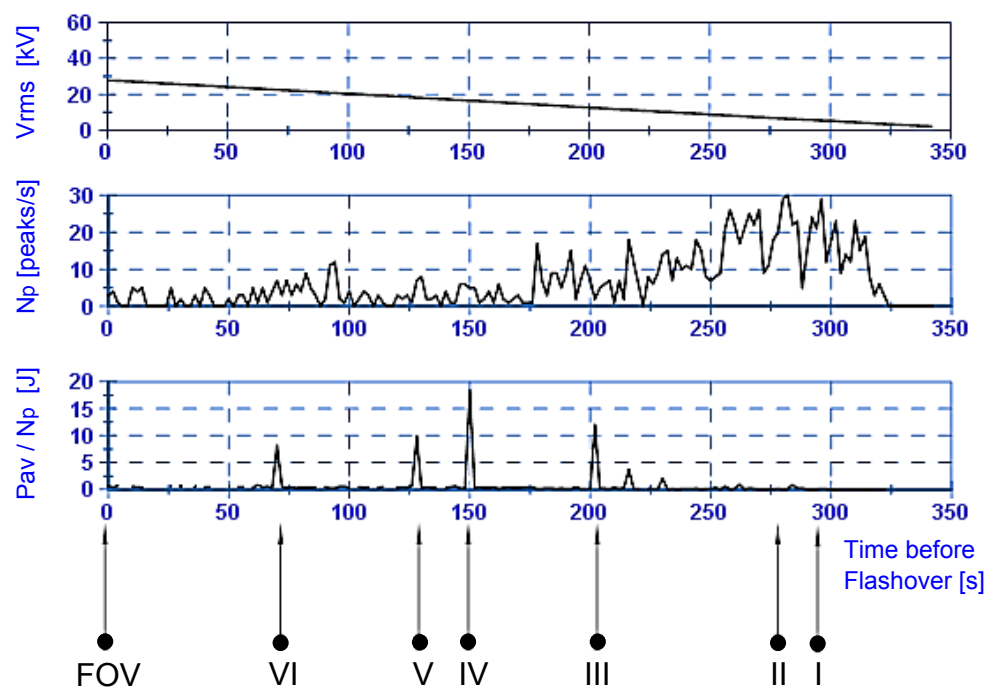
Figure 6a

Voltage ramp.  
 Partial-arc activity (current peaks  $> 0.5A$ ) per second).  
 Energy dissipation in events I – VI.

6a is the mean energy loss per partial arc. This is given by the ratio  $P_{av}/N_p$ , where the mean power loss  $P_{av}$  during each time window is calculated from leakage current and voltage measurements. Power dissipation can exceed 1 kW in partial-arc events, and energy loss in the largest arcs is usually 10 J or more. Although the streamer discharges of a dry band appear to be a necessary precursor for the formation of a partial arc, any streamers which are not so transformed may act as a stabilising influence, since significant local voltage falls are necessary to maintain the dry-band streamers.
