Let There Be Light! Investigating Vernacular Daylighting in Moroccan Heritage Hammams for Rehabilitation, Benchmarking and Energy Saving

Magda Sibley

Sheffield School of Architecture, The University of Sheffield, Arts Tower, Western bank, Sheffield S10 2TN, UK; m.sibley@sheffield.ac.uk or sibleym3@gmail.com; Tel.: +44-7930-988-8193

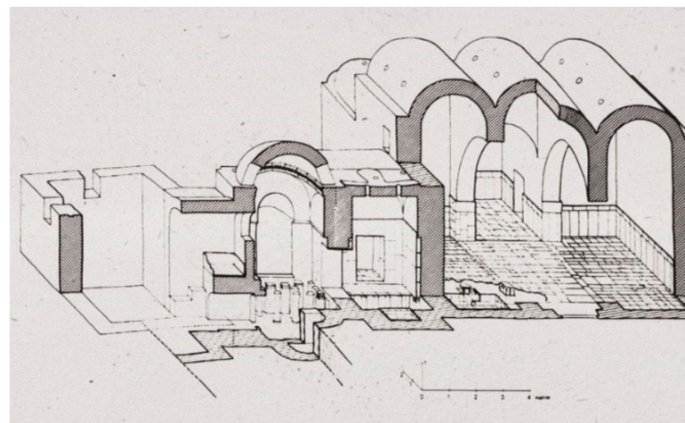
Figure 1. Qusayr Amra three vaulted bathing rooms with small oculi [2].

The decline of the Roman and Byzantine public bath institution in the West was followed by the development and proliferation, during the early Islamic era, of small public baths, reminiscent of the Roman baths known as balnea. These baths feature three successive bathing rooms of increasing temperature, as well as the underfloor heating system known as hypocaust, both were maintained in the architecture of Islamic hammams. However, daylighting provision was replaced by a number of small oculi, pierced in the vaults and domes of the hammam roof, becoming a distinctive characteristic of hammam buildings. This architectural feature can be seen in two early Islamic baths: Hammam Qusayr Amra, an 8th Century structure [3] in the Jordanian desert (Figure 1) and in Hammam Aghmat,

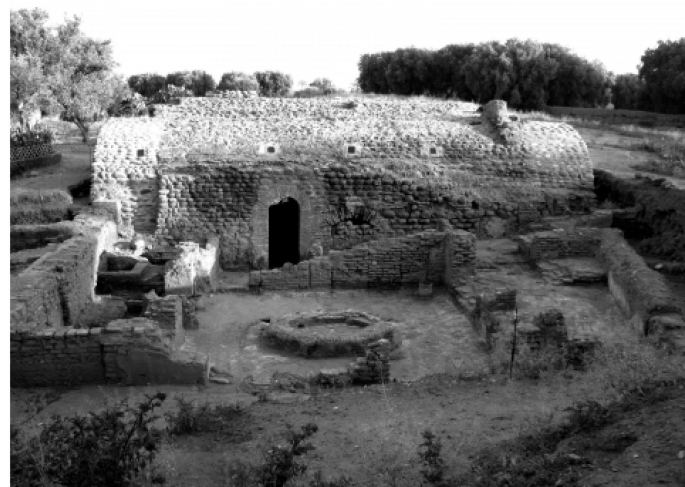
Figure 2. Hammam Aghmat: 11th Century Almoravide era, Morocco [3].

an 11th Century Almoravid structure [4] excavated in Aghmat, 30 kilometres South East of Marrakech in Morocco [4,5]. The Aghmat hammam [6] displays rows of circular openings or oculi in the three vaults covering the cold, warm and hot rooms (Figure 2). Such a configuration will continue unchanged in the architecture of Moroccan and Andalusian hammams for many centuries onwards [7–9]. The small circular piercings of 18 to 25 cm in diameter, located in the vaults and domes of the hammam roof are capped with blown glass bells. These allow shafts of daylight and sunlight to penetrate into the bathing spaces, cutting through the thick steam and creating different atmospheres at different times of the day. They constitute one of the unique and authentic experiential qualities of hammam buildings as illustrated in the case of one Mamluk and one Ottoman hammam (Figure 3a,b). Known in Arabic as little moons “Qamariyyat” or little suns “Shamsiyyat”, they make a clear connection between the bather and the changing sunlight conditions of the sky. They also allow low levels of daylight into the steamy bathing spaces, hence maintaining some level of visual privacy, bearing in mind the strict religious codes governing nudity and gazing at another bathers’ body. The act of washing one’s body is indeed not a task that requires high levels of daylight, however, the manipulation of daylight in hammam spaces is believed to be highly linked to cultural and spiritual norms. It is argued in this paper that the vernacular daylighting system in hammams constitutes an intrinsic part of the heritage value and authenticity of this building type that needs to be fully understood in order to be properly rehabilitated in existing heritage structures and carefully reintroduced in the architecture of contemporary hammams in Morocco and beyond.

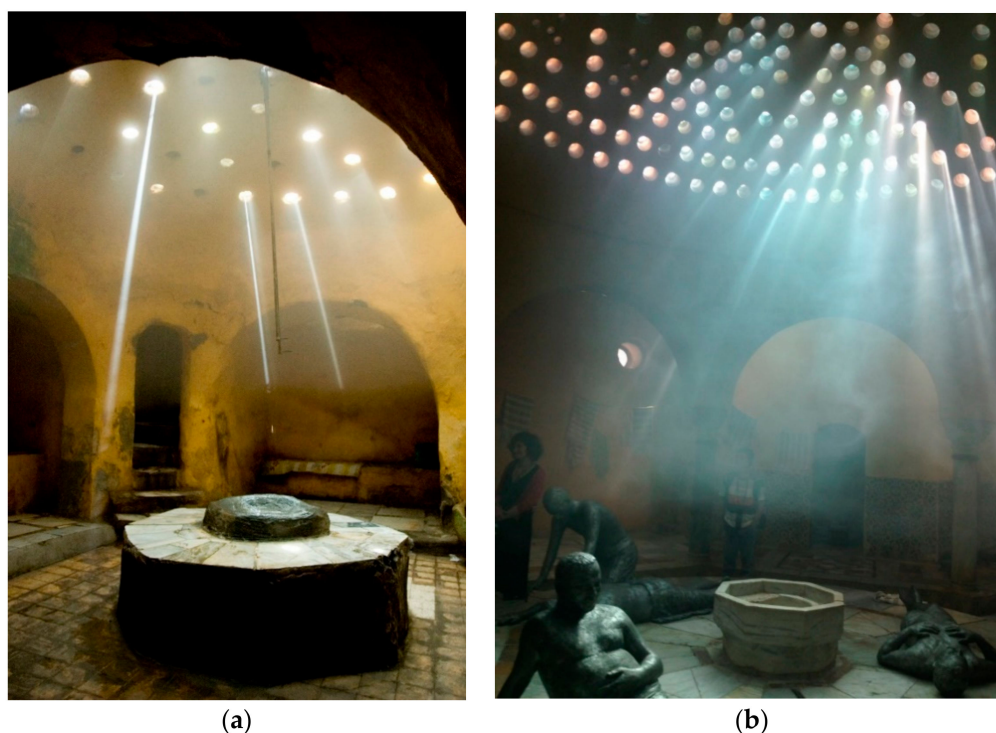
Figure 3. Hammam lightscape in the hot room of (a) Hammam al Hussayniya in Cairo (Mamluk era); (b) Hammam al Bacha in Acre (18th Century Ottoman era).

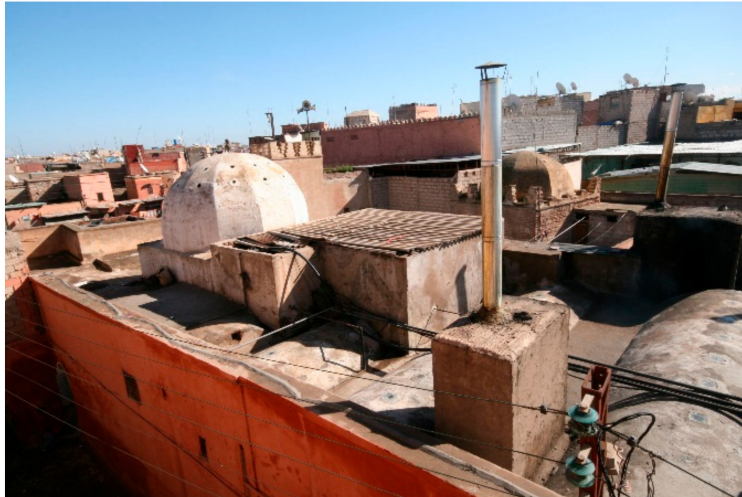
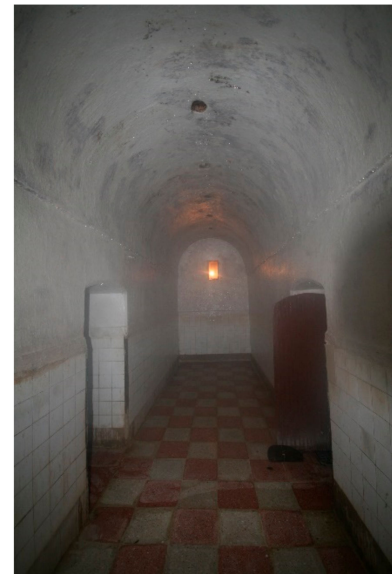
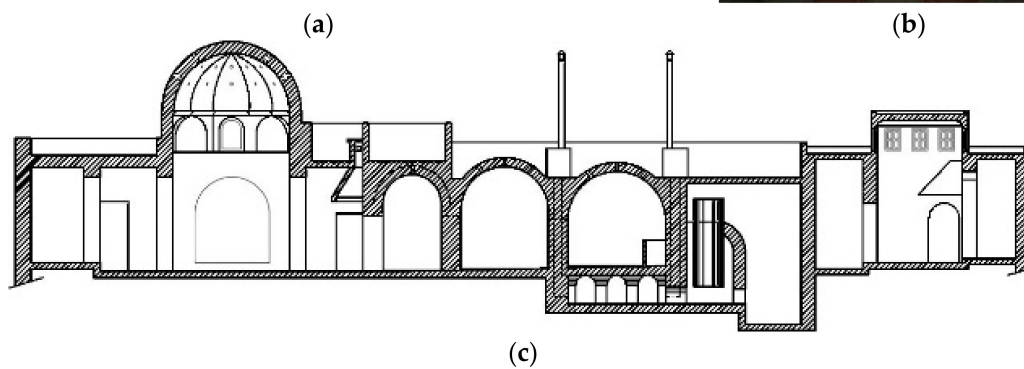
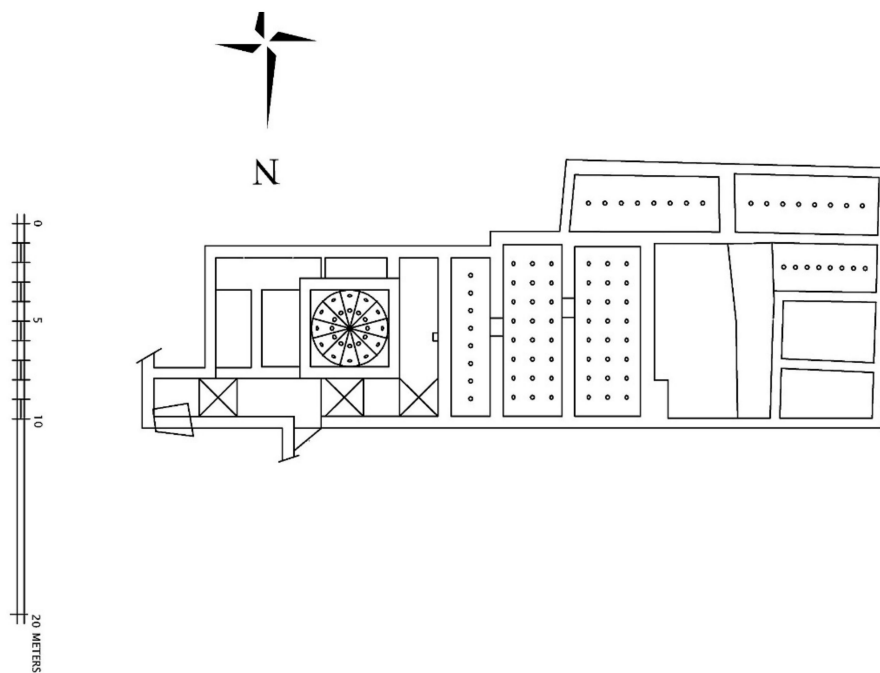
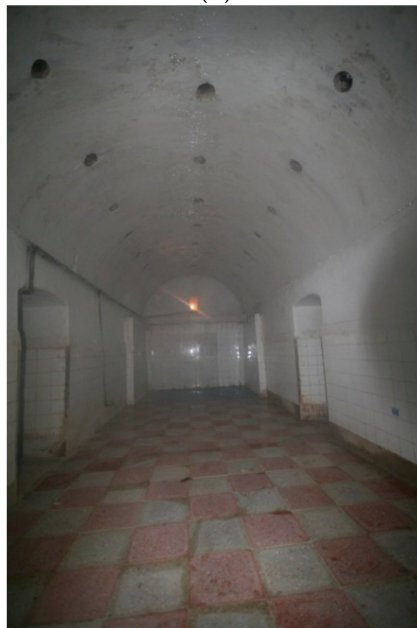
Figure 5. Hammam Sidi Ayyub (16thC) from left to right (a) view of the roof; (b) internal view of the blocked oculi in the cold room; (c) building section illustrating the proportions of the three bathing spaces; (d) roof plan with oculi location; (e) internal view of the blocked oculi in the warm room.

This organisation is found in the vast majority of the hammams (11 out of 13) as illustrated in the case of hammam Sidi Ayyub (Figure 5) and is reminiscent of the early Moroccan Islamic hammams excavated near the Roman settlement of Volubilis and the Alomravid settlement of Aghmat. In addition to the bathing spaces, all hammams comprise a changing room with an intermediate space with toilets connecting the changing room to the cold room. The configuration of three successive vaulted rectangular bathing rooms is reflected in the roof architecture of 11 out of the 13 heritage hammams surveyed as illustrated in Figure 6. The architecture of the cold and hot rooms, consisting of

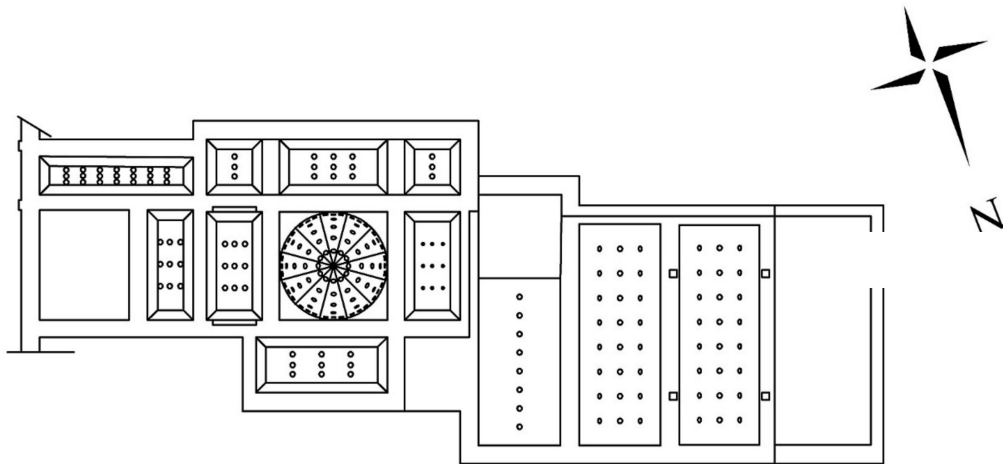
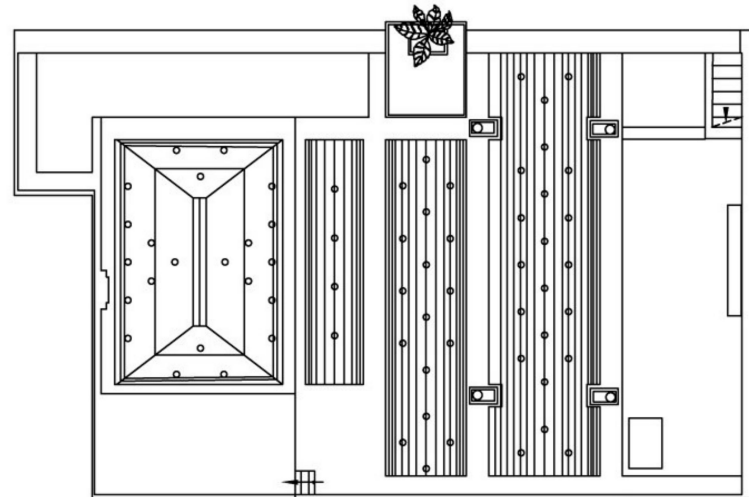
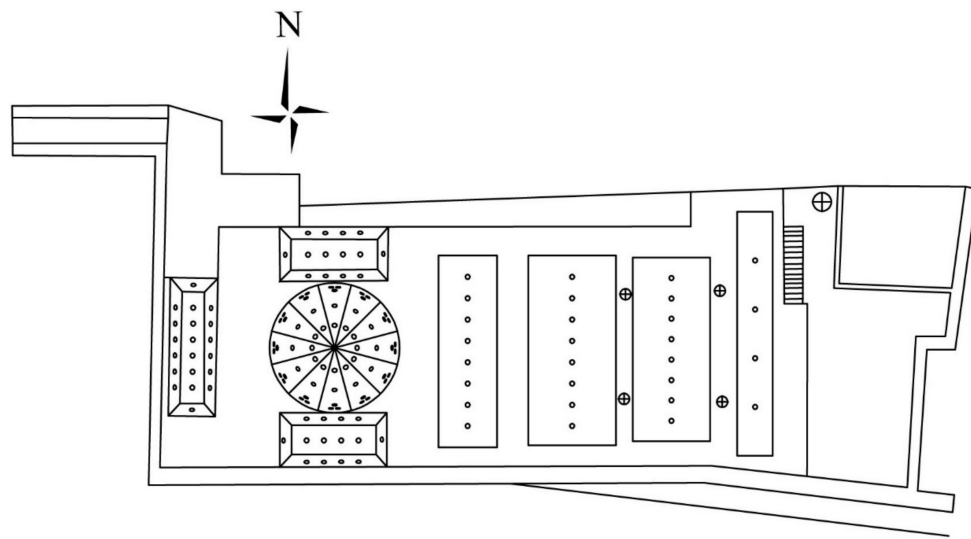
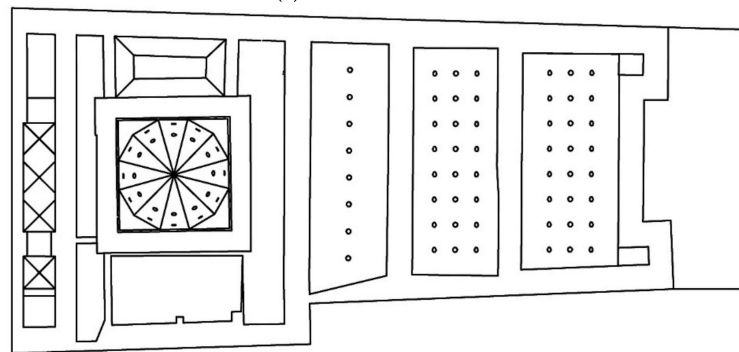
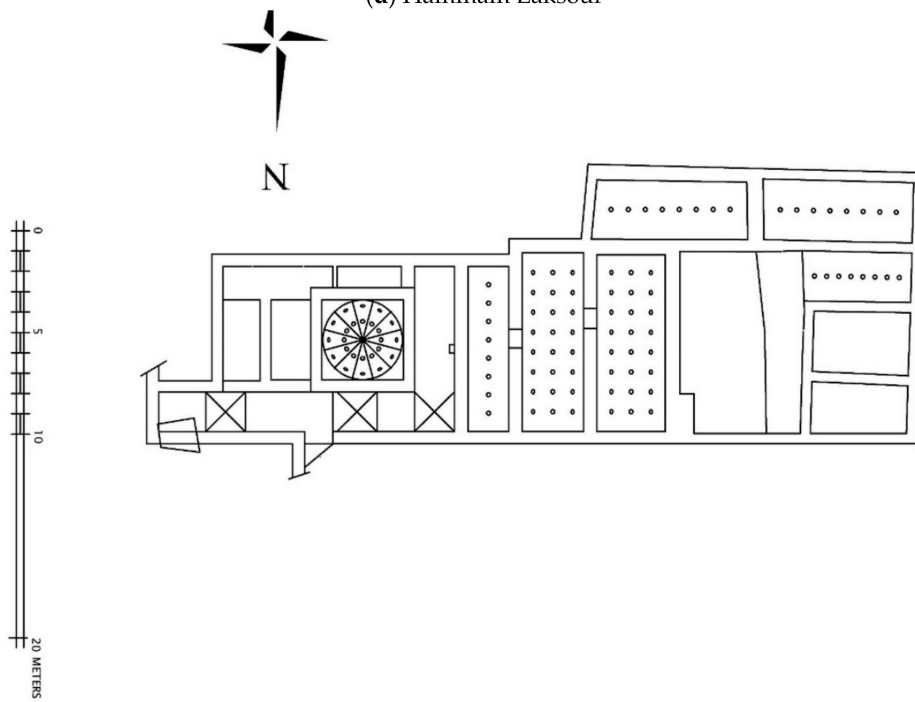
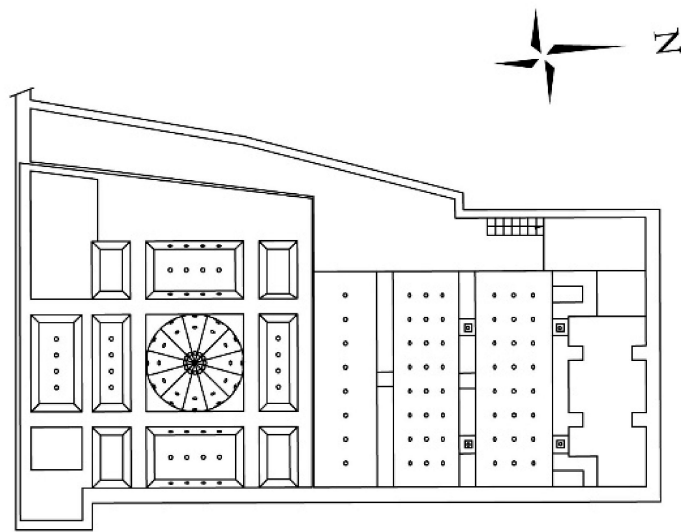
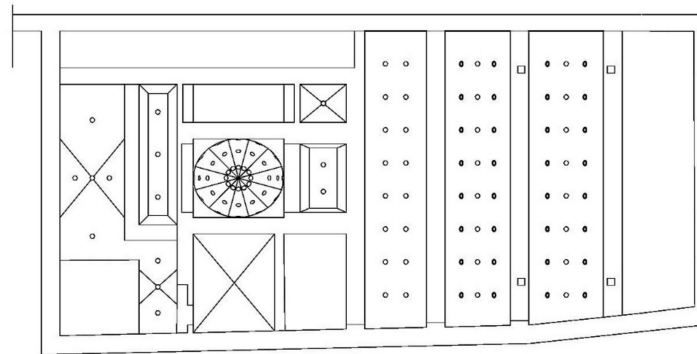
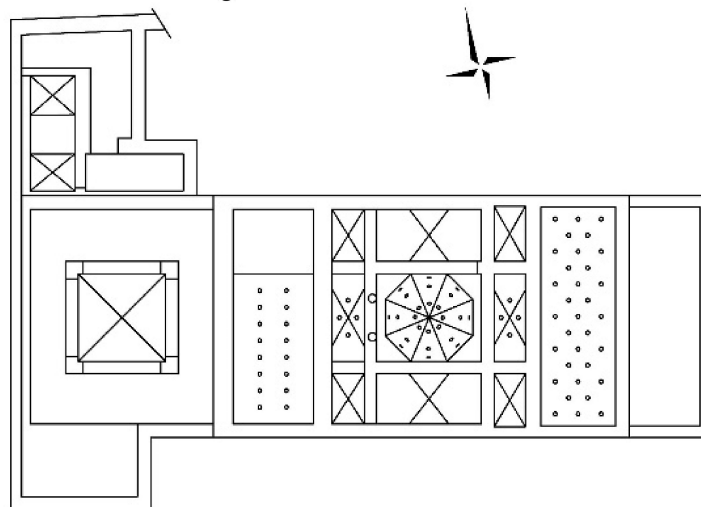
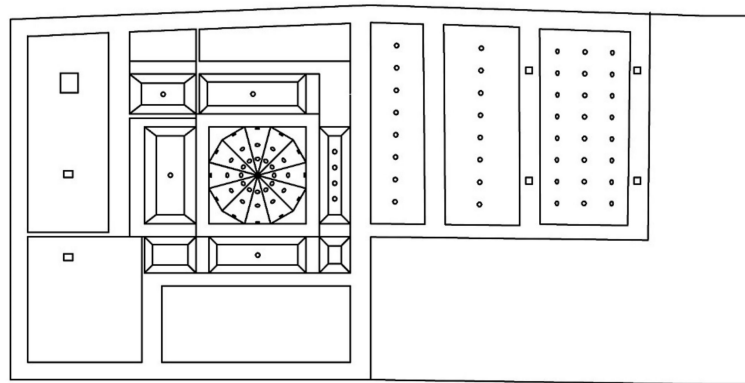
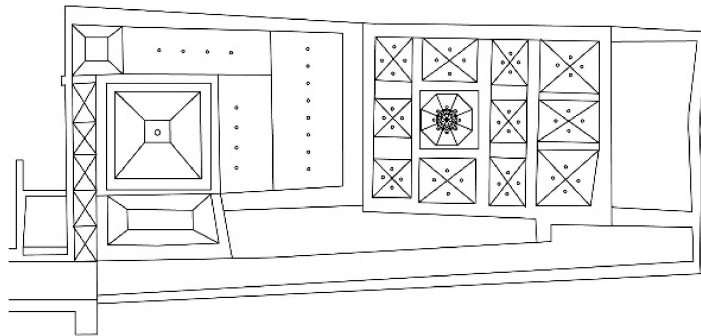
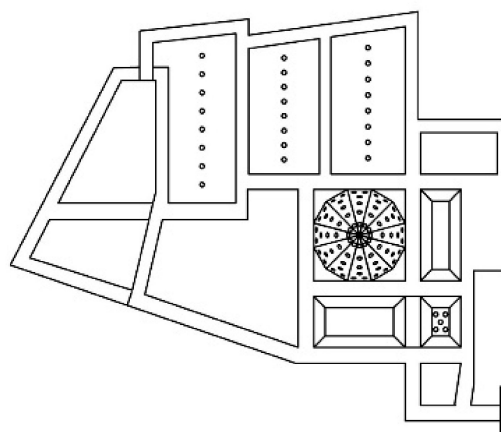
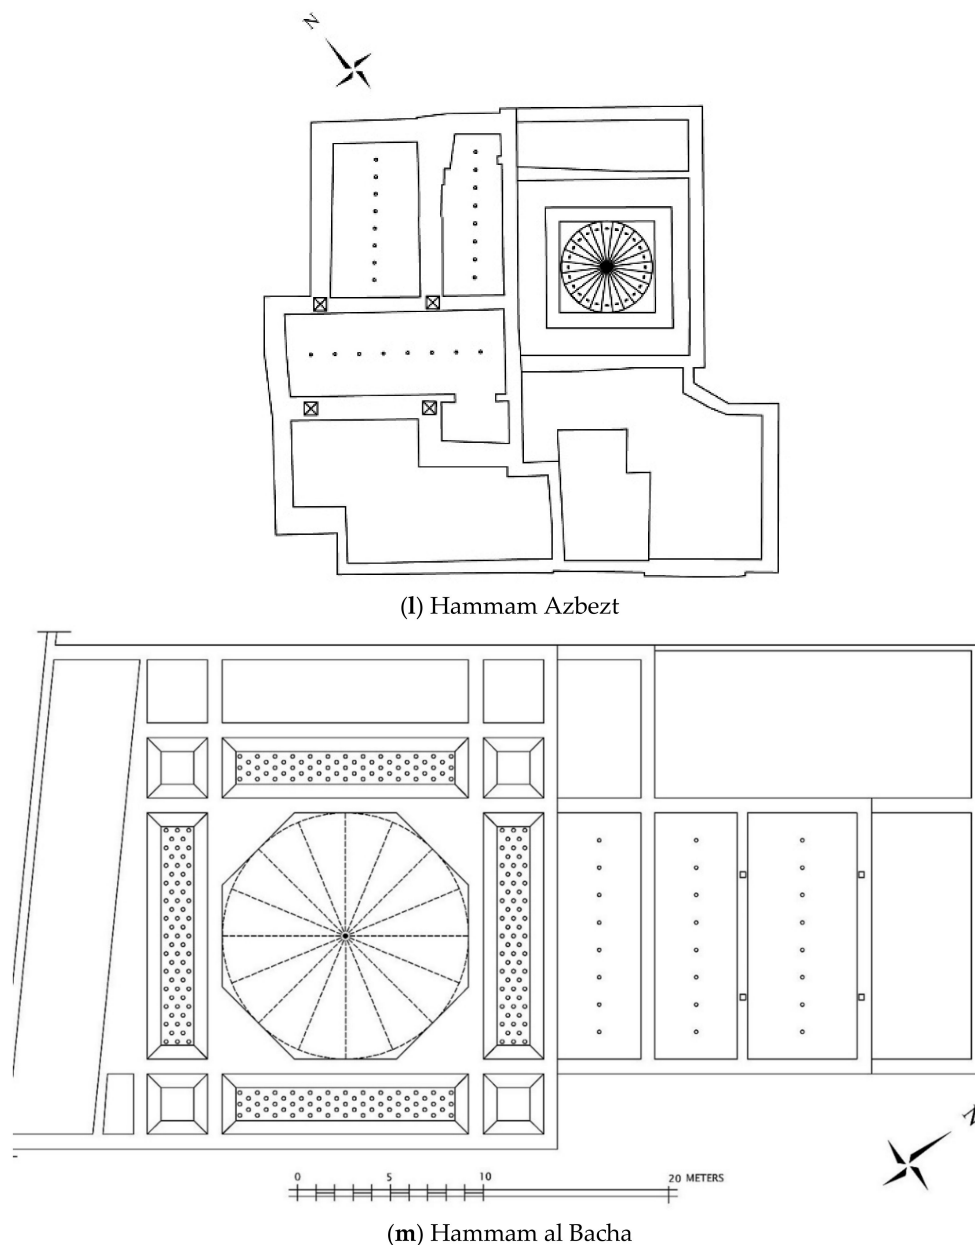
Figure 6. Roof plans of the 13 surveyed hammams. (a) Hammam al suq (b) Hammam Bab Ailene (c) Hammam Ziani (d) Hammam Laksour (e) Hammam Sidi Ayub (f) Hammam Qannaria (g) Hammam Sidi Abdelaziz (h) Hammam Bab Doukala (i) Hammam Derb Arjane (j) Hammam Mouassine (k) Hammam Dahab (l) Hammam Azbezt (m) Hammam al Bacha.

- There is a recurrence in the number of eight oculi or multiples of eight, ranging from 8 to 24 oculi (of 18 cm diameter) in the roof vaults covering the bathing spaces (see Table 2).
- The configuration of oculi on the roofs of the cold, warm and hot bathing spaces tends to be in rows of eight along the length of the vaults. The number of rows can vary from one to a maximum of three rows, depending on the width of the bathing space. A single row seems to be a constant feature of the cold room and is not dependent on its floor area (Figure 6).
- Pierced masonry domes tend to be found in the majority of changing rooms' roofs as illustrated in 10 out of the 13 surveyed hammams (Figure 6). They are also found in the warm room of a few

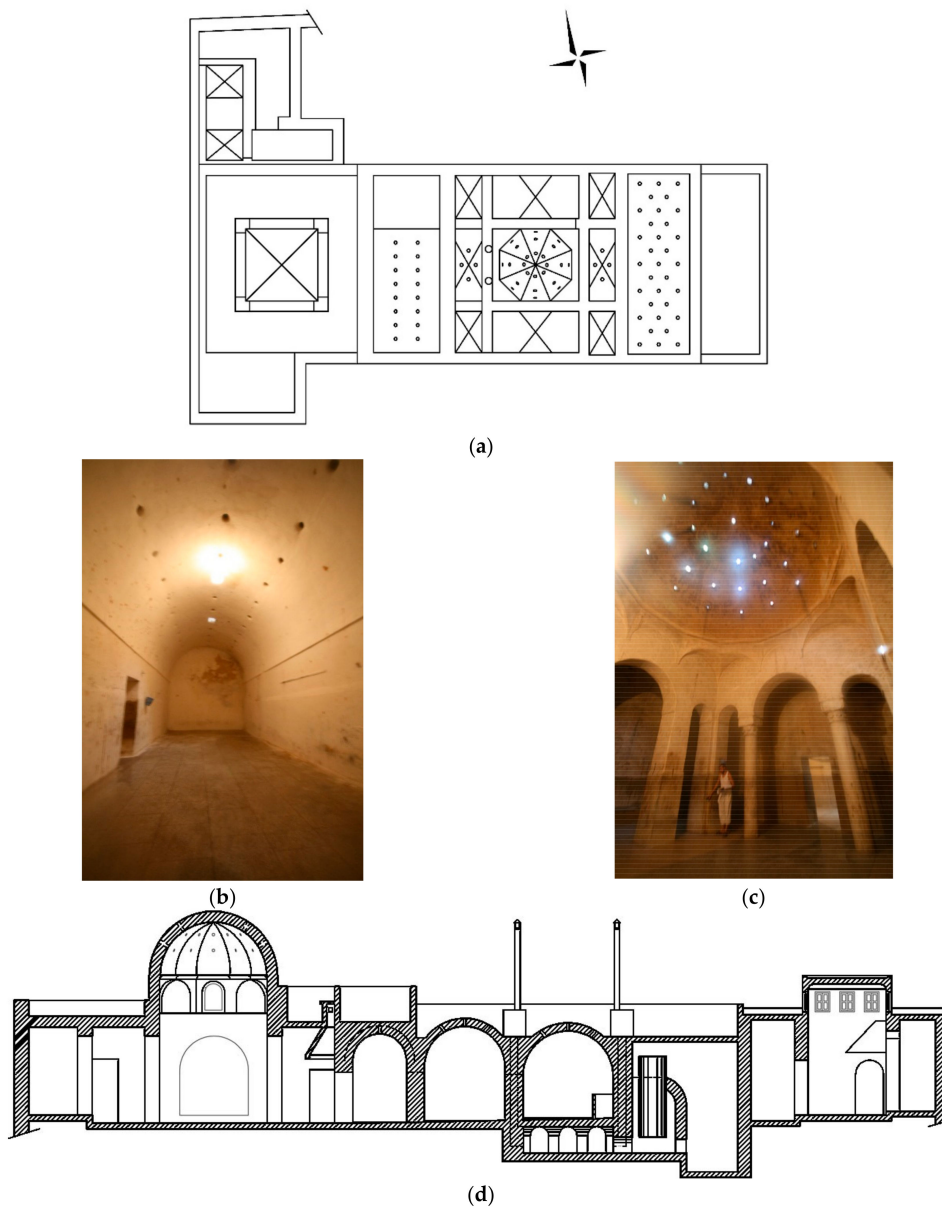
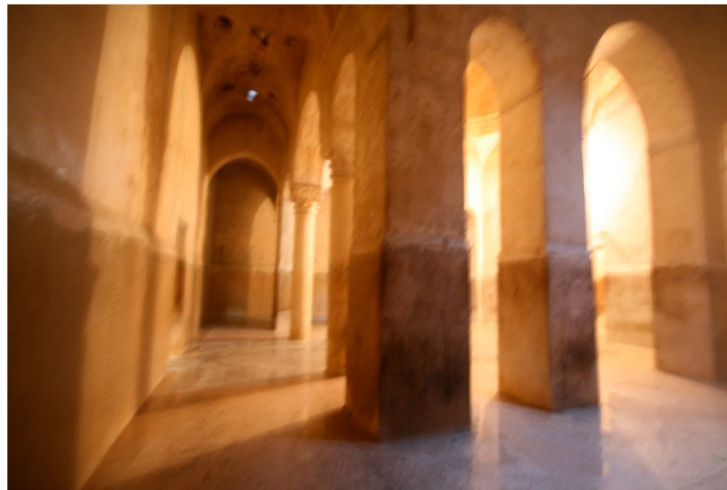
Figure 7. Hammam Bab Doukala from top left clockwise: (a) Roof plan; (b) interior view of hot room pierced vault; (c) warm room central pierced dome; (d) building section; (e) warm room pierced cross vault.

larger hammams, as illustrated in the roof plans of hammams Mouassine and Doukala (Figures 7 and 8). The dome openings are based on the octagonal formation of the dome resulting from a 45-degree rotation of one square plan over another. This explains the number of dome openings as multiples of four.

- The number of oculi on a dome is generally much larger than that of a vault and can exceed 60 oculi.
- The warm room is the only bathing space where a central dome with a large number of oculi is sometimes found and is surrounded by cross vaulted spaces (Figures 7b and 8d).
- Three of the 13 surveyed hammams have a tiled roof wooden structure covering the central area of their changing room as illustrated in the case of hammams Doukala and Mouassine (Figures 7 and 8).

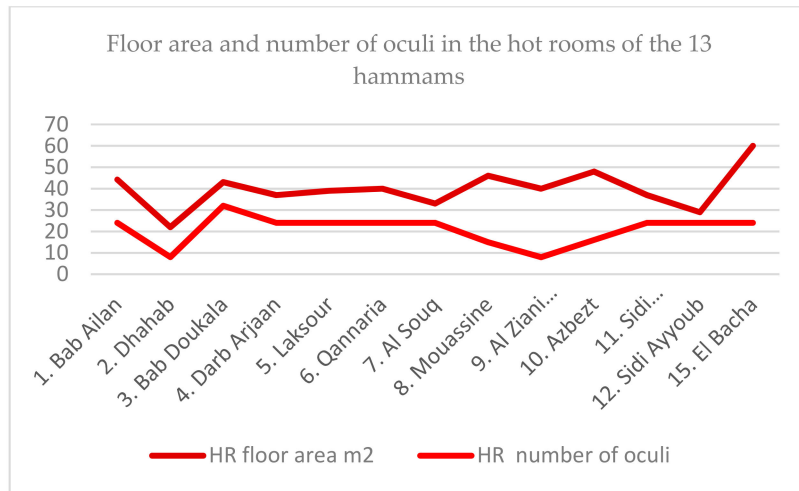
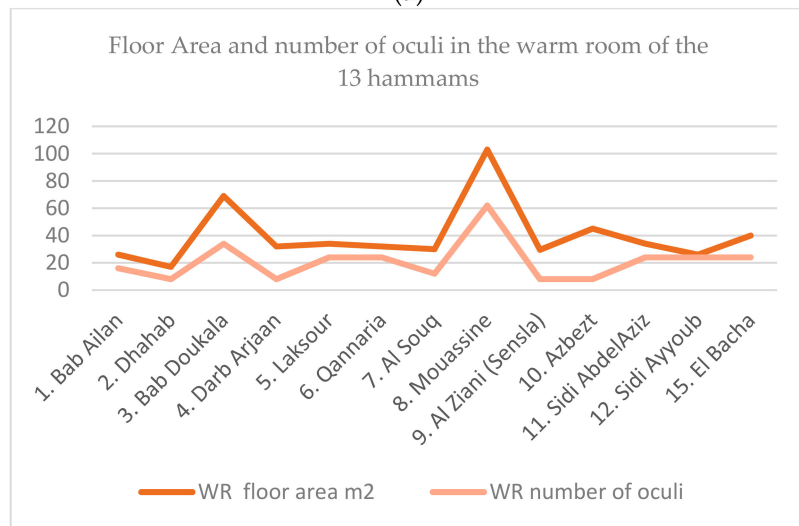
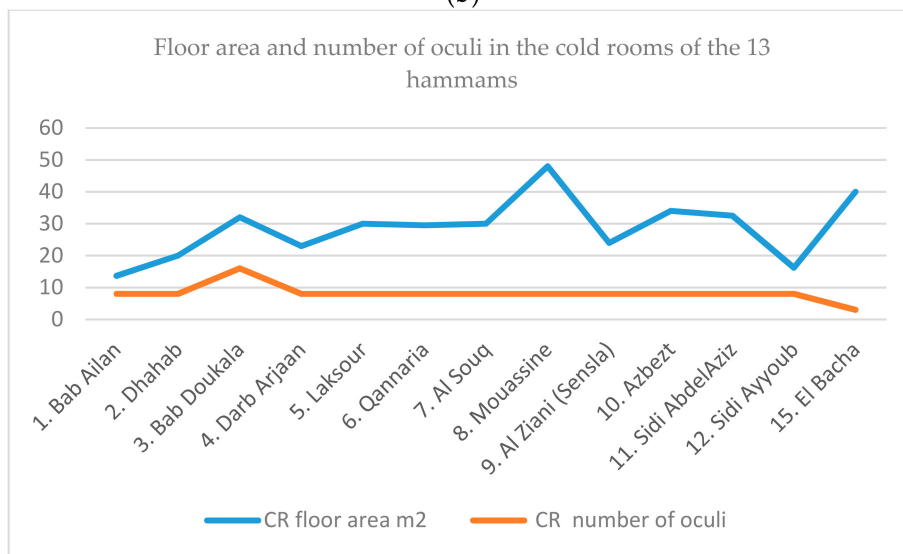
Figure 9. Relationship between floor area and number of roof oculi per type of bathing space: (a) The hot room; (b) the warm room; (c) the cold room. The horizontal axis is the hammam as they appear in Table 1.

The number of oculi in the roof of each of the bathing spaces is dependent on its floor area as illustrated in Figure 9a,b, where the graphs show (as expected) a clear correlation between the floor area of the space and the percentage of roof openings' total area in both the hot and warm rooms as illustrated in Figure 9a,b. The largest number of oculi is found in the warm room, when this has a central dome as is the case of hammam Mousassine (Table 2). However, the key finding here is that the cold room's total area of roof openings, consisting on one row of eight oculi, is not related in any way to its internal space floor area (Figure 9c).

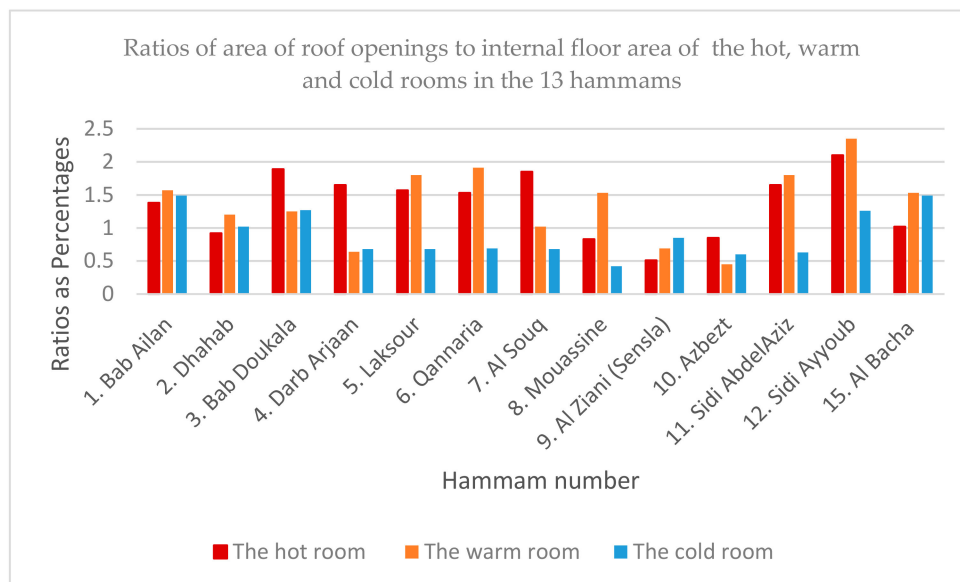
Figure 10. Comparison of ratios of roof opening total area in relation to floor area in the three bathing spaces of the 13 surveyed hammams.

It is clear from Table 2 and Figure 10 that the cold room has the smallest proportions of roof openings as compared to the hot and warm rooms in the vast majority of the surveyed hammams. It is also interesting to note that the maximum total area of oculi roof openings does not exceed 2% of the internal floor area of the bathing space above which they are located as illustrated in 12 of the 13 surveyed hammams (Figure 10).

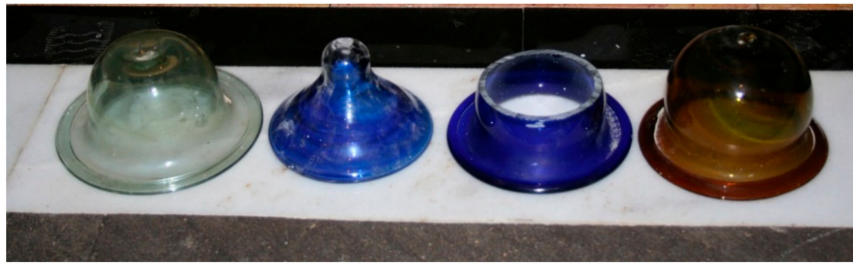
Figure 11. Samples of blown glass bells produced in Syria in 2007 based on vernacular prototypes examined to restore hammam daylighting. The blue version is an openable oculus glass cap for natural ventilation.

All surveyed heritage hammams have completely lost the original daylight qualities in their bathing spaces, as the vernacular blown glass caps (Figure 11) have all been replaced by poor alternatives, such as glass bricks or flat sheets of reinforced glass (Figure 12a), or have been completely blocked by layers of cement. Poor incandescent or fluorescent electric lighting that is neither appropriate nor safe for the steam conditions of these spaces was found to be used all day long in the surveyed hammams, increasing consumption of electricity. Furthermore, face-to-face interviews conducted with three female hammam workers in Marrakech indicated the occurrence of headaches and fatigue which they attributed to the lack of daylight and natural ventilation in the bathing spaces. A follow-on discussion with the head of the hammam managers association in Marrakech revealed that there was a lack of knowledge of the original blown glass caps which used to cover the roof oculi amongst most hammam managers. This situation is further exacerbated by the loss of glass blowing workshops in Moroccan cities, with the exception of the one and only glass blowing workshop opened by a French entrepreneur in Marrakech and employing the last two glass blowers in Morocco. Based on the form of vernacular glass bells, the transparent blown glass bells of 18 cm in diameter was used by the author as a prototype to produce locally 48 glass bells, using recycled glass (Figures 11 and 12).

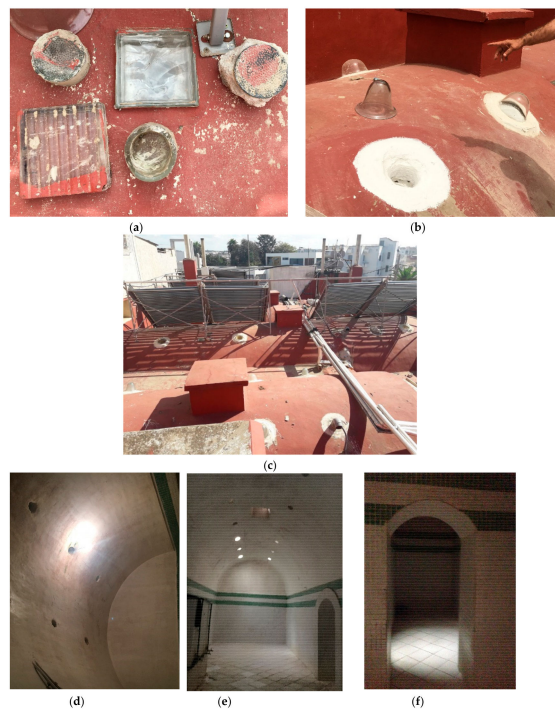
Figure 12. The roof of Hammam Rjafalla: (a) Removing poor alternatives of oculi covers; (b) re-opening the oculi and placing the blown recycled glass caps; (c) solar panels over the warm room affecting indoor daylight measurements; (d) blocked oculi in the hot room; (e) vernacular daylight restored; (f) oculi natural light effect.

Access to a working heritage hammam in Marrakech to restore the blown glass caps over the oculi system was impossible. However, the opportunity to restore the vernacular daylighting system in a working heritage hammam presented itself in Rabat (the administrative capital of Morocco) in July 2016. Built in the 1950s, during the French protectorate, the Hammam Rjafalla is located in an informal, low-income housing neighbourhood, known as Hay Rjafalla, in the area of Yacoub al Mansour. The building presents a typical Moroccan vernacular hammam architecture, consisting of three successive rectangular parallel rooms with two rows of eight oculi in each of the three north/south facing vaulted roofs (Figure 12c).

The rehabilitation of the vernacular daylighting system took place in July 2016, under the initiative and supervision of the author, at a time when the hammam was temporarily closed for its annual maintenance work. The hammam manager has been in charge of the building for the last 36 years and is the only active female member of the National Federation of Moroccan hammam managers. She is also one of the key participants to the sustainable hammam initiative in Morocco which was presented at the COP22 in Marrakech in November 2016 [16]. The re-opening of the closed oculi and the installation of the blown glass bells was carefully conducted in order to avoid damaging the pottery

tubes located in the masonry of the vaults and which form the base for the glass cap (Figure 12c). Once the vernacular daylighting system was restored, HOBO data loggers were installed in the same position within each of the three parallel bathing rooms at a height of two metres from the floor and at the base of the vault. This allowed for the recording of horizontal illuminance at a similar point on the internal south facing wall under the steam conditions of a working hammam and without interfering with bathers' activities (Figure 13).

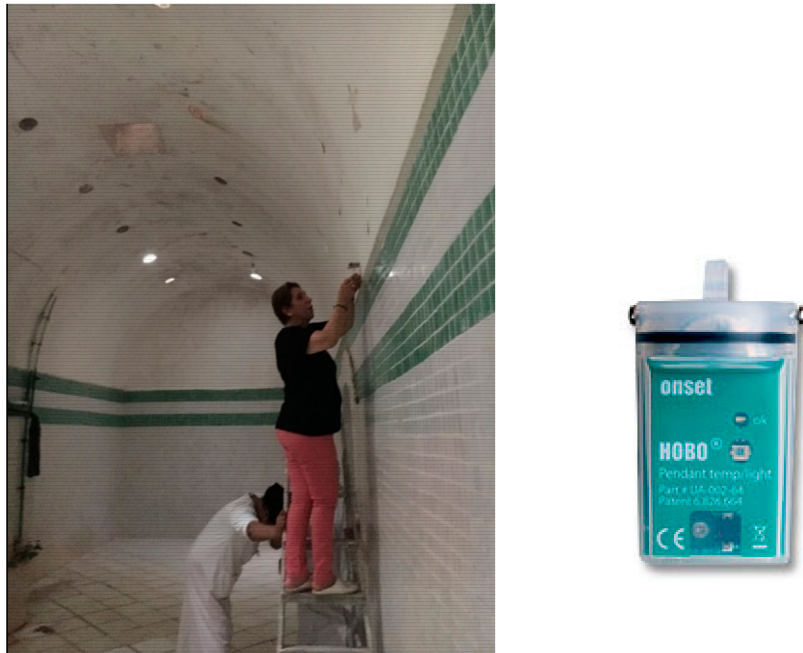
Figure 13. Installation of HOBO data loggers for measuring temperature and light: Temperature range: $-20\text{ }^{\circ}\text{C}$ to $70\text{ }^{\circ}\text{C}$, light measurement range: 0 to 320,000 lx (0 to 30,000 lumens/ft²).

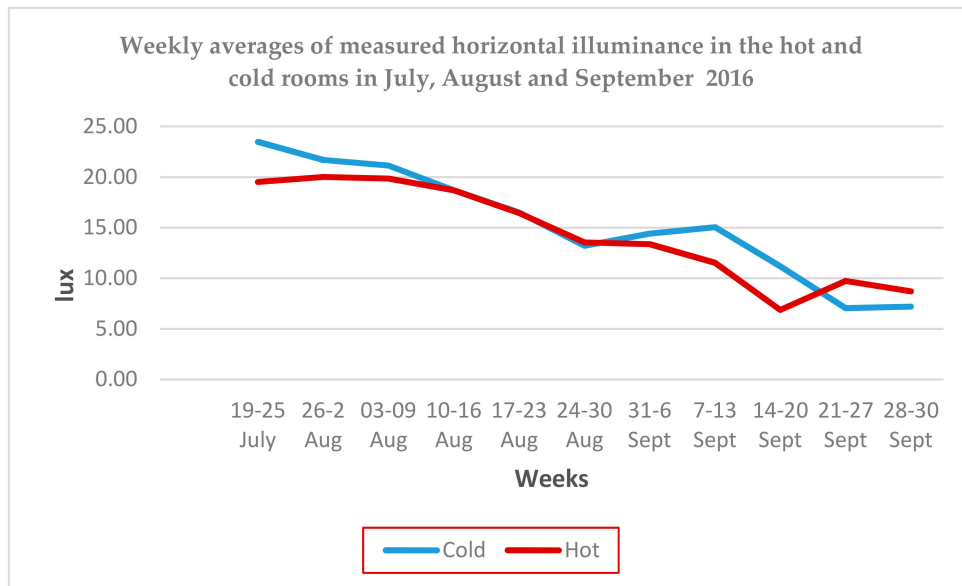
Figure 14. Weekly averages of horizontal illuminance (lx) recorded in the hot and cold rooms (19 July to 30 September 2016).

There is a rapid decline in weekly illuminance averages in September leading to much lower levels inside the bathing spaces (Figure 14).

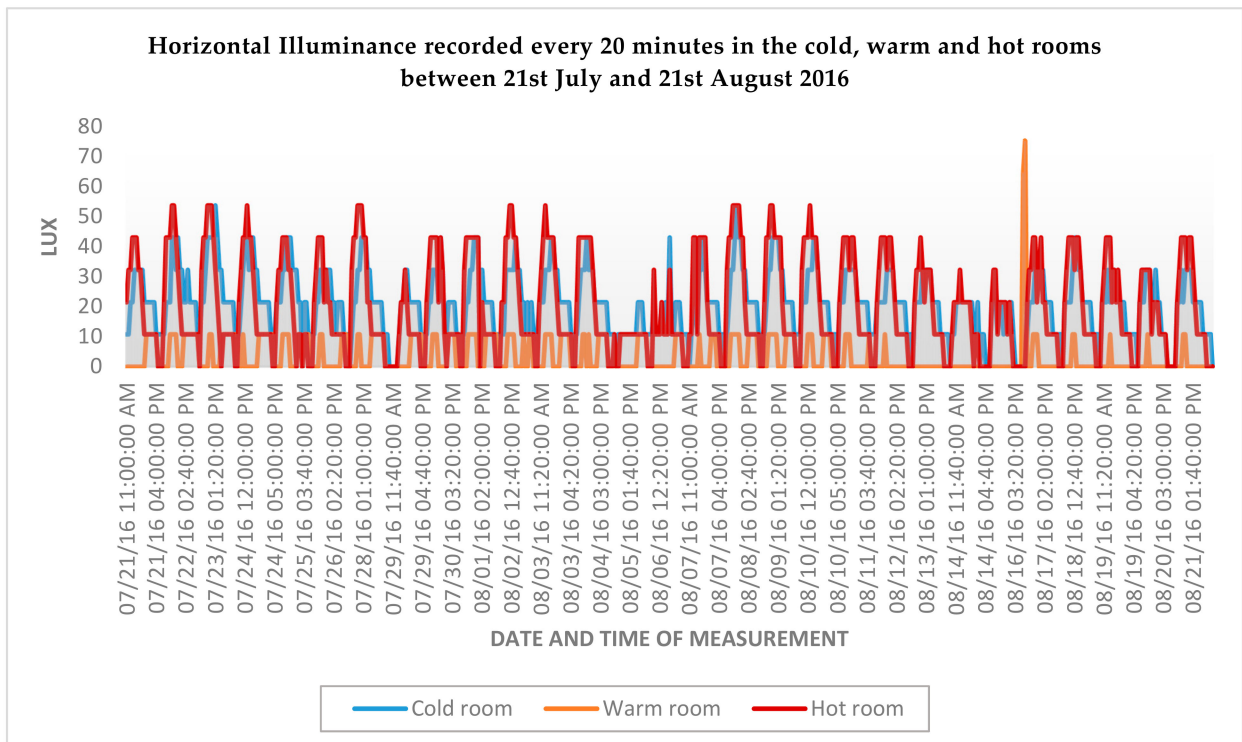
Figure 15. Horizontal illuminance values recorded in the three bathing spaces during the summer of 2016 on a daily basis between 11:00 a.m. and 05:00 p.m.

The plotting of weekly averages of horizontal illuminance (recorded every 20 min between 11:00 a.m. and 17:00 p.m.) over a period of almost two months and a half, clearly indicates that the averages of daylight levels do not exceed 25 lx and that the cold room tends to have slightly higher averages than the hot room despite their same configuration and orientation (Figure 14). However, when examining daily plotting of recorded illuminance in the three spaces, the results show that horizontal illuminance (lx) recorded in the hot and cold rooms varies between 10 and 60 lx with the hot room recording slightly higher levels than the cold room (Figure 15 and Table 3).

The plotting of horizontal illuminance levels over a period of two months and a half clearly indicate that it is in the hot room where the highest levels of horizontal illuminance were recorded (Figure 15). However, these levels remain well below 100 lx and do not exceed 60 lx (Figure 14). The levels recorded for the warm room remain the lowest as they have been jeopardised by the installation of two large solar panels, casting shadows over the oculi (Figure 12c) and resulting in levels being at 10 lx or below despite the sunny and clear sky conditions during the summer months. However, this indicates that the vernacular daylighting provision works best in conditions where the roof vaults have a good sky exposure and are not shaded by roof installations or adjacent buildings.

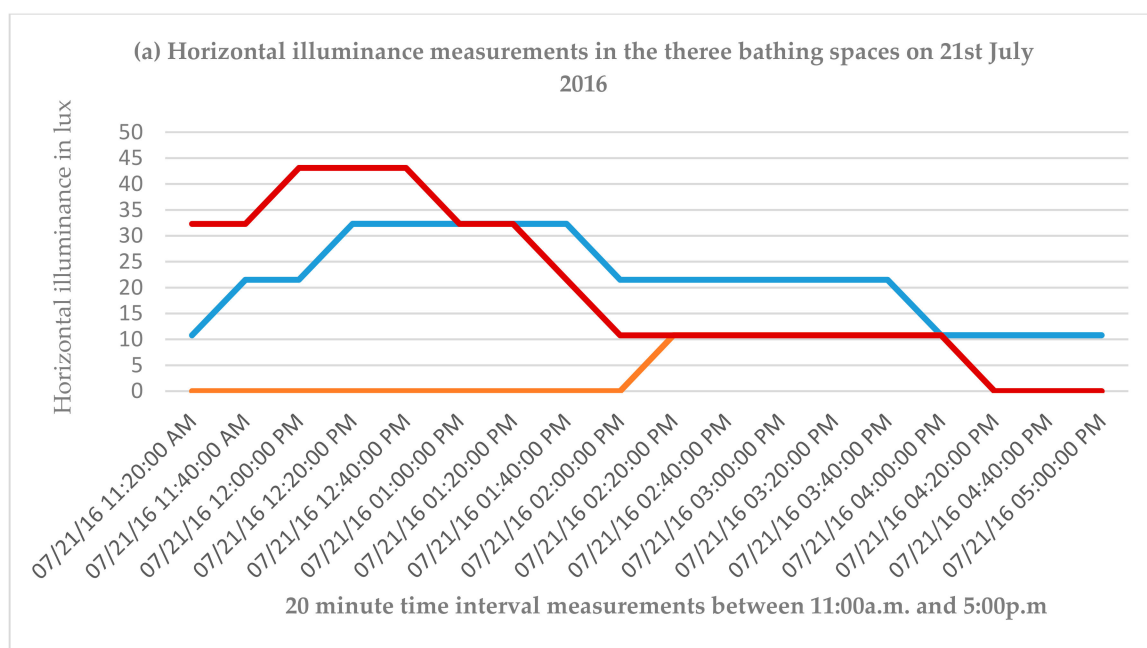
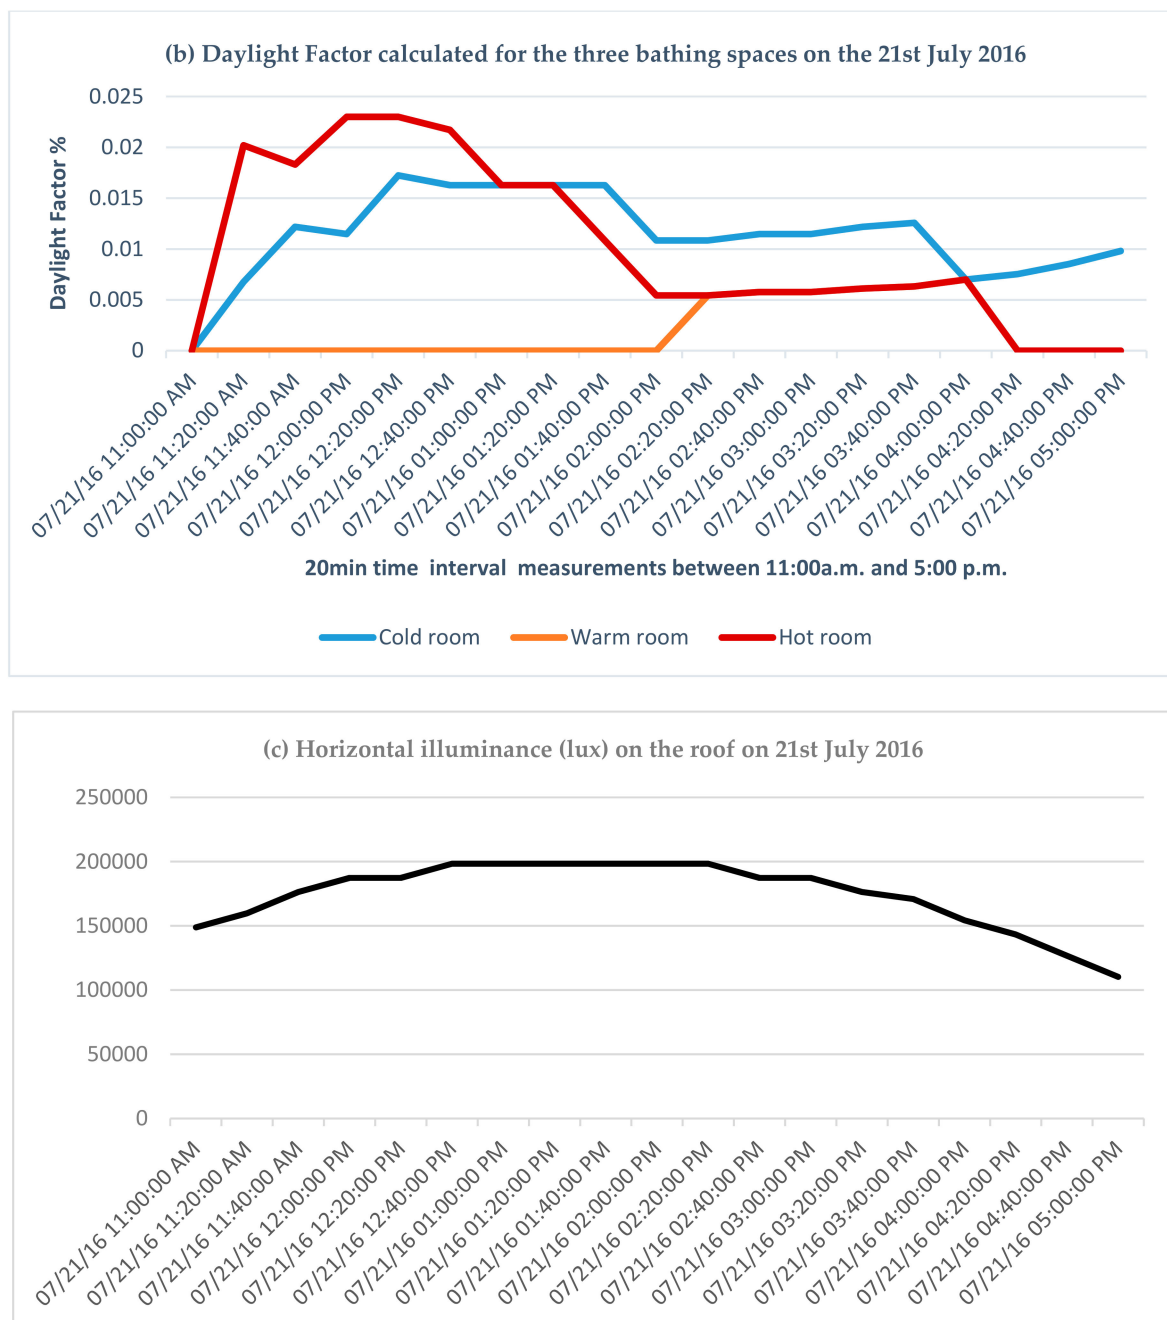
Figure 16. Horizontal illuminance in the three bathing rooms and on the roof and the calculated daylight factor on the 21 July 2016 between 11:00 and 17:00.

The plotting of the 21 July 2016 measurements in the cold, warm and hot room, as well as on the roof, reveals a more detailed pattern of illuminance variation in the three bathing spaces and the roof sky conditions (Figure 16). These plots, together with Table 3, illustrate a clear correlation between the sky conditions and the daylight levels afforded by the vernacular system.

The drop in light levels is much more sudden in the hot room than in the cold room and this could be explained by the high level of steam (98% humidity) reached in the space by early afternoon, when the use of the hot room by bathers is at its highest. The daylight factor calculation for the same day, based on real data, reveals that there is a sudden reduction in the DF in the hot room early afternoon (Figure 16b) below that of the cold room as the humidity and steam in the hot room reach saturation levels.

The comparison of recorded illuminance on the roof and the three bathing spaces on the 21 July 2016 (between 11:00 and 17:00) clearly illustrates that the sky conditions are directly reflected into indoor daylight levels in the hammam bathing spaces (Figure 16). This indicates that the vernacular
