International Journal of Disaster Risk Reduction

Myths and realities about the recovery of L'Aquila after the earthquake

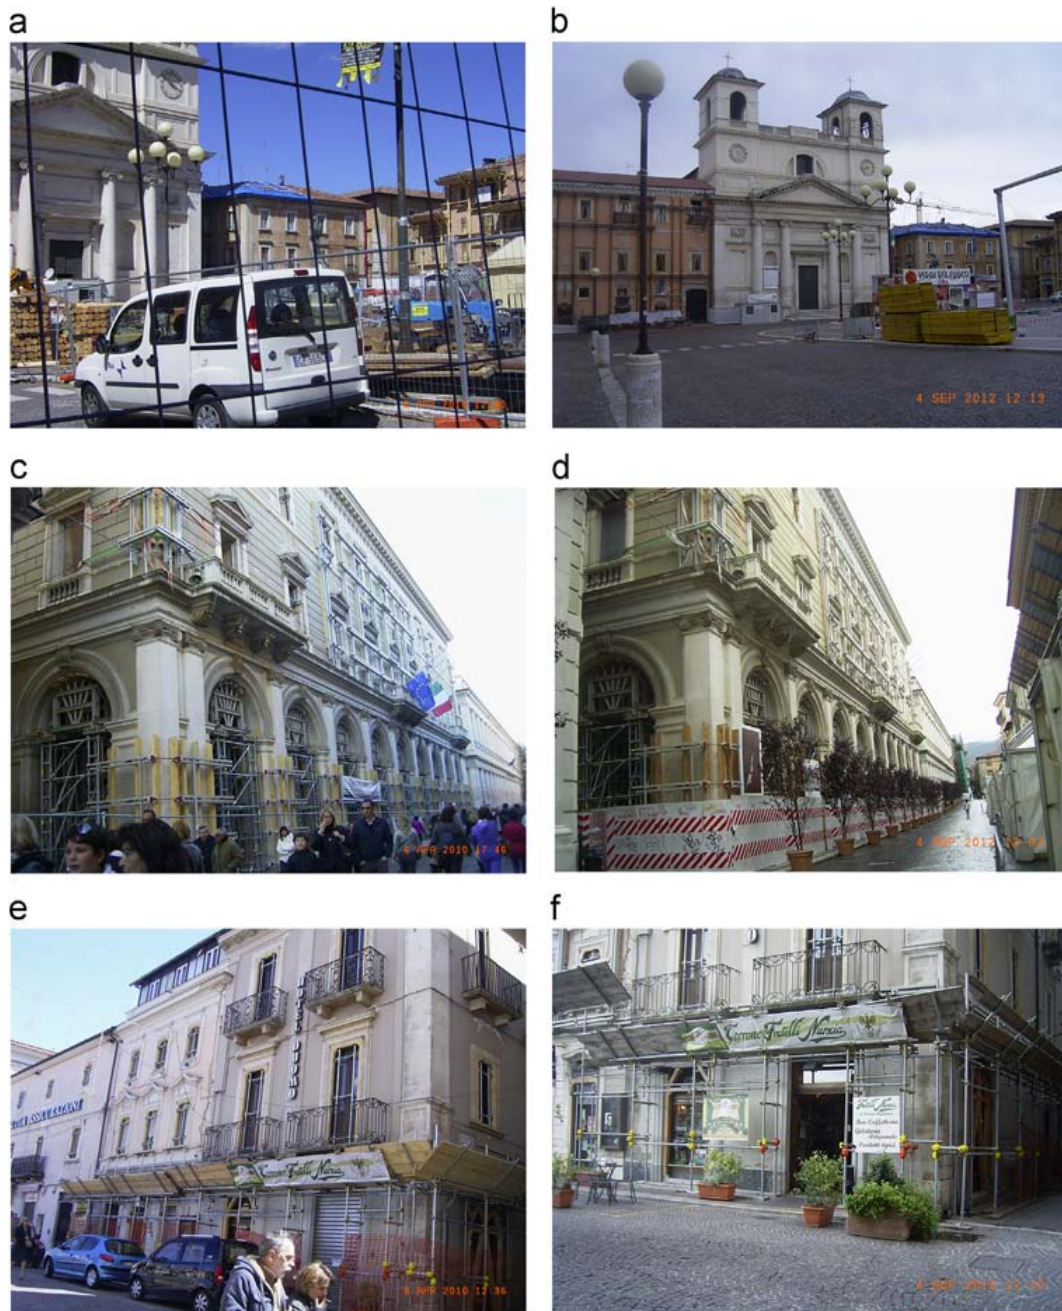
Fig. 4. Changes around Piazza del Duomo in L'Aquila (Italy) between 2010 and 2012. (a) Duomo with fences (2010); (b) Duomo without fences (2012), but the entrance remains forbidden; (c) Via Corso Vittorio (2010); (d) Via Corso Vittorio with some landscape interventions (2012); (e) Bar – Caffetteria – Gelateria Fratelli Nurzia (2010) and (f) Bar – Caffetteria – Gelateria Fratelli Nurzia (2012). Photos by Diana M. Contreras M.

In the piazza del Duomo, the fences have been removed (Fig. 4a and b), but the columns are still propped.

Some landscape considerations, such as positioning plants in front of the columns along the Vittorio Emanuele street were done (Fig. 4c and d). In L'Aquila, the areas along Via XX Settembre, Corso Federico II, Vittorio Emanuele II, Via Sallustio, Piazza del Duomo, and around Piazza Regina Margherita, Piazza Battaglione Alpini and Piazza Fontesecco show signals of recovery, with the reactivation of the commercial activities existing before the event (Fig. 4e and f).

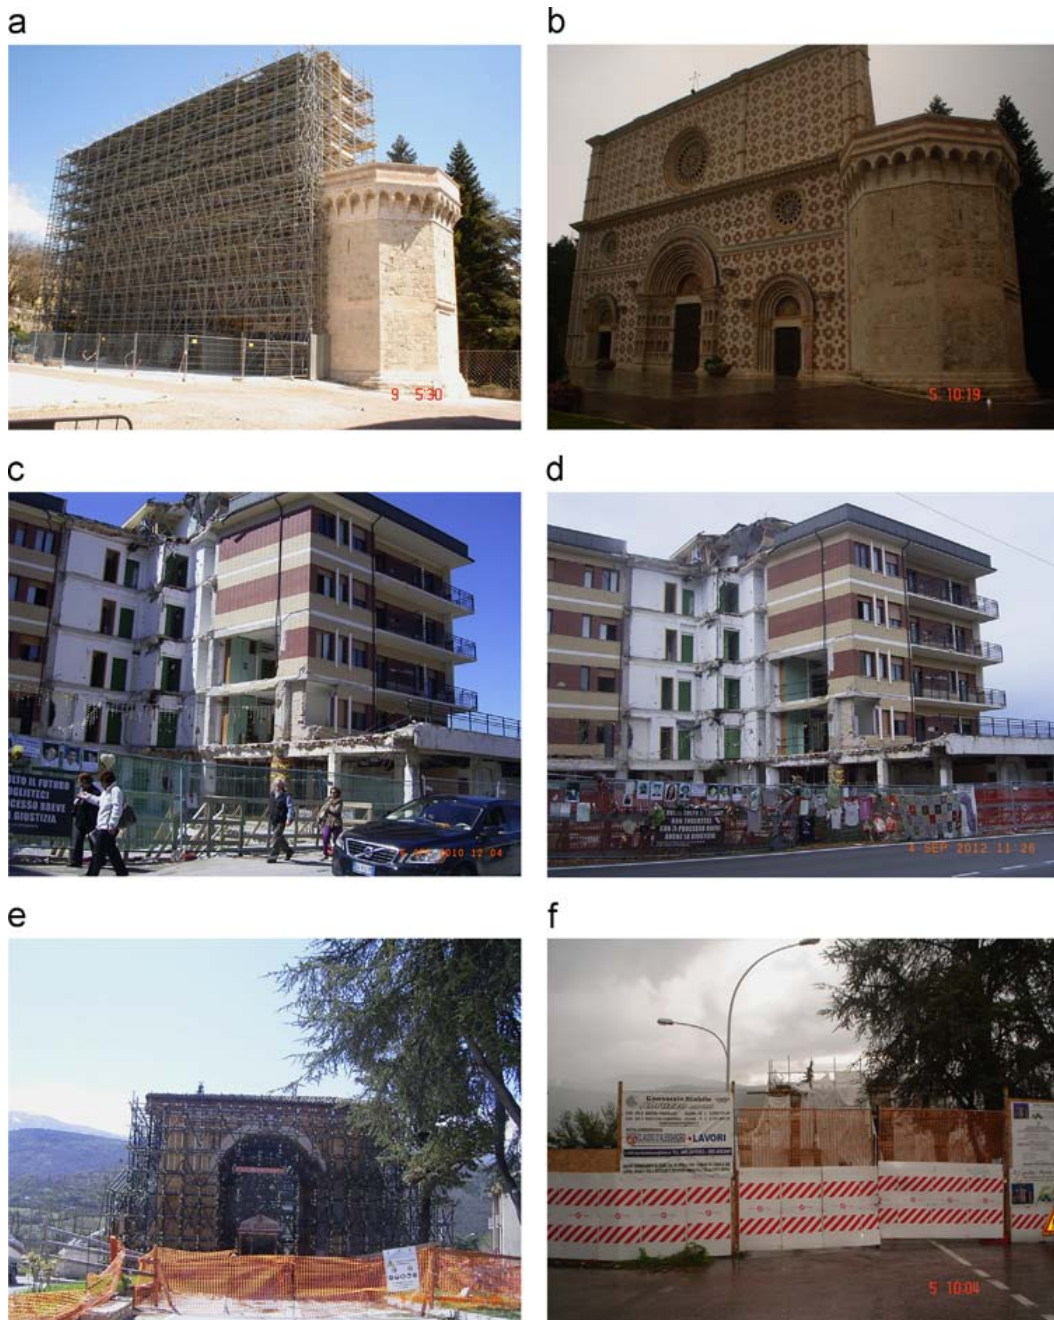
Fig. 5. Cases in the stages of the buildings. Progress in the reconstruction: (a) Santa Maria de Collemaggio (2010) and (b) Santa Maria de Collemaggio (2012) (inside is still propped). No changes between 2010 and 2012: (c) Student hostel (2010) and (d) Student hostel (2012). Buildings more deteriorated: (e) Porta Napoli (2010) and (f) Porta Napoli (2012). Photos by Diana M. Contreras M.

Since 2010, some buildings show some progress in terms of reconstruction (Fig. 5a and b), while others remain in the same stage as in 2010 (Fig. 5c and d), and some appear to have even further deteriorated (Fig. 5e and f). Within the restricted area, you could find houses that were already occupied by 2012. Nevertheless, sometimes it was difficult to determine if a house was occupied or not: at a first glance it may have seemed to

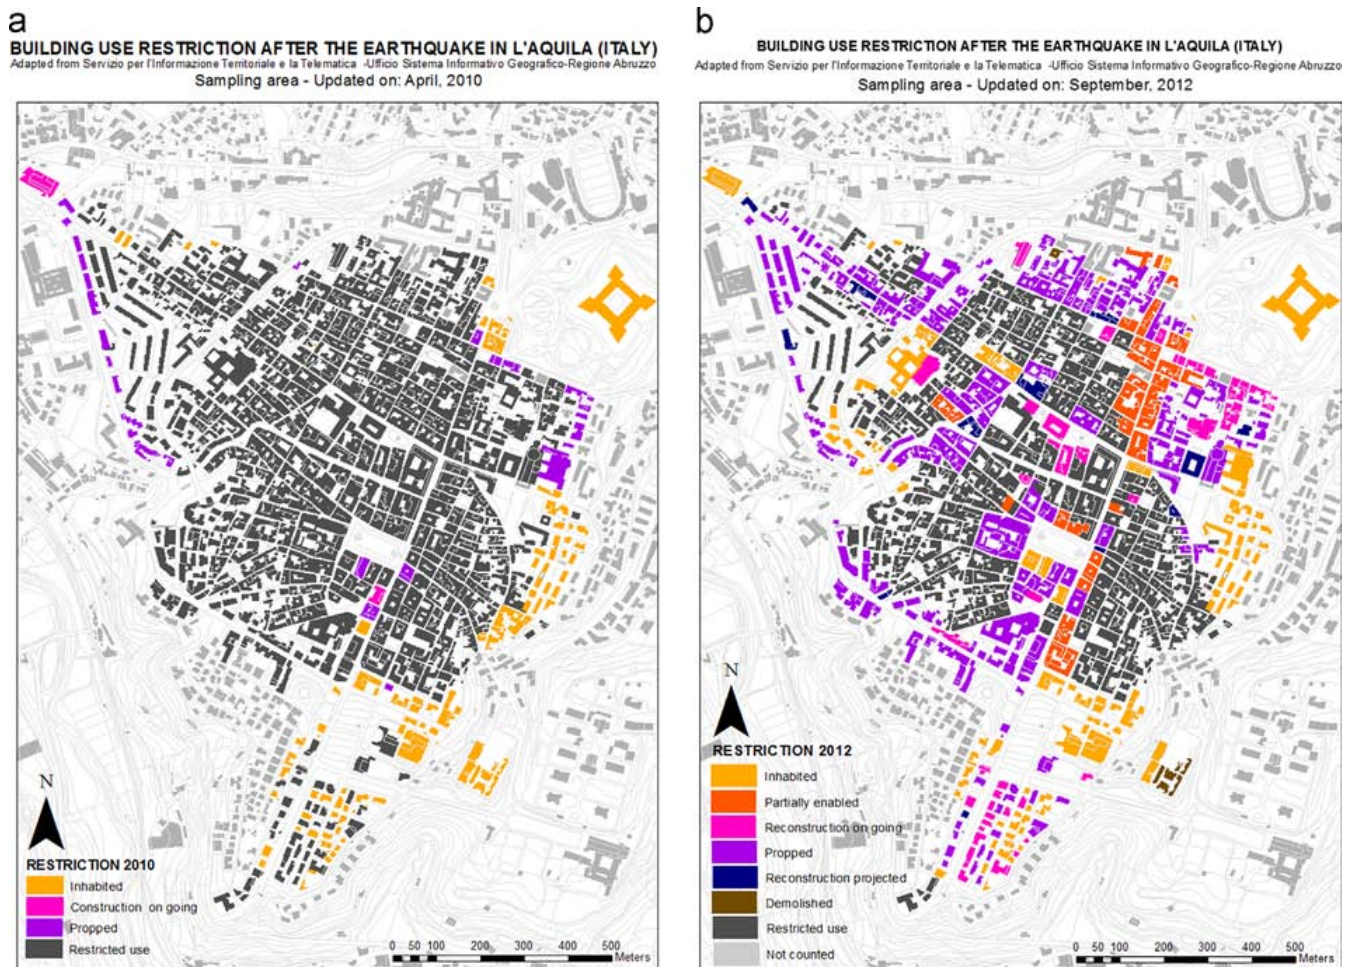
Fig. 6. Time series to compare the changes in a sampling area within the restricted zone in L'Aquila (Italy) after the earthquake between (a) 2010 and (b) 2012.
