Prior, Jonathan 2016. Urban river design and aesthetics: A river restoration case study from the UK. *Journal of Urban Design* 21 (4) , pp. 512-529. 10.1080/13574809.2016.1187557

Urban River Design and Aesthetics: A River Restoration Case Study from the UK

Jonathan Prior, Cardiff University

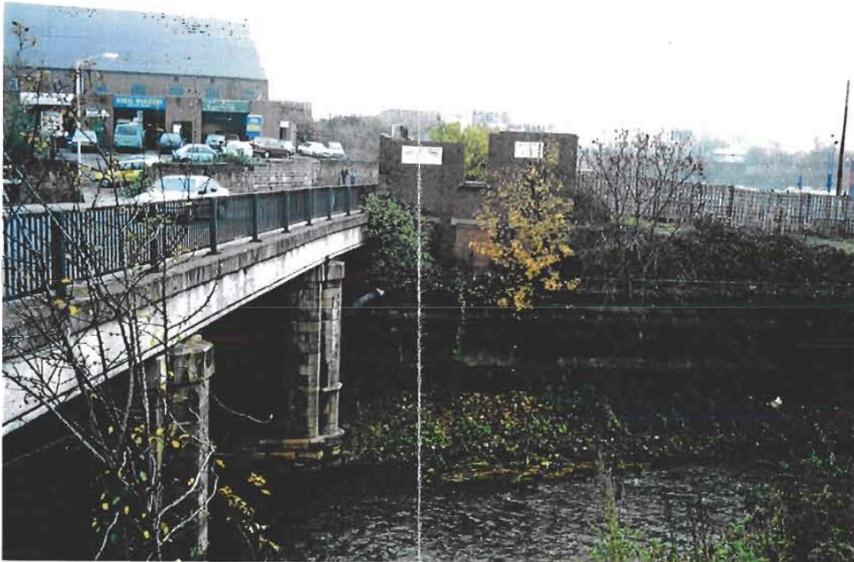
Section 1

‘has a particularly distinctive character largely dominated by its industrial past’

‘the left bank is edged by a large concrete railing wall that includes untidy pipes, metal railing and fencing’

‘the river in this area has lost its original character and has become canalized and downgraded’

“...urban public space. This has been split between amenity grass, including ornamental planting, and semi-natural vegetation. In addition there is also a small area of degraded industrial space” (SGS Environment, 1994, p. 15). In the assessment, the river was divided into six sections, based on “important landmarks or a change in character” (*ibid.*, 4), which is excerpted in Figure 1.

Figure 1. Selected photographs, descriptions, and classifications of the River Skerne from the Landscape Assessment (from SGS Environment, 1994, copyright the River Restoration Centre, reproduced with kind permission from the River Restoration Centre).

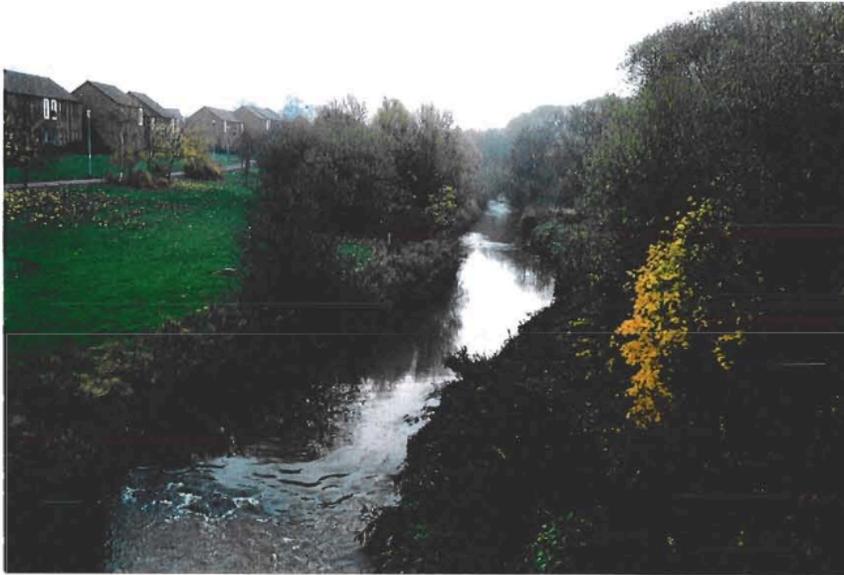
Section 2

‘the river has a soft edge on both sides with a fairly uniform profile’

‘industrial premises edge the right bank, these are located on an elevated plateau and are screened behind a densely vegetated embankment’

‘apart from the traffic noise on Albert Bridge the area is peaceful’

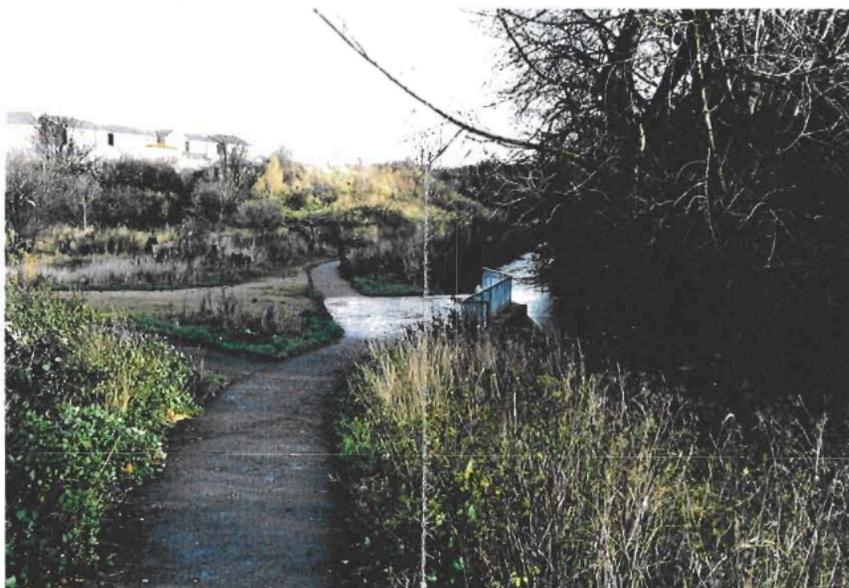
Section 3

‘the character of the area is...fragmented and varied, but generally of an enclosed semi-natural or part derelict appearance’

‘semi-natural vegetation provides a valuable green edge screening out unsightly buildings’

‘the right bank includes a confined corridor with mature trees adjacent to allotments’

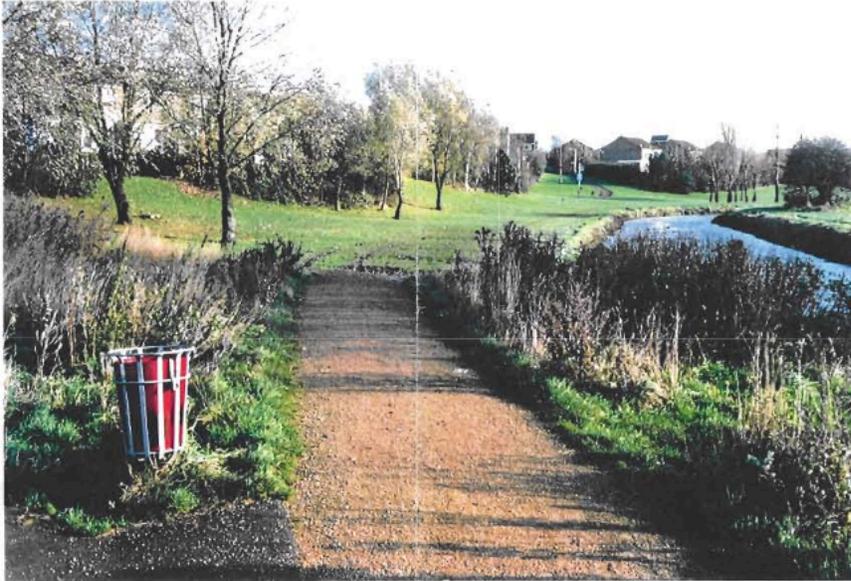
Section 4

‘the corridor consists of a complex series of spaces which appear as fragment units containing both semi-natural and tamed areas’

‘the character adjacent to the housing area changes to managed parkland with mown grass and groups of trees’

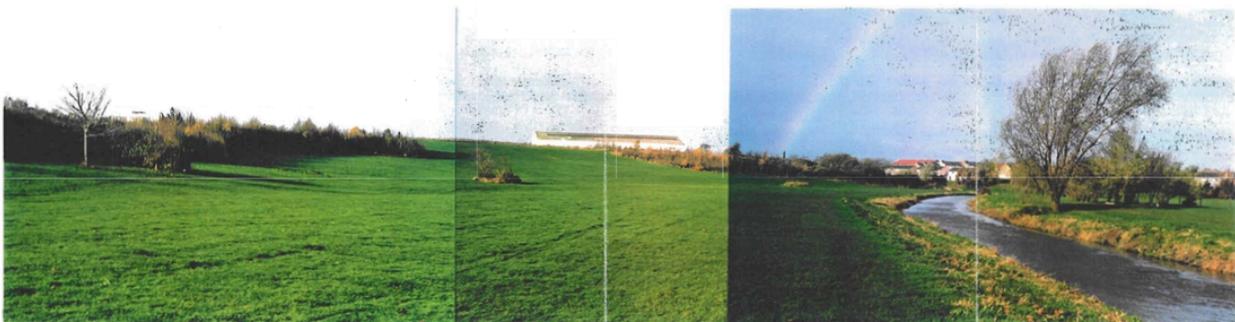
Section 5

‘it has a medium scale open space which has a unified feel’

‘the character is one of managed parkland on both sides of the river with few features’

‘industrial buildings dominate the skyline on the left bank’

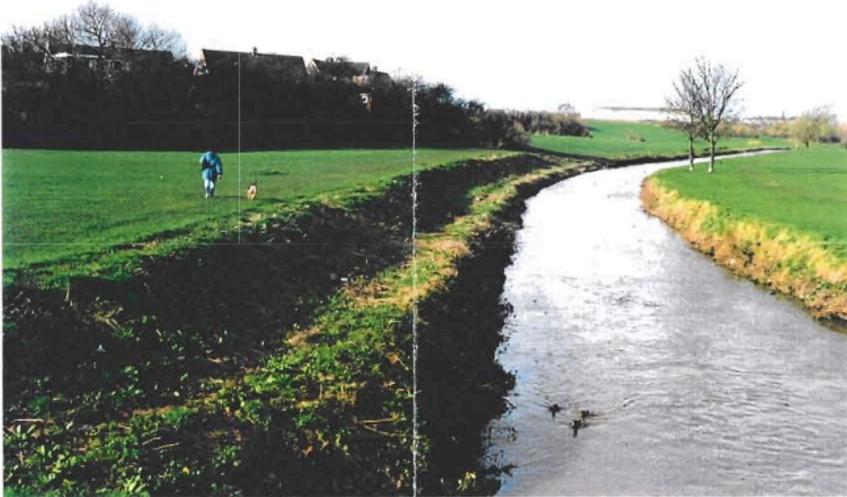
Section 6

‘the area is managed parkland with a fairly unified appearance’

‘traffic noise on Haughton Road has a major impact on the area’

‘the river channel has been subject to various works including an unattractive terrace built in the 1970s as part of flood defence measures’

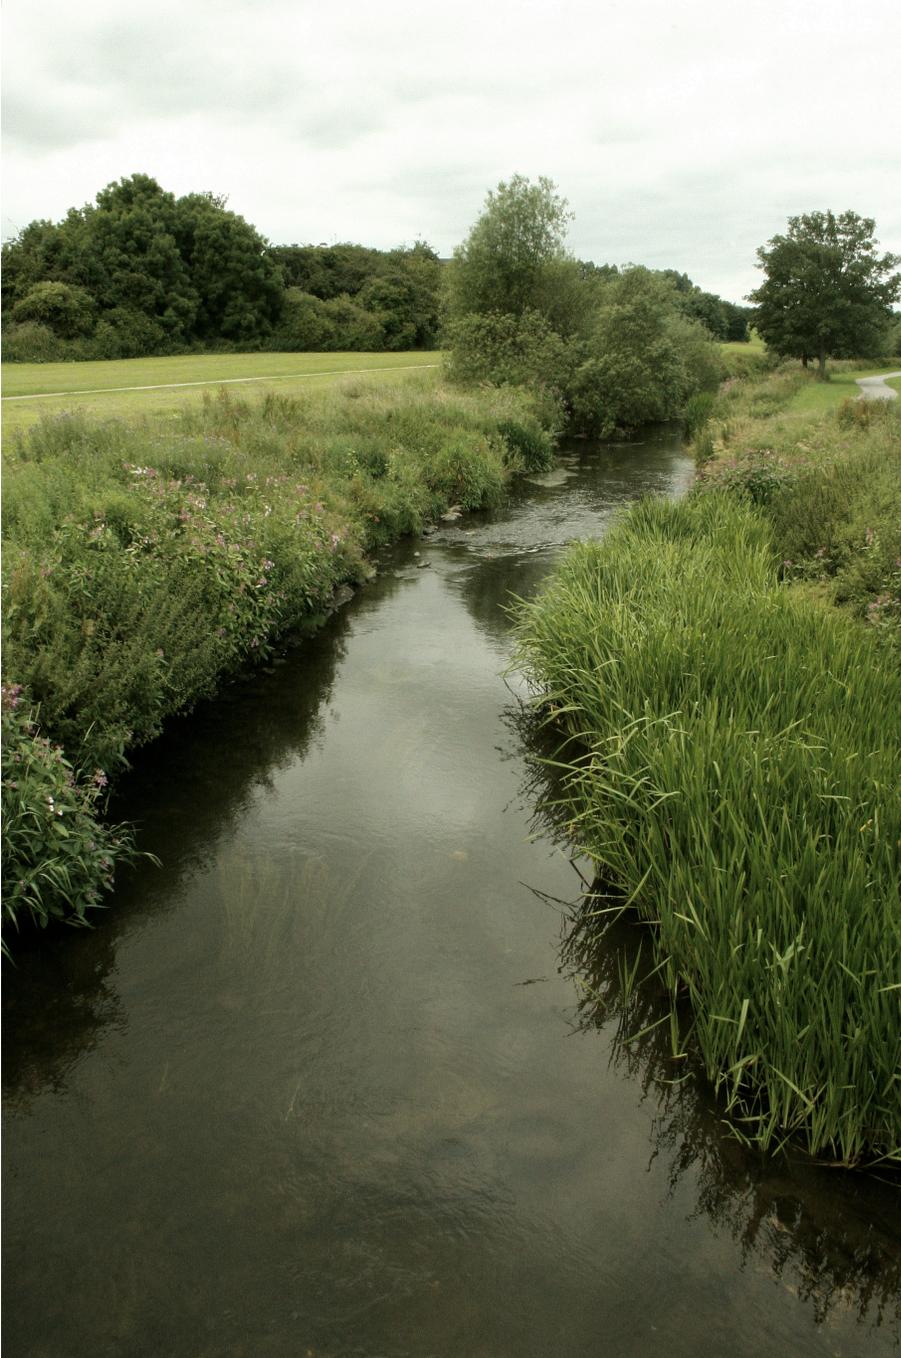
Figure 2. A view of the restored River Skerne. Note the designed aquatic ledge within the channel in the foreground on the right, a self-rooted willow downstream (likely derived from a willow revetment), and the general re-shaping and planting of the channel as compared to the pre-restoration image of section 6 in Figure 1(f) (Photograph by author).

As with the meanders, we see here an interesting interplay between technique design and visual aesthetics. As the visible materials used are natural (the mesh nylon is concealed by the living willow), these interventions at once obscure their artifactual qualities. Thus, along the river, soft engineering does not merely ‘soften the edges’ of hard engineering but rather dissolves the very notion of an engineered river. It also results in the visual integration of discrete structural interventions – meanders, revetments – into a seamless and coherent naturalistic whole. To the

uninformed eye, the meanders and revetments are read as integrated within the channel system, not as a series of discrete restoration techniques (see Figure 2).

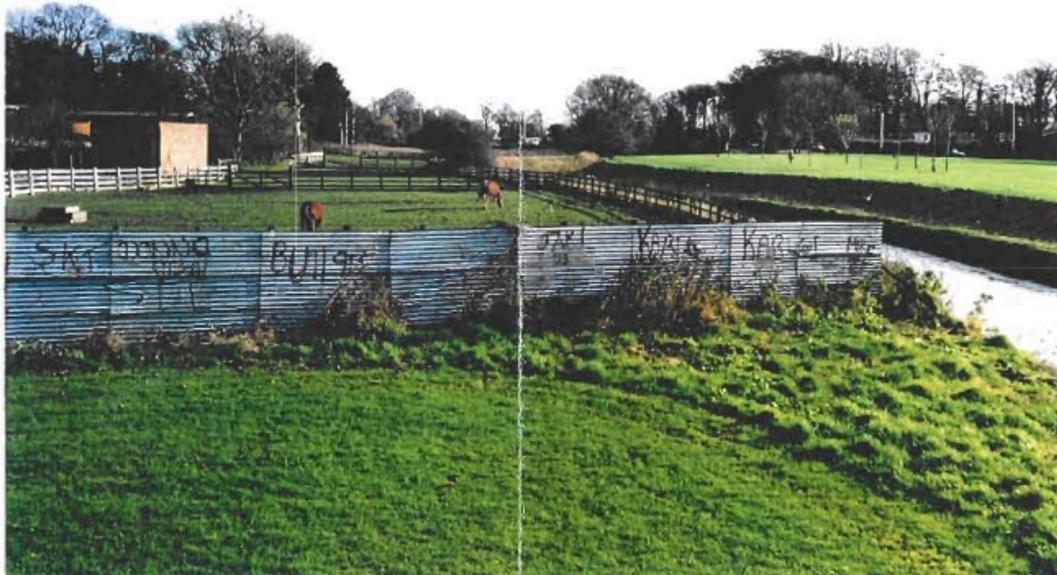
Figure 3. A metal fence at the perimeter of the site before restoration works (3(a)), and after when concealed with hawthorns, elder and dog rose (3(b)). (3(a) copyright the River Restoration Centre, reproduced with kind permission from the River Restoration Centre; 3(b) photograph by author).

Multi-sensory framing through design also encompasses attempts to screen certain visual and sonic aesthetic qualities of the pre-restored landscape. Metal fences have been concealed with hawthorns, elder and dog rose (compare Figure 3(a) with Figure 3(b)), and graffitied walls with ivy; trees have been strategically planted to visually and sonically screen an industrial site to the south of the river; and a flat expanse of clay that was “bare and horrid” (Interviewee 2, September 2009) has been landscaped with grass, creating a smoothly graded incline that peaks at the northernmost section of the site. Collectively, this creates a strong visual and sonic boundary that demarcates the restoration site from adjacent landscapes; in landscape design terminology, this is the production of a “spatial edge” that: “...encloses space, terminates sight line, and defines viewshed” (Motloch, 2000, p. 190).

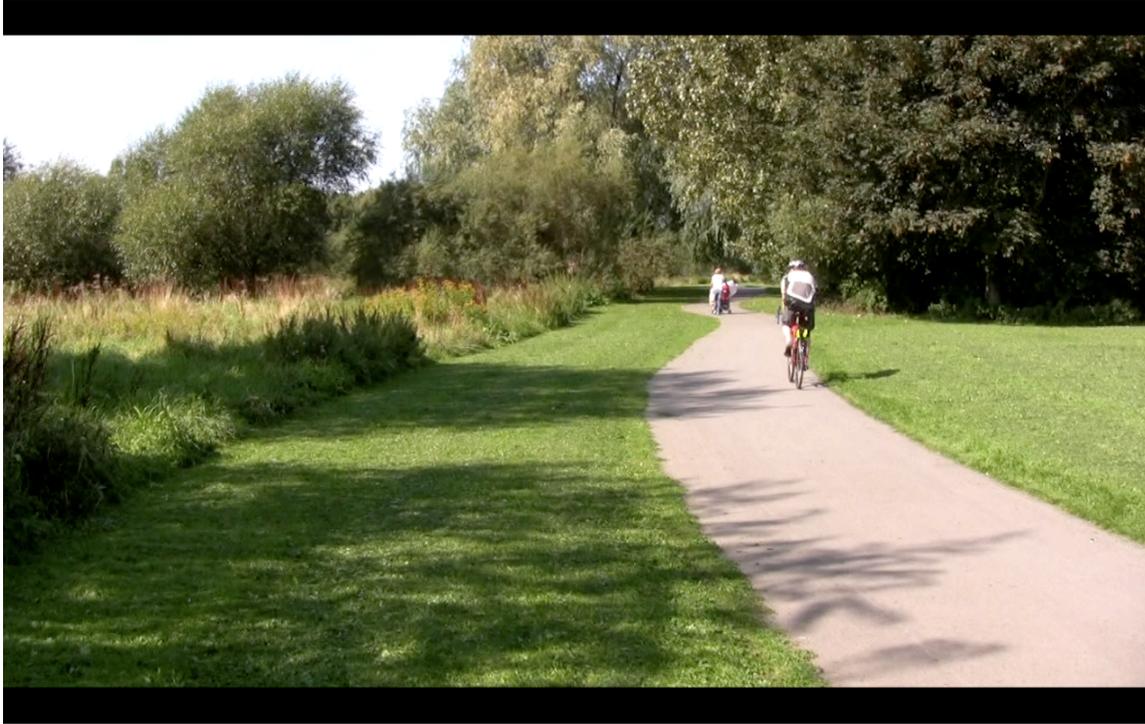
Figure 4. Bitumen cycle and walking path tracing the contours of the new river channel meanders (Photograph by author).

Finally, one concrete walking path to the south and one bitumen cycle and walking path to the north have been laid, which both trace and thus visually accentuate the contours of the new river meanders (Figure 4). Both also allow for comfortable, smooth mobility along the river’s edge, and are suitable for pushchairs and wheelchair users. The concrete path’s buff colour was “chosen to blend with the surroundings once weathered”, and “resting/passing areas were placed approximately every 100m in positions affording interesting views of the site” (RRC, 2002, 8.3). A new footbridge has also been installed to create a circular walk between it and the existing footbridge to the east of the site.

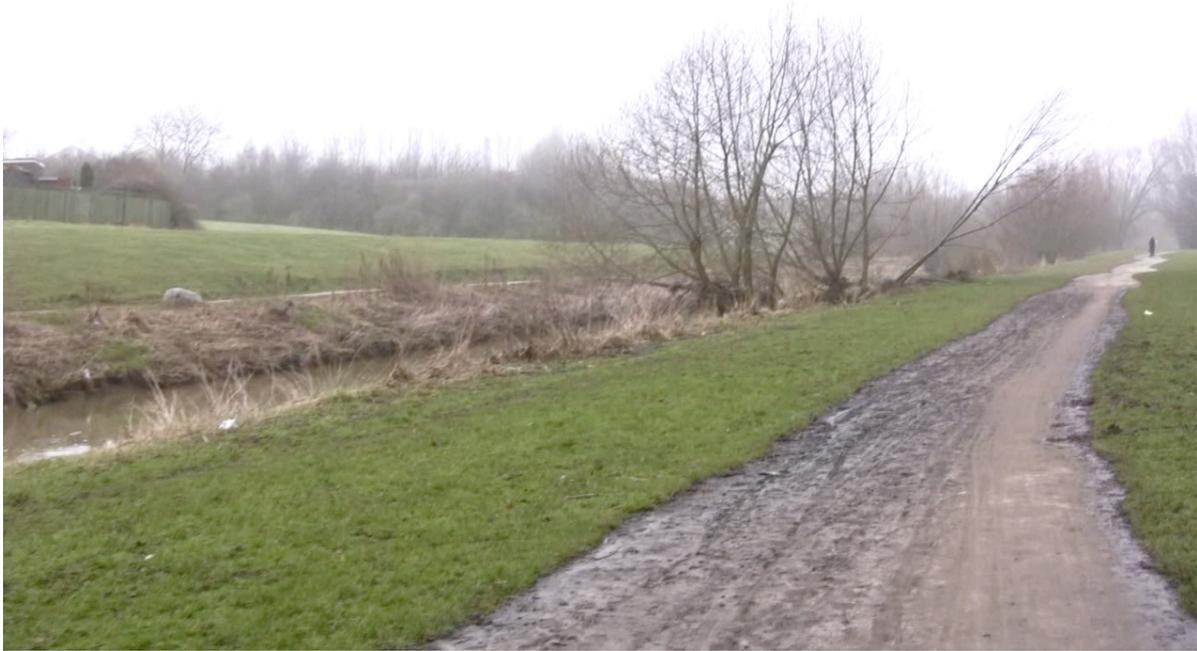
Figure 5. Bankside and river channel after winter cutback (Photograph by author).

These operations result in their own particular spatio-temporal aesthetic qualities. Near-total cutback of vegetation along the banks in September allows for the meandering river channel to be clearly viewed during the winter, and gives a more ‘open’ visual perspective across the landscape (Figure 5). However, the sheer cut is an example of how “...seasonal landscape elements are poorly catered for in environmental management” (Boyd & Gardiner, 2005, p. 197). During this time, an observer of the landscape is made keenly aware that the river’s vegetation relates to cyclical and predictable human design, while the removal of cut debris intervenes in any aesthetic regard for the full cycle of death and regrowth of vegetation, interrupting a seasonal sense of landscape rhythm (after Motloch, 2000, p. 122).
